# Water Resources Report

RILEY PURGATORY BLUFF CREEK WATERSHED DISTRICT  
2017 ANNUAL REPORT

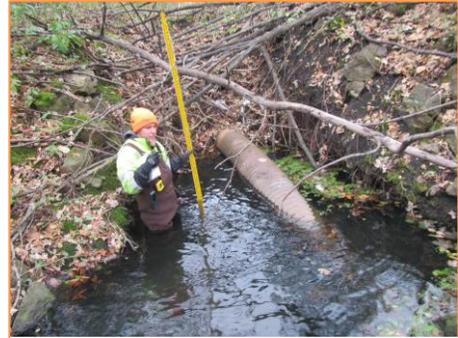
**Figure 4.4-1 Degraded Stormwater Culvert PT2B**

Subreach PT2A is a wetland complex and should not have been scored in the previous assessment. PT2B Tier I score shifted from good to poor because of large amounts of sediment covering all instream habitat. Large erosion areas also existed along the entirety of the subreach including the severely eroded stormwater culvert seen in Figure 4.4-1. PT2C shifted from moderate to good overall because the city of Chanhasseen completed a large restoration project that had been successful in stabilizing the subreach. Subreach PT2D and both the middle and southern ravine scores changed from good to moderate which was mostly based upon the more abundant erosion areas present that were missed upon reviewing old photos. A summary of the score changes can be seen in **Error! Reference source not found.**

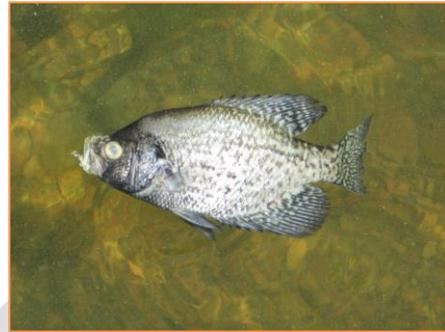
**Figure 4.8-1 Deceased Crappie Observed on Lotus Lake 6/5/2017**

On May 12<sup>th</sup>, 2017, while conducting a regular check of District lake level sensors, RPBCWD staff observed several dead bluegills and crappies on Hyland lake around the boat launch. Additionally, on June 5<sup>th</sup>, 2017, staff noticed some dead bluegills and crappies near the boat ramp of the Lotus Lake public boat access while conducting regular water quality monitoring (Figure 4.8-1). The fish found had been dead for at least a few days and a majority were whole. Most of the fish were of catchable size with very few small fish visible, however smaller fish are scavenged more easily and could have been removed. Surface water temperatures on Lotus had warmed 3.09 degrees Celsius from the previous month's sampling date (5/16/2017) on Lotus.

These fish kills were likely due to rapidly rising water temperatures combined with increased stress. Fish kills can occur on different area lakes when water temperatures warm in May and June following spawning activity. In the past, pathology investigations have identified a bacterial infection *Flexibacter columnaris* as a reason for previous fish kills. The University of Minnesota had previously collected fish samples from Lotus Lake in 2016 to determine if the bacterial infection is a secondary cause or a primary cause, but the results were inconclusive due to desiccation. Staff reported the 2017 fish kills to the University of Minnesota Fish Kill Reporting Map. See information below about *F. columnaris* provided by the MNDNR:

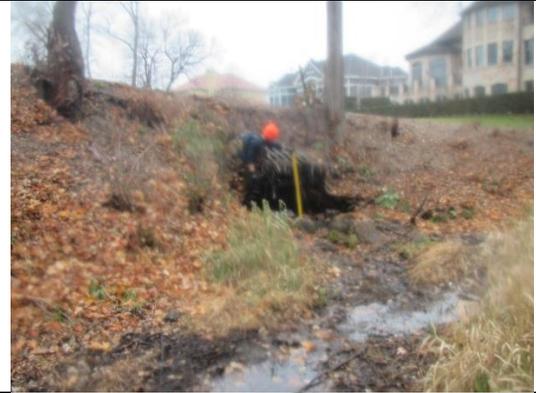
<p><b>IMG_2191</b></p> <p>Stormwater culvert suspended 3ft and undercut 3.5ft, RB, US.</p>

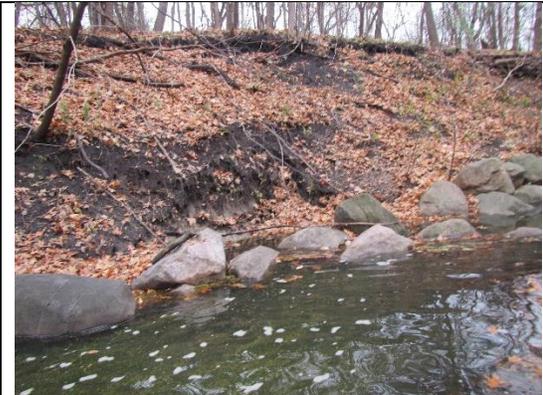
<p><b>IMG_2149</b></p> <p>Failed riprap/ boulder placement, LB.</p>

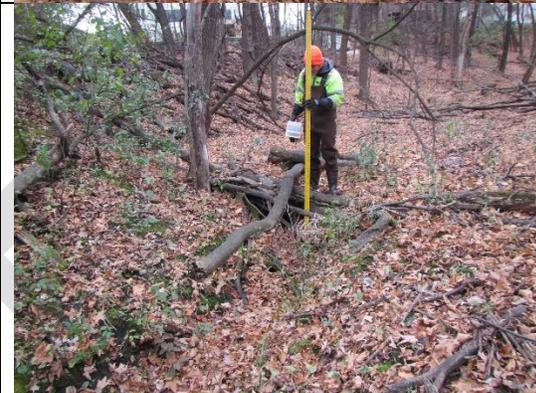
<p><b>IMG_2117</b></p> <p>Large woody debris dam; small waterfall with 0.8ft of erosion, RB; US.</p>

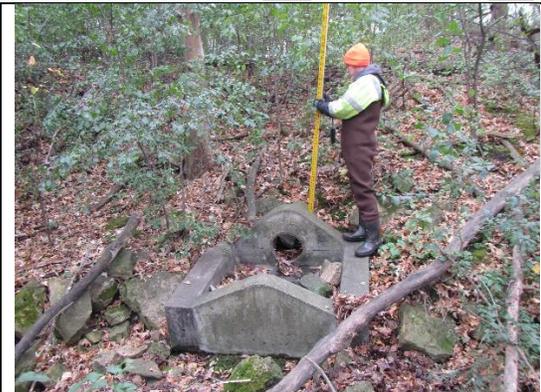
<p><b>IMG_2118</b></p> <p>Old stormwater culvert, RB.</p>
