# **Creek Restoration Action Strategy**

# 2017 Report

Riley Purgatory Bluff Creek Watershed District

May 2017

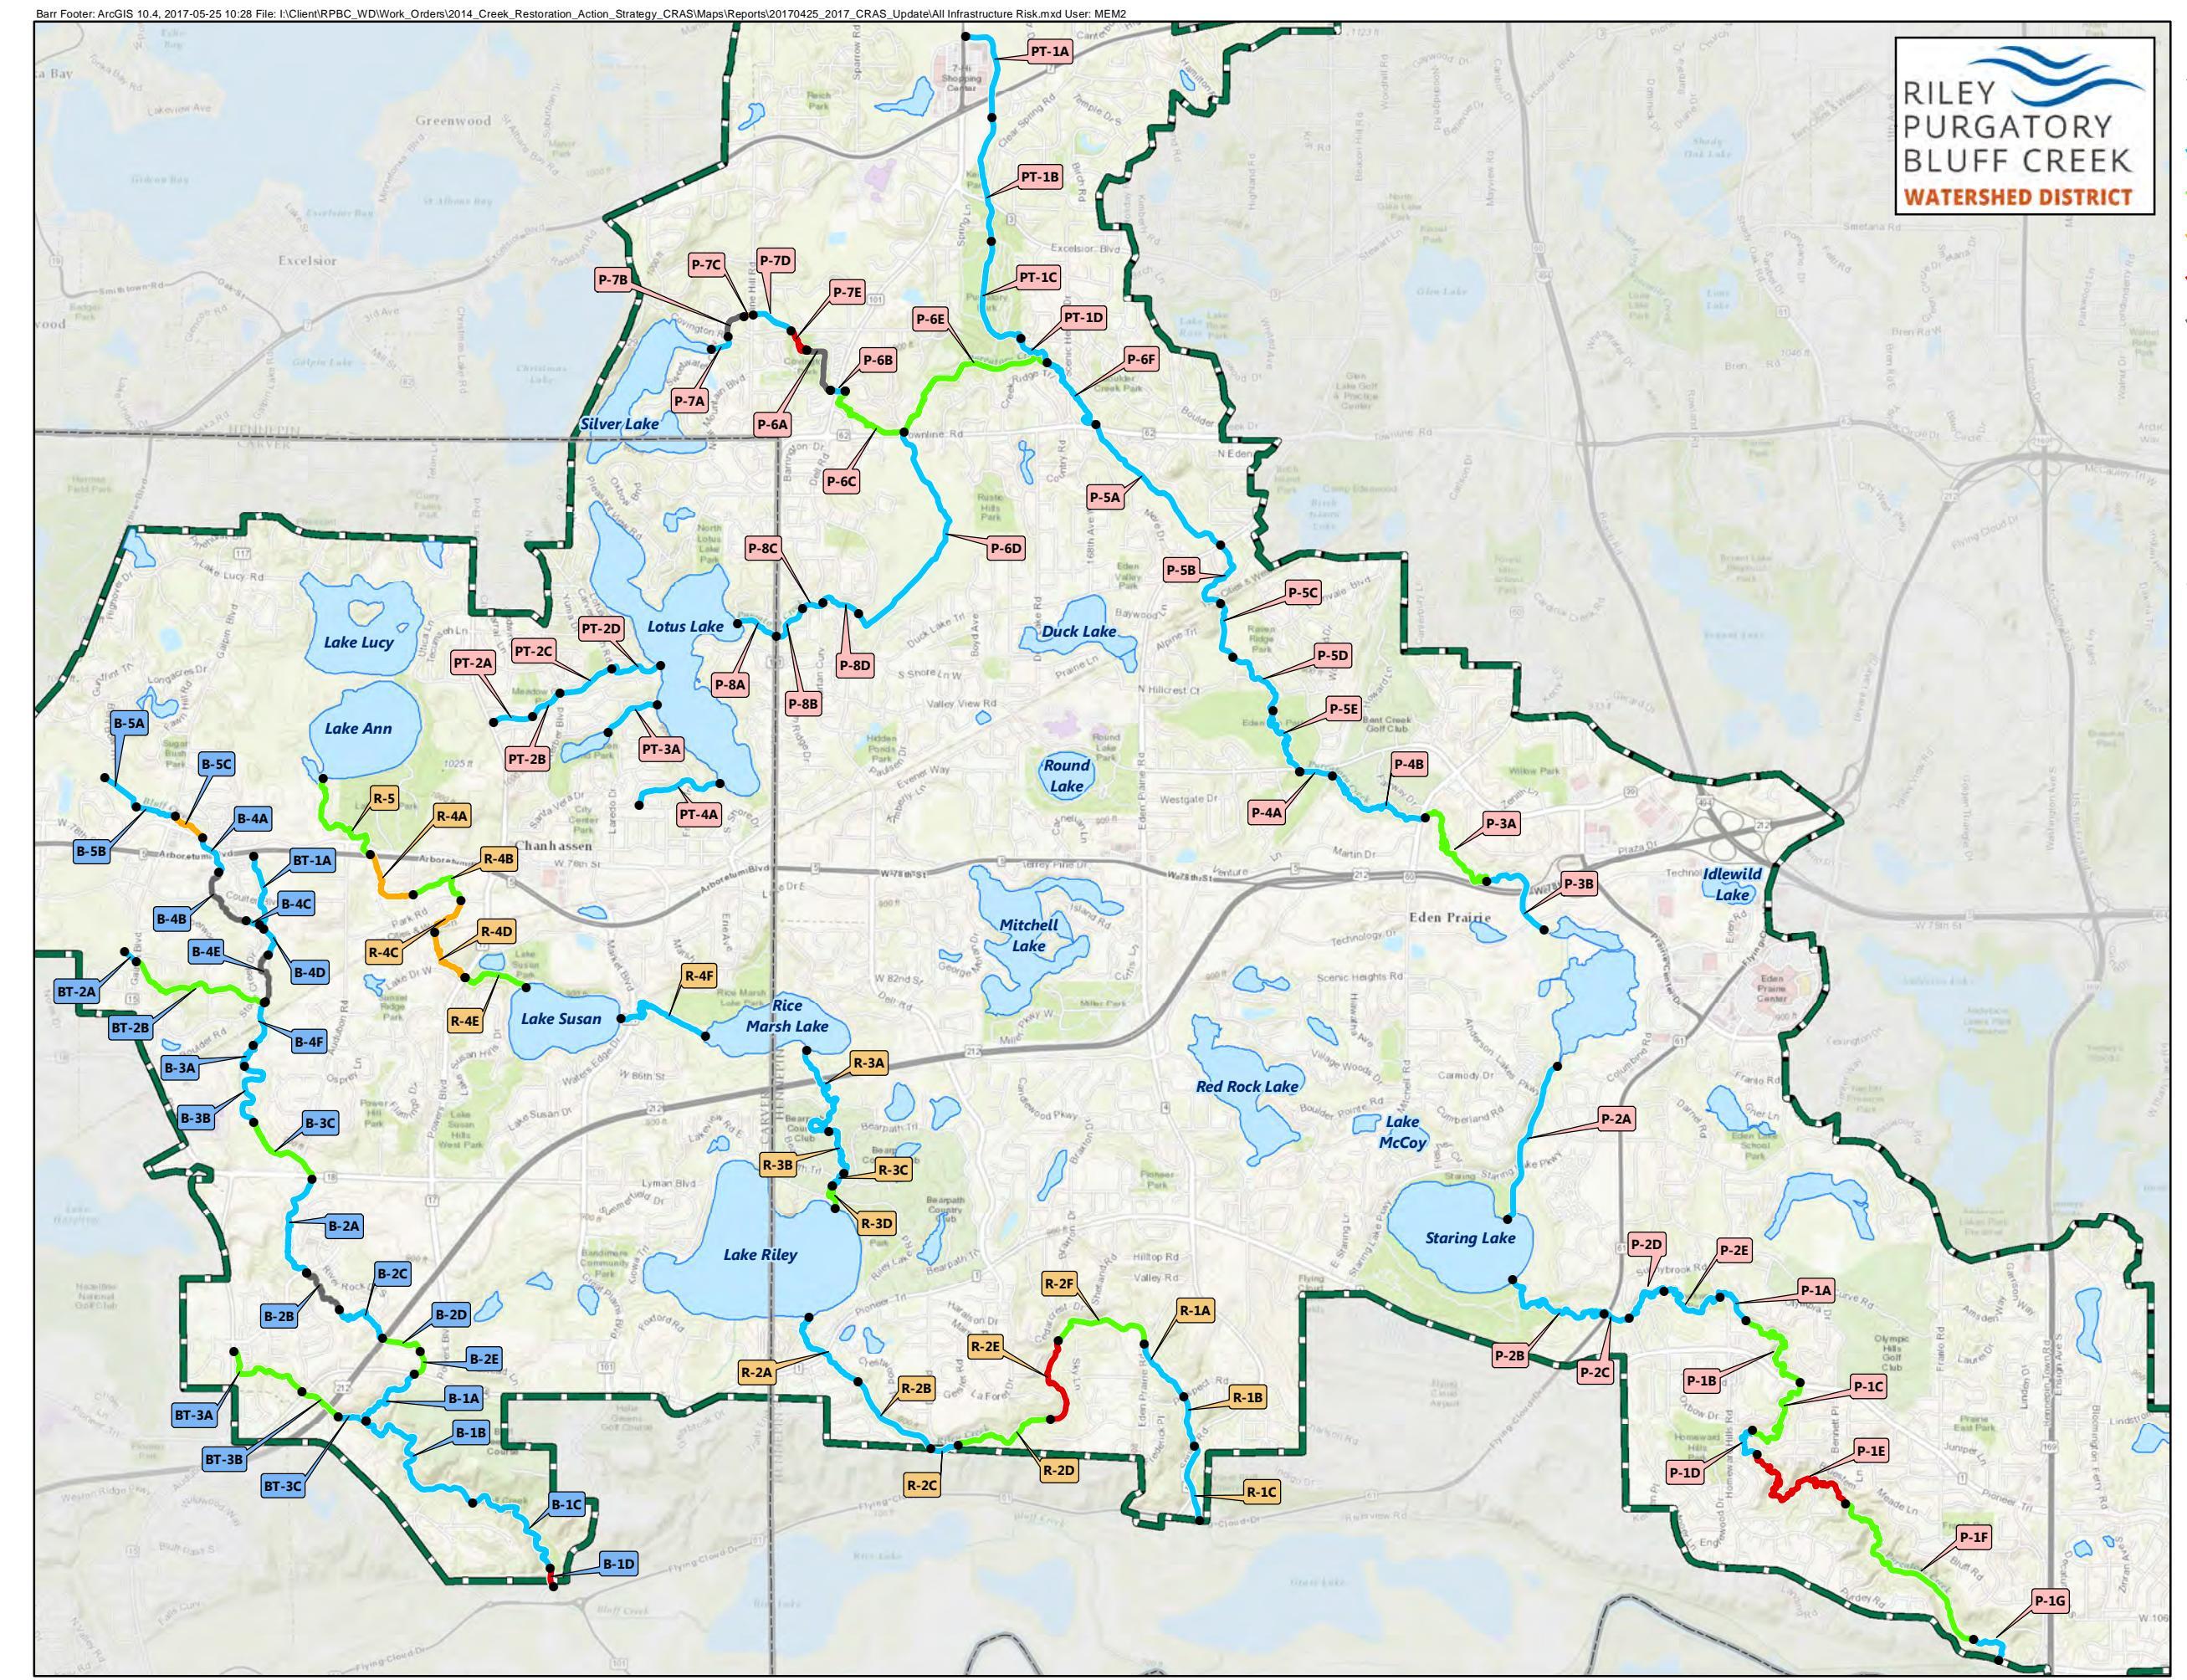
As shown in Table 5-1, the majority of the sub-reaches scored in the poor/high or severe category for erosion and channel stability (49 sub-reaches, equaling 58% of all sub-reaches). As shown in Figure 5-7, the majority of poor/high or severe erosion scores occur in lower valleys of the creeks and is largely related to mass wasting on tall valley walls.
