Water Resources Report

RILEY PURGATORY BLUFF CREEK WATERSHED DISTRICT
2020 ANNUAL REPORT

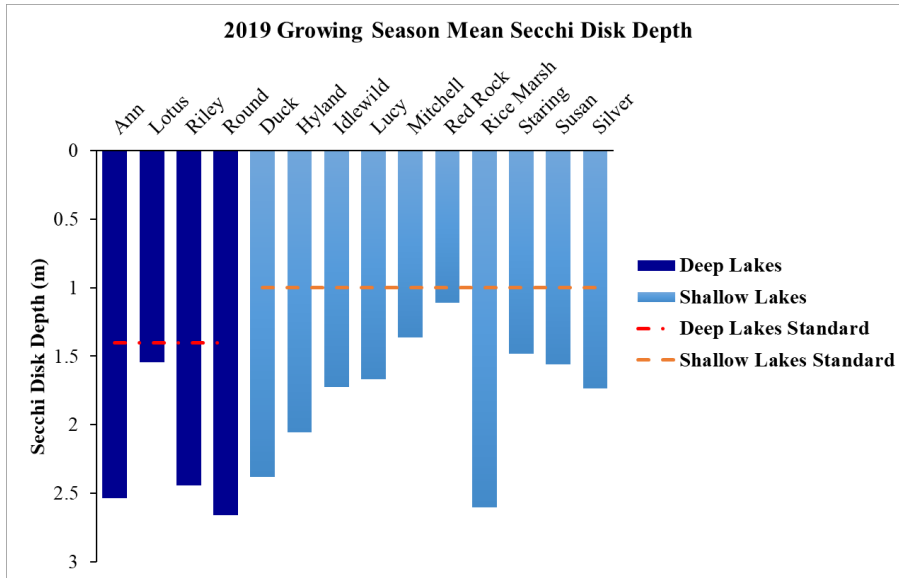
Figure 4 2020 Lakes Growing Season Mean Secchi Disk Depth

Lakes growing season (June-September) mean secchi disk depths (m) for shallow (lakes <15 ft. deep, >80% littoral area-light blue bars) and deep lakes (lakes >15 ft. deep, <80% littoral area-dark blue bars) in the Riley Purgatory Bluff Creek Watershed District during 2019. The dashed lines represent the Minnesota Pollution Control Agency water quality standards for secchi disk depths for shallow (>1 m-orange dashed line) and deep lakes (>1.4 m-red dashed line).

The MPCA standard for secchi disk depth/water clarity for deep lakes (> 1.4 m) was met by all Ann, Riley, and Round. Lotus met the standard in 2019 (1.54 m) but had reduced water clarity in 2020 (1.24 m). Ann and Round remained relatively stable from 2019 with secchi disk averages remaining between 2 and 2.5 m. Lake Riley had the highest summer average for all lakes sampled in 2020 and the average was the highest recorded since 1971 on the lake (4.64 m). For shallow lakes, all ten lakes monitored achieved the MPCA secchi disk depth water quality standard (>1m), an increase from eight of ten lakes monitored in 2018. For shallow lakes, the MPCA standard was not met by Mitchell and Red Rock in 2020. Red Rock had the lowest (worst) secchi reading at 0.66 m which was down from 1.11 m. Duck, Hyland, Idlewild, Silver, and Lucy had secchi readings near 2 and Rice Marsh was reduced from 2.6 m in 2019 to 2.2 m in 2020. Lake McCoy had depths less than 1 m and water clarity was to the lake bottom. Lake Staring and Lake Susan were just above the standard in 2020 (1.03 m).

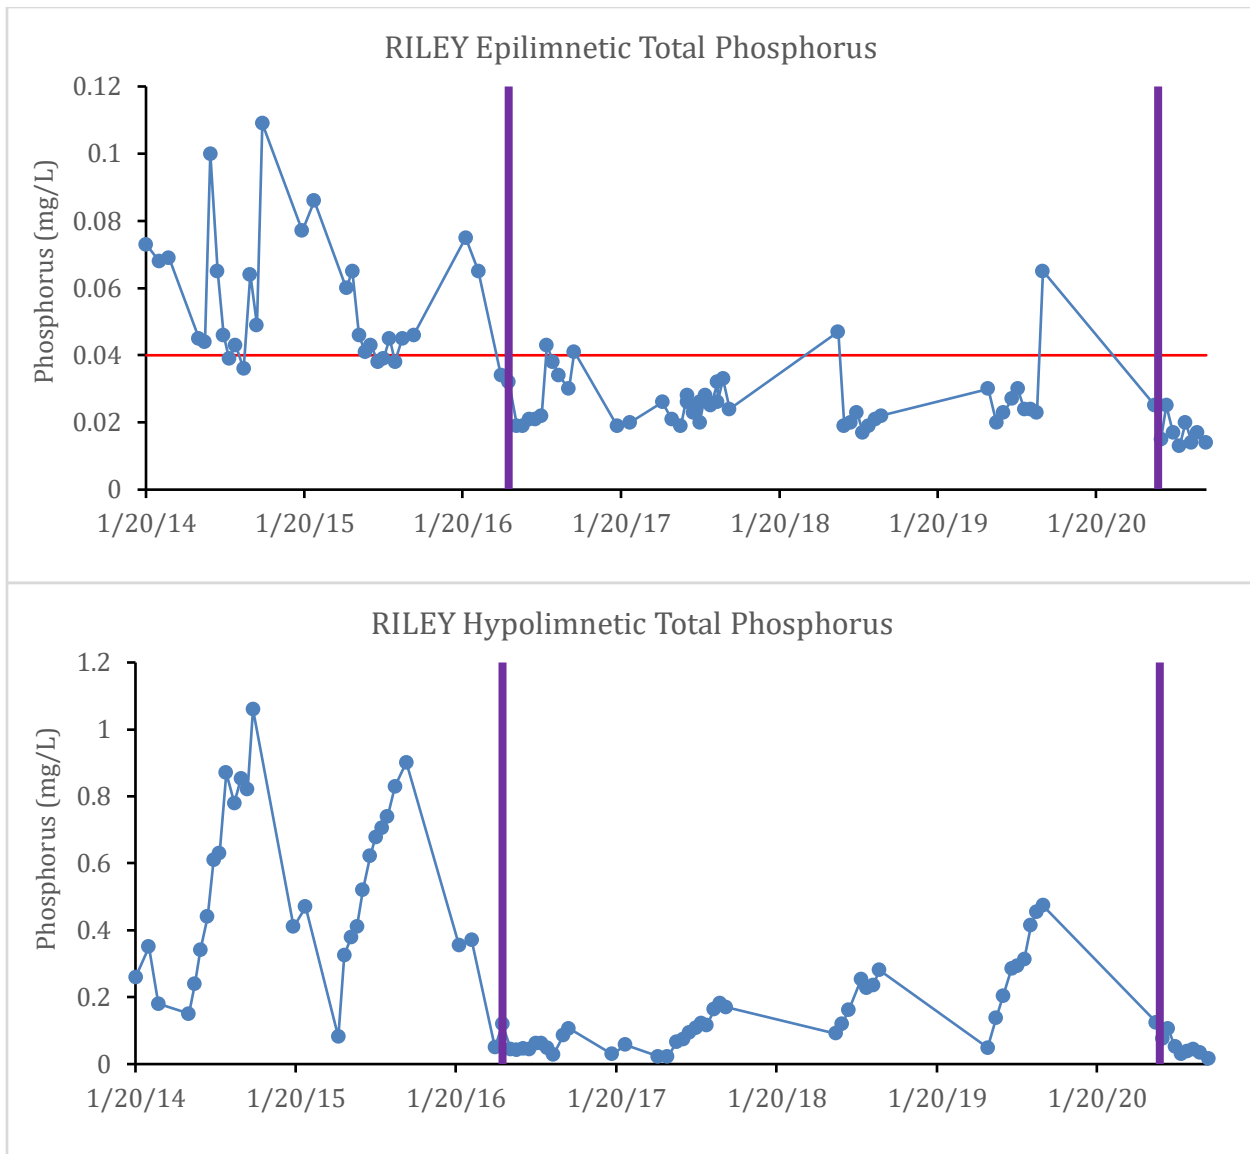
Figure 6 Lake Riley Total Phosphorus Levels pre- and post- Alum Treatment

Total phosphorus levels (TP) in Lake Riley between January 20, 2014 and September 30, 2020. The aluminum sulfate (Alum) treatments occurred on May 5, 2016 and June 11, 2020 (indicated by vertical bar). The upper graph displays TP levels (mg/L) measured from 2 m composite samples taken at the lake surface and the lower graph displays the TP levels (mg/L) measured from samples taken 0.5-1 m above the sediment near the deepest point in the lake. The MPCA water quality standard for TP is represented in the upper graph by the horizontal red line (0.04 mg/L).

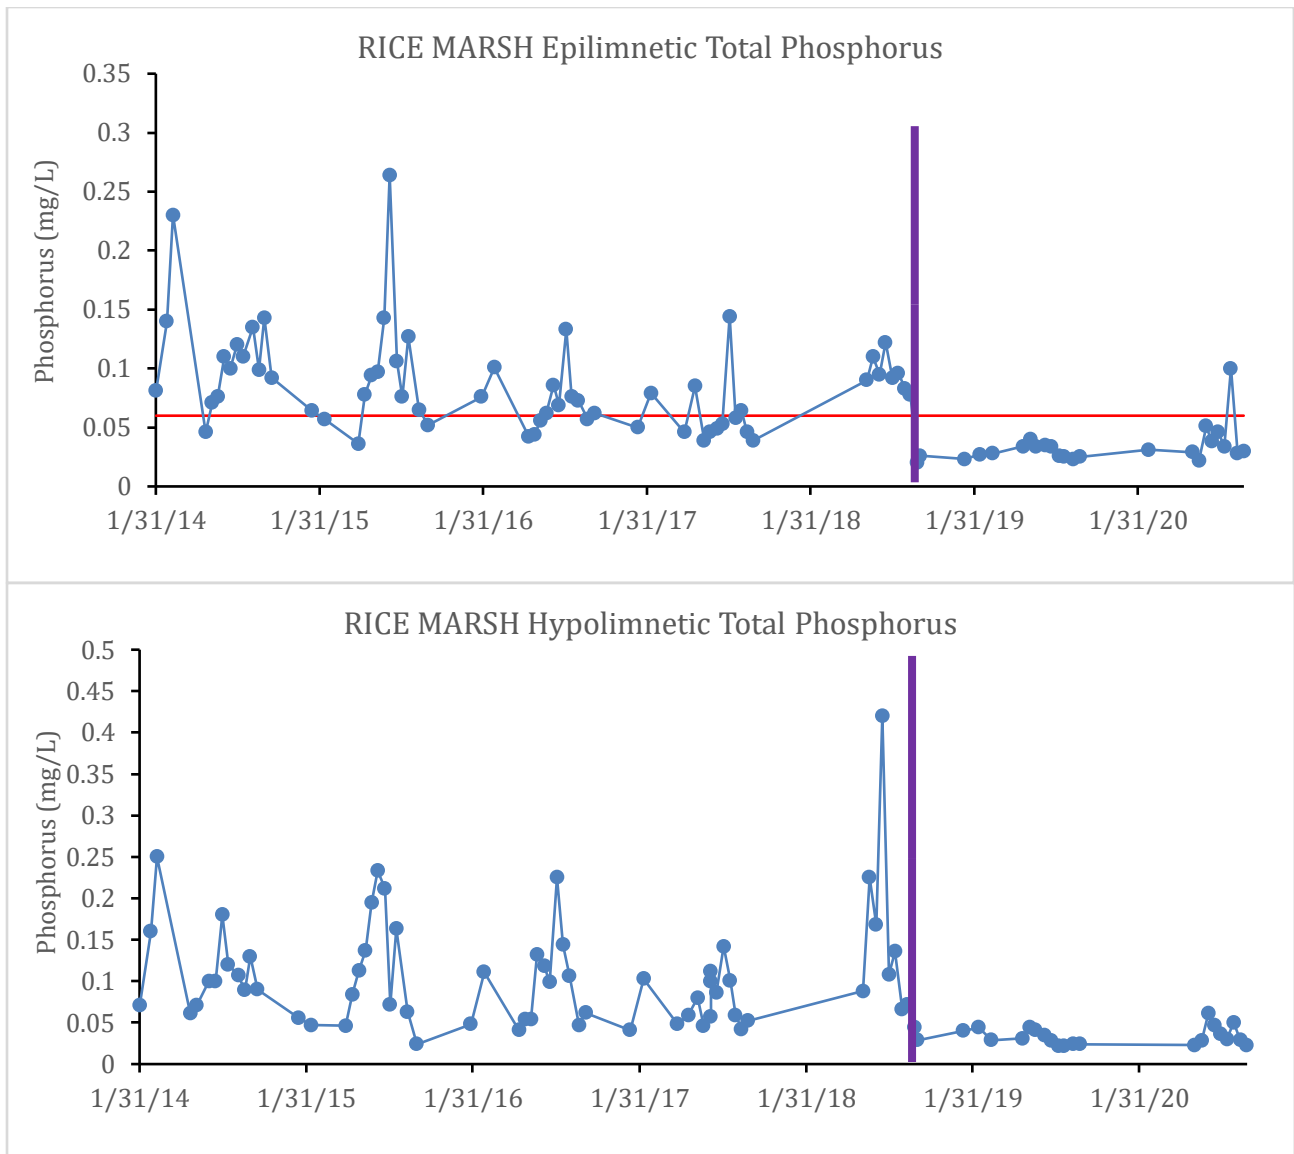
Figure 7 Rice Marsh Lake Total Phosphorus Levels pre- and post- Alum Treatment

Total phosphorus levels (TP) in Rice Marsh Lake between January 31, 2014 and September 23, 2020. The aluminum sulfate (Alum) treatment occurred on September 21, 2018 (indicated by vertical bar). The upper graph displays TP levels (mg/L) measured from 2 m composite samples taken at the lake surface and the lower graph displays the TP levels (mg/L) measured from samples taken 0.5-1 m above the sediment near the deepest point in the lake. The MPCA water quality standard for TP is represented in the upper graph by the horizontal red line (0.06 mg/L).

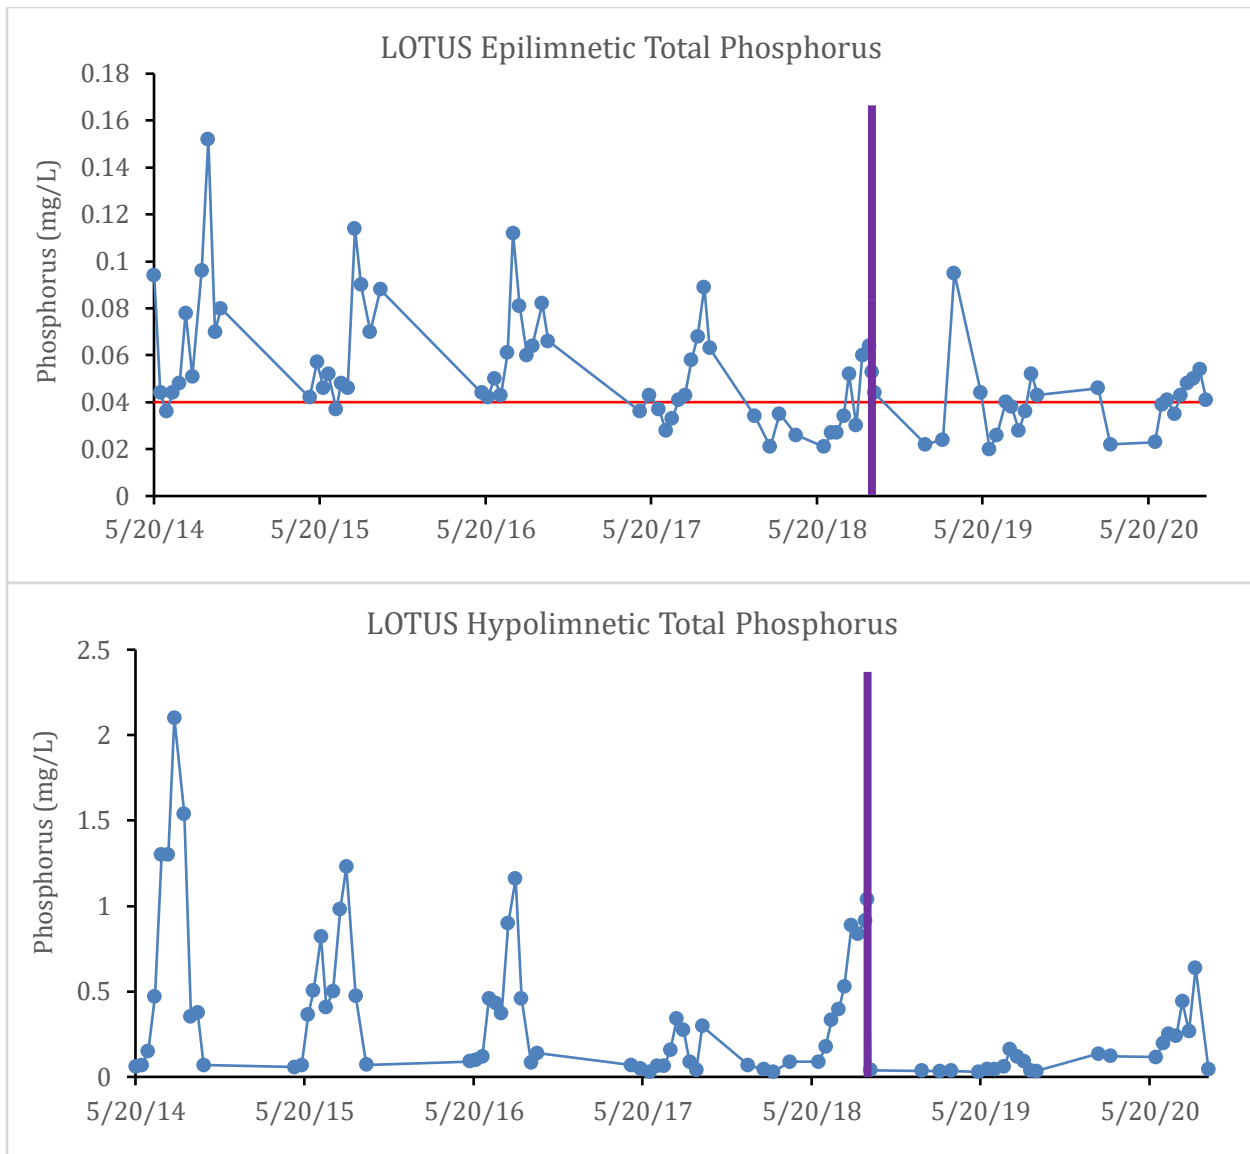
Figure 8 Lotus Lake Total Phosphorus Levels pre- and post- Alum Treatment

Total phosphorus levels (TP) in Lotus Lake between May 6, 2014 and September 24, 2020. The aluminum sulfate (Alum) treatment occurred on September 18, 2018 (indicated by vertical bar). The upper graph displays TP levels (mg/L) measured from 2 m composite samples taken at the lake surface and the lower graph displays the TP levels (mg/L) measured from samples taken 0.5-1 m above the sediment near the deepest point in the lake. The MPCA water quality standard for TP is represented in the upper graph by the horizontal red line (0.04 mg/L).

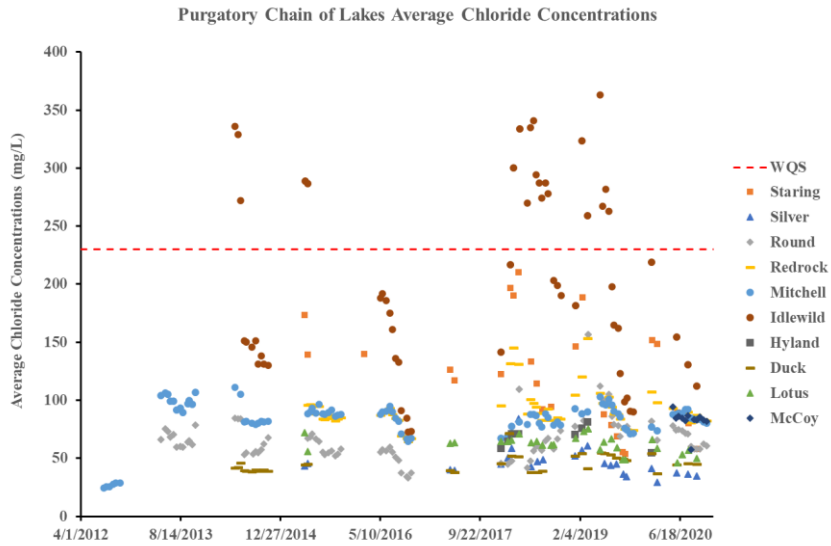
Figure 11 2013-2020 Chloride Levels within the Purgatory Chain of Lakes

All average chloride sampling results (mg/L) on the Purgatory Chain of Lakes from 2013-2020. The MPCA chloride chronic standard for class 2B waters (230mg/L) is indicated by the red line.

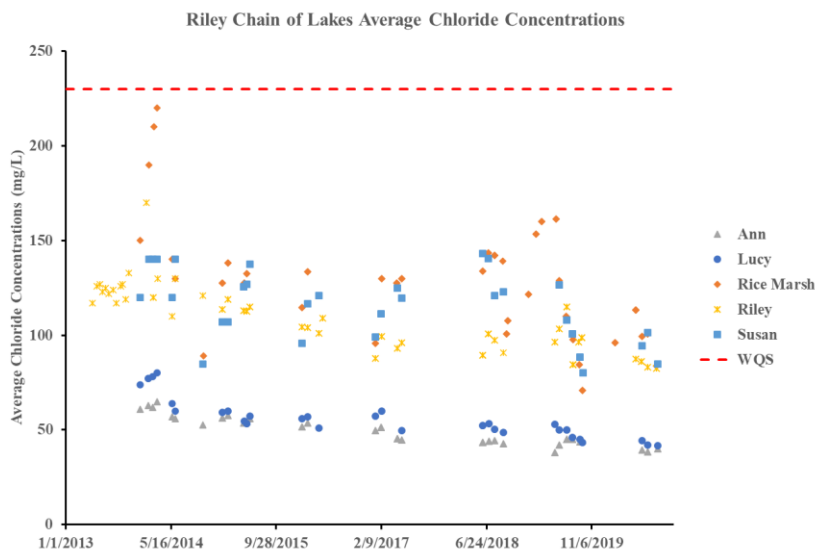
Figure 12 2013-2020 Chloride Levels within the Riley Chain of Lakes

All average chloride sampling results (mg/L) on the Riley Chain of Lakes from 2013-2020. The MPCA chloride chronic standard for class 2B waters (230mg/L) is indicated by the red line.

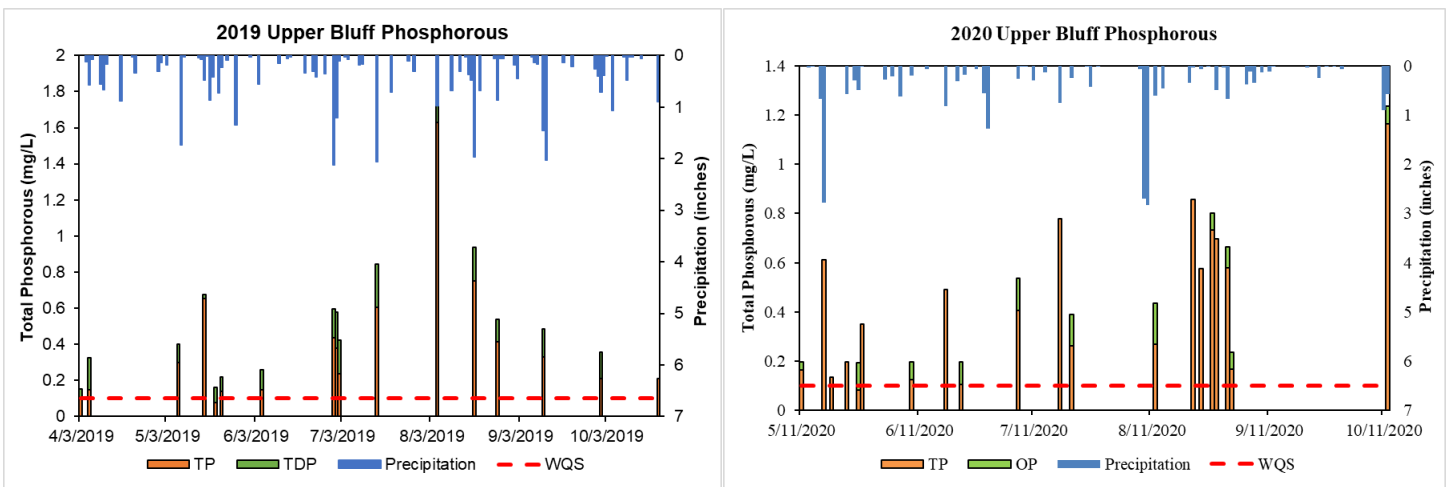
Table 13 2019 and 2020 Upper Bluff Creek Phosphorus

The Total Dissolved Phosphorus (TDP) and Total Phosphorus (TP) concentrations (mg/L) from Bluff Creek under Galpin Blvd from 2019 automated, level triggered, flow-paced samples. Dashed line represents the Minnesota Pollution Control Agency standard for TP in class 2B creeks (≤ 0.1mg/L).

In 2019 and 2020, total phosphorus levels at the upper Bluff Creek site during storm events were high compared to the MPCA standards, as seen in **Error! Reference source not found..** As seen in **Table 12**, the average TP across 17 samples was 0.525 mg/L in 2019 and 0.425 mg/L in 2020. This level is over four times the MPCA eutrophication water quality standard for class 2B streams ($\leq 0.1\text{ mg/L TP}$). Across both years, all TP samples collected measured above the MPCA standard with the highest TP concentration having occurred in early August in 2019 at 1.77 mg/L and 1.12 mg/L in mid-October of 2020. 2019 TDP average in 2019 was 0.135 mg/L with the highest measurement of 0.237 mg/L (**Table 12**). OP average in 2020 was 0.094 mg/L with the highest measurement of 0.168 mg/L. The average amount of TSS across the 17 samples taken was 84.6 mg/L in 2019. The average amount of TSS across the 15 samples taken was 26.4 mg/L in 2019. To achieve the MPCA TSS stream water quality standard, a stream may not exceed 30 mg/L TSS more than 10% of the time. Across all the sampling events, nine of the 17 samples taken in 2019 were above 30 mg/L TSS and only five of the fifteen samples taken in 2020 were above the standard (**Error! Reference source not found.**). Four of the six in 2019 and five of six in 2020 Chl-a samples collected were less than the MPCA eutrophication water quality standard of $\leq 18\text{ ug/L Chl-a}$ (**Table 12**). It is important to remember that these samples are targeted samples, representative of the initial flush of water and pollutants that occurs during a rain event, and do not represent season-long pollutant levels in Bluff Creek. Therefore, a direct comparison to the MPCA water quality standards is cautioned.

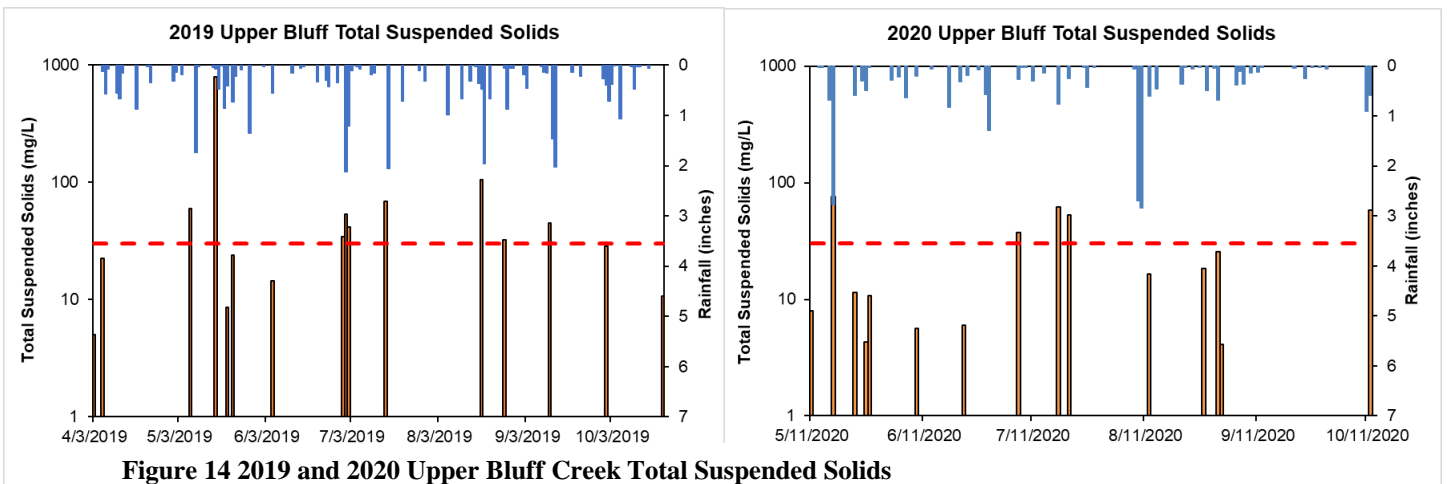
Figure 14 2019 and 2020 Upper Bluff Creek Total Suspended Solids

Total Suspended Solids (TSS) concentrations (mg/L) from Bluff Creek under Galpin Blvd from 2019 and 2020 automated, level triggered, flow-paced sampler. Dashed line represents the Minnesota Pollution Control Agency standard for TSS in class 2B creeks (≤ 30 mg/L TSS no more than 10% of the time).

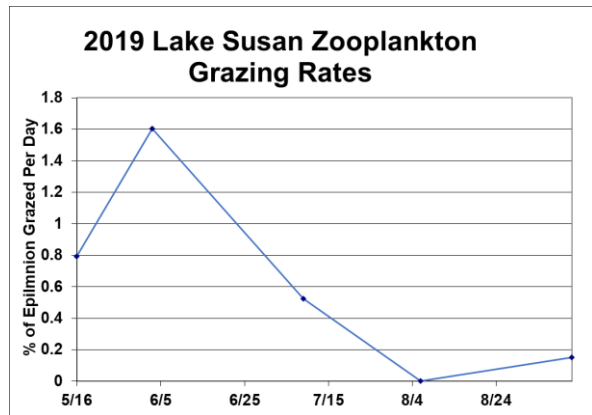
Figure 22 2019 Lake Susan Epilimnetic Grazing Rates

The estimated epilimnetic grazing rates upon algae observed in 2018 were, ranging from 0.1% to 11%. However, in 2019, the epilimnetic grazing rate was only around 1% (Figure 22). This is mainly due to the very limited number of Cladocera present in all the samples collected. The highest grazing rate was observed in early June when *Daphnia pulex* were more numerous in the zooplankton community.

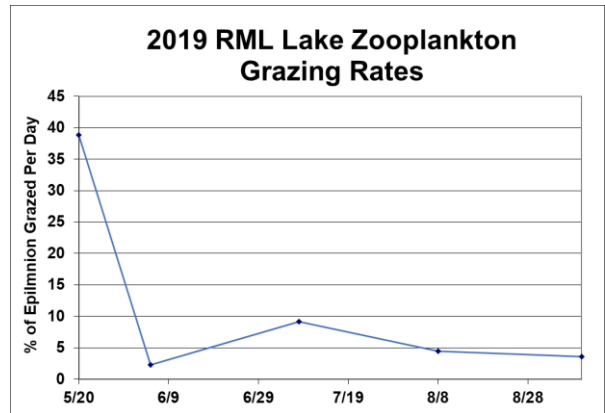
Figure 25 2019 Rice Marsh Lake Epilimnetic Grazing Rates

The estimated epilimnetic grazing rates of Cladocera observed in 2018 ranged from near 0% to 23% on Rice Marsh Lake. In 2019, the epilimnetic grazing rate was highest during the May sample at 39% (**Figure 25**). After the first May sampling event, grazing rates averaged near 5% for the remainder of the

year. The highest May grazing rate was linked with the presence of the larger bodied Cladocera *Daphnia pulex*. The most common Cladocera present was *Bosmina longirostris* which are commonly found in bog lakes such as Rice Marsh Lake.

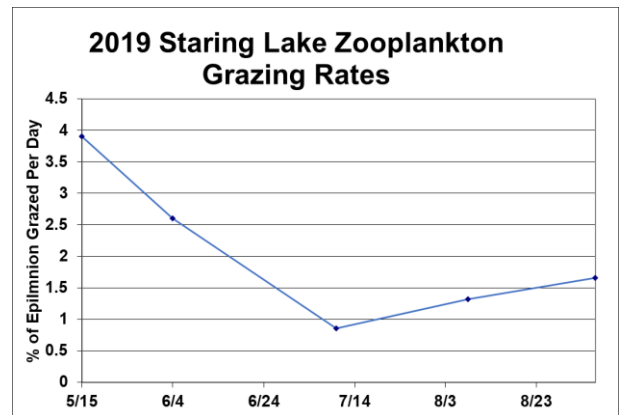
Figure 28 2019 Staring Lake Grazing Rates

Large Cladocera consume algae and may have the potential to improve water quality when present in large densities. The estimated epilimnetic grazing rates observed in 2018 ranged from 2% to 24%. The 2019 were much lower at 1-4% (Figure 28). The max grazing rate in May corresponded optimal feeding temperatures near 21 degrees Celsius.

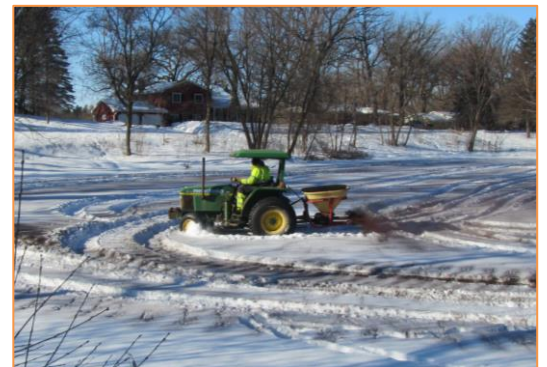
Figure 35 Minnetonka Iron Filings Application

- The use of iron filings in stormwater ponds has been successfully tested by the University of Minnesota in improving water quality under lab conditions. The District, Cities, and the UMN worked together and applied iron filings to 2 ponds (**Figure 35**), which will be expanded to 3 in 2021, to test this innovative approach. Initial results from 2020 monitoring data shows variability in the results. Some ponds appeared to have some reductions, but others had little change. This variability can be partially explained by the seasonal variability in stormwater ponds which may be caused by different climatic conditions. UMN will continue monitoring activities in 2021.

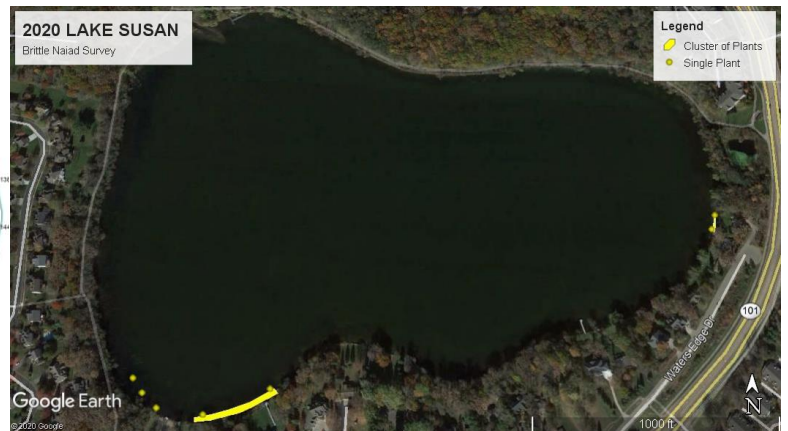
Figure 38 2020 Lake Susan Brittle Naiad Map

In 2020, staff conducted a roving survey Lake Susan to determine if any established areas of brittle naiad were missed or if the population expanded (Figure 38). During the survey staff found one additional location on the east side of the lake. In both locations, the plants seemed to be in less than 2 feet of water and were dense populations.

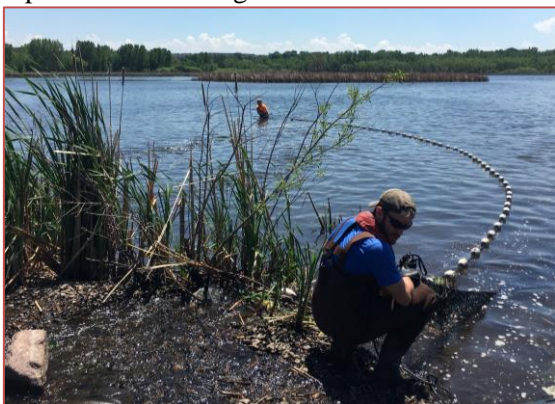
Figure 43 Common Carp Removal at the PCRA Berm

During the spring of 2020 spawning run, staff utilized an electrofishing boat and a backpack electrofishing unit combined with block nets to remove common carp (**Figure 43**). Boat electrofishing was added in UPCRA because in 2019 carp were seen congregating in large groups. Backpack electrofishing and block nets were utilized in the channel upstream of the barrier and at the breach in the berm that separates the Upper and Lower Purgatory Creek Recreational Area. Most of the fish were captured via backpack electrofishing at the breached berm site. This breach allows water to short circuit the overflow

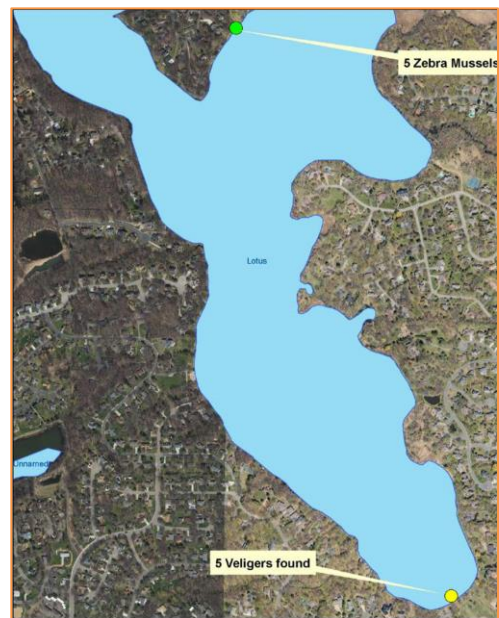
Figure 44 2019 Lotus Lake Zebra Mussel Map

On August 30, 2019, 5 zebra mussel veligers were found in veliger tows collected by Carver County from the public access of Lotus Lake (**Figure 44**). No zebra mussel veligers were found in samples collected on June 20, 2019 or September 10, 2019 by the RPBCWD. Additional in-lake searching occurred on October 9, 2020 by RPBCWD staff. No adult zebra mussels were found during the search. An additional veliger tow was collected on October 10, 2019 and eDNA samples were taken at 4 locations. On October 24, 2019 staff from DNR, Carver County and the RPBCWD surveyed pulled docks on shore around the lake and found 5 zebra mussels ranging in size from 6-16 mm on a single boat lift footing in the east bay (**Figure 44**). After the October survey, the eDNA results were complete and indicated zebra mussel eDNA was present near the boat launch sample and the east bay sample near where the adults were captured. Based on the collected information, Lotus Lake was added to the Infested Waters List for zebra mussels for 2019. In 2020, veliger tows were again collected twice in the spring, but yield no zebra mussel veligers. Both boat launch and mussel plate checks (expanded to 11 plates) yielded no adult mussels.

Staff visually searched for mussels twice in 2020, once in August and once in October after docks were pulled. No mussels were found. The eDNA results for 2020 were positive for the deep-water area near the boat launch only. Staff will continue to monitor for zebra mussels in 2021.

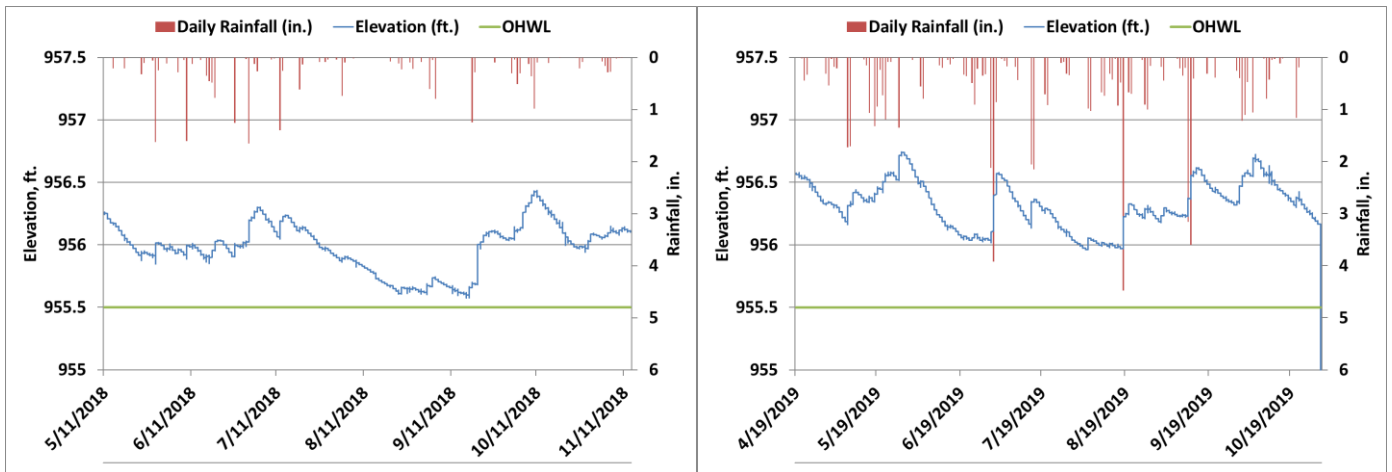
Figure A-1. **Lake Ann** level elevation data (ft.) for 2018 and 2019 along with the lake's ordinary high-water level (OHWL). Daily rainfall (in.) is displayed along the top of the graph (NOAA).

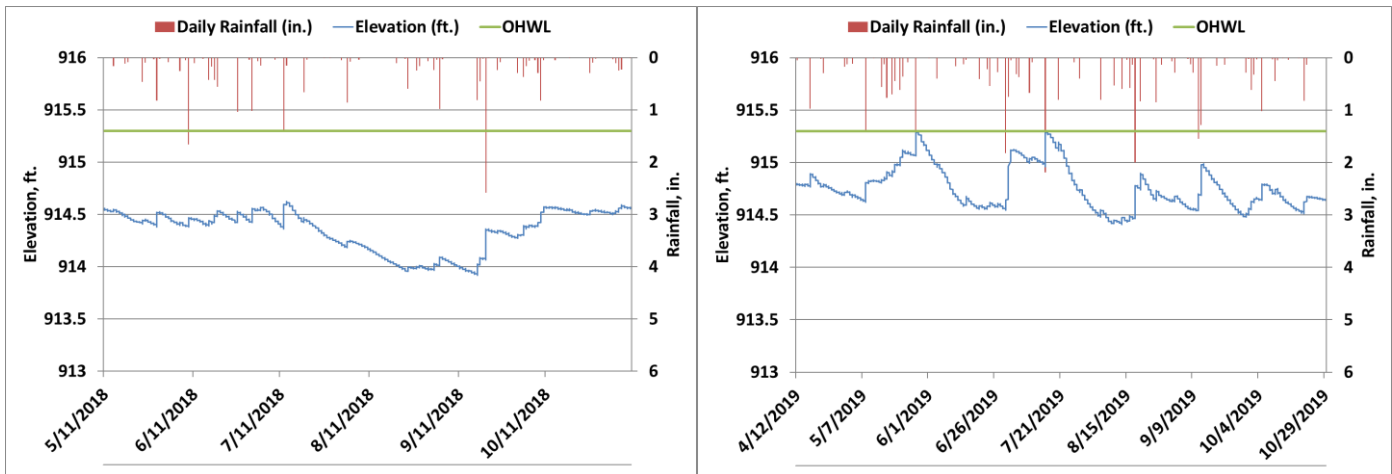
Figure A-2. **Duck Lake** level elevation data (ft.) for 2018 and 2019 along with the lake's ordinary high-water level (OHWL). Daily rainfall (in.) is displayed along the top of the graph (NOAA).

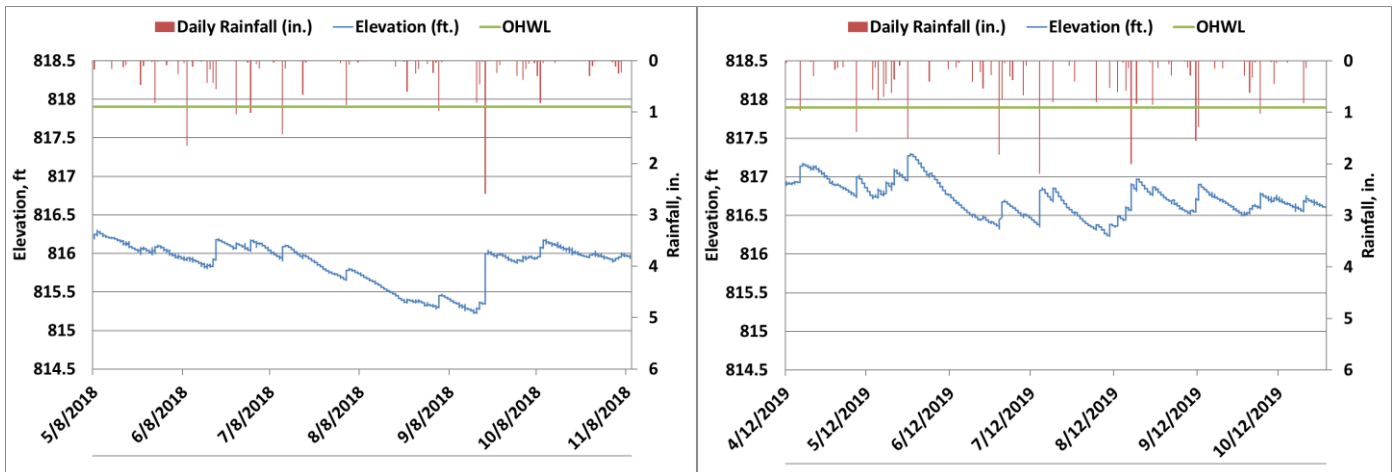
Figure A-3. **Hyland Lake** level elevation data (ft.) for 2018 and 2019 along with the lake's ordinary high-water level (OHWL). Daily rainfall (in.) is displayed along the top of the graph (NOAA).

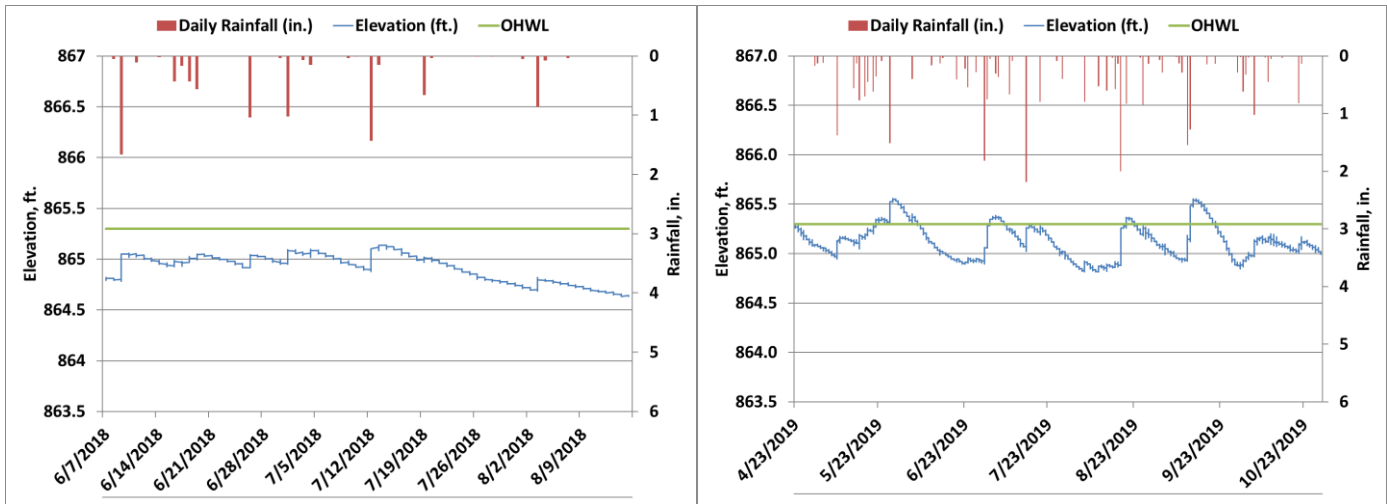
Figure A-10. **Lake Riley** level elevation data (ft.) for 2018 and 2019 along with the lake’s ordinary high-water level (OHWL). Daily rainfall (in.) is displayed along the top of the graph (NOAA).
