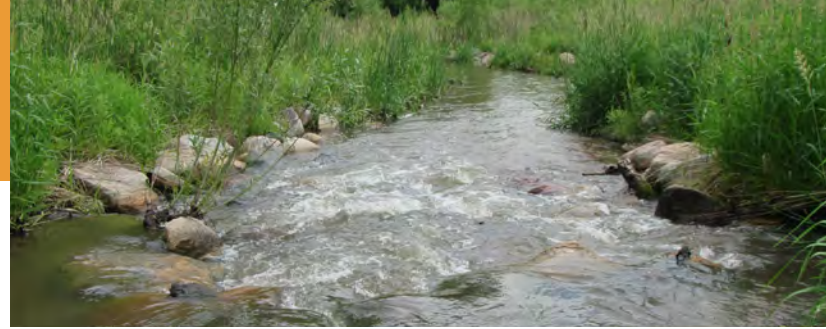
The three major types of data used in creek monitoring

District staff and the Metropolitan Council have monitored the creek's water quality for almost 20 years. The District developed a tool to assess the creek: the Creek Restoration Action Strategy (CRAS). The CRAS uses water quality data, as well as information on erosion and habitat, to rank which creek stretches (sections) are doing the best and which are doing the poorest. CRAS scores for each stretch of stream are located on the next page.

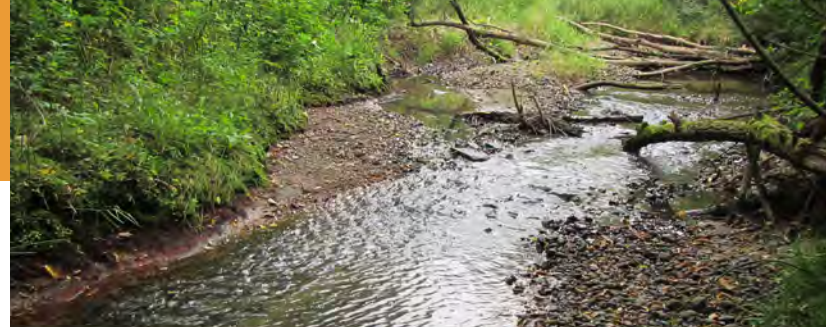
The three major types of data used in creek monitoring

District staff have monitored Bluff Creek since the 1980s. To assess creek health, staff developed a tool called the Creek Restoration Action Strategy (CRAS). CRAS uses water quality data, as well as information on erosion and habitat, to rank which creek stretches (sections) are doing the best and which are doing the poorest. CRAS scores for each stretch of stream are located on the next page.

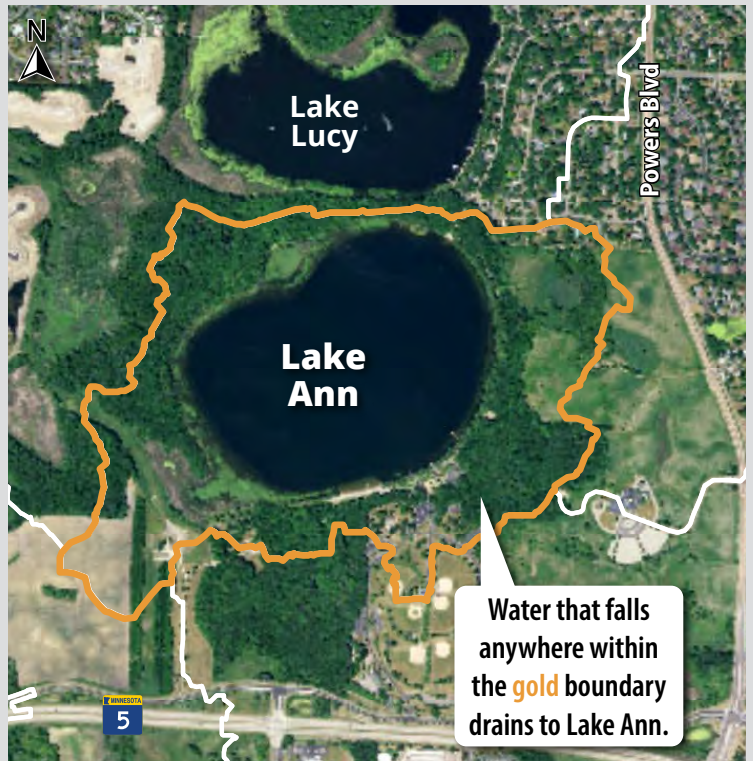
Native Aquatic Plant Diversity

How does **Lake Ann** compare to **other lakes** in the District in **number of native plant species?**

Plants: Lake Ann has the highest plant diversity of all lakes in the district at 22 species. Coontail was the most common plant found at 67% of sites followed by Flatstem Pondweed at 55% of sites. White Water Lily was the most dominant floating plant at 28% frequency of occurrence. In the 2023 survey, no Eurasian Watermilfoil was sampled. However, for the first time, Brittle Naiad was at a detectable level (4% frequency of occurrence) since its discovery in the lake in 2017.

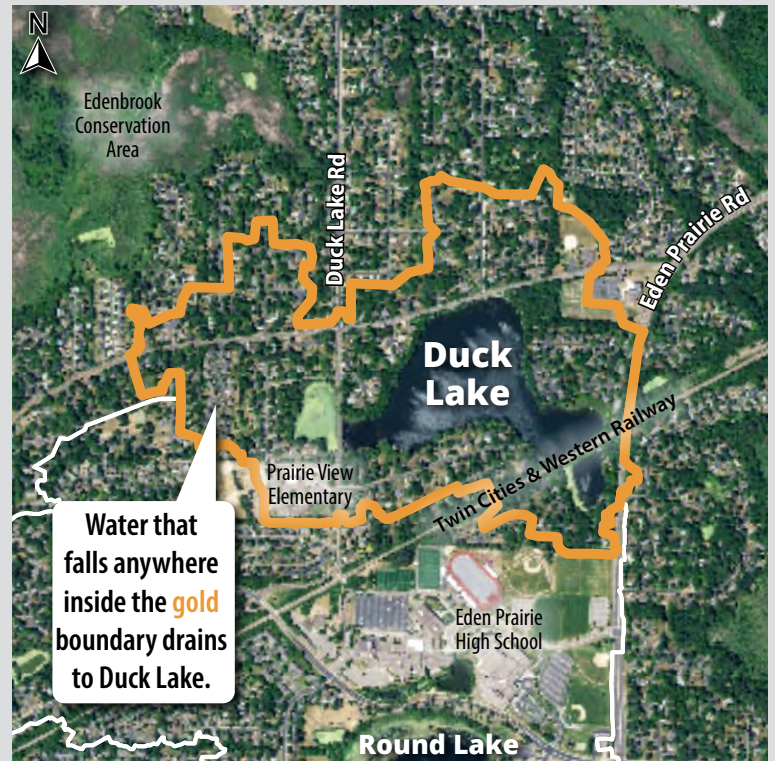
Native Aquatic Plant Diversity

How does **Duck Lake** compare to **other lakes** in the District in **number of native plant species?**

Plants: Coontail was the most dominant plant species (96% of sites) followed by Flatstem Pondweed at 52% of sites. Overall, plant growth in Duck Lake covered 100% of the lake surface. The number of plants increased from 6 in 2020 to 16 in 2023. This is partially due to the inclusion of the west bay and very low densities of additional floating and emergent native species that previously were not found (Longleaf Pondweed, Arrowhead, American Lotus, and Hardstem Bullrush).

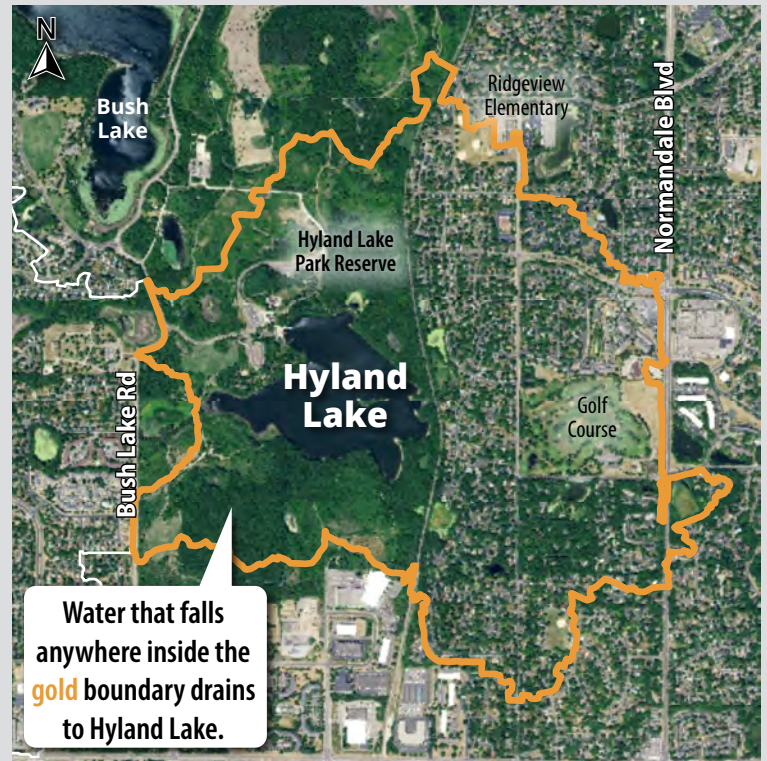
Native Aquatic Plant Diversity

How does **Hyland Lake** compare to **other lakes** in the District in **number of native plant species?**

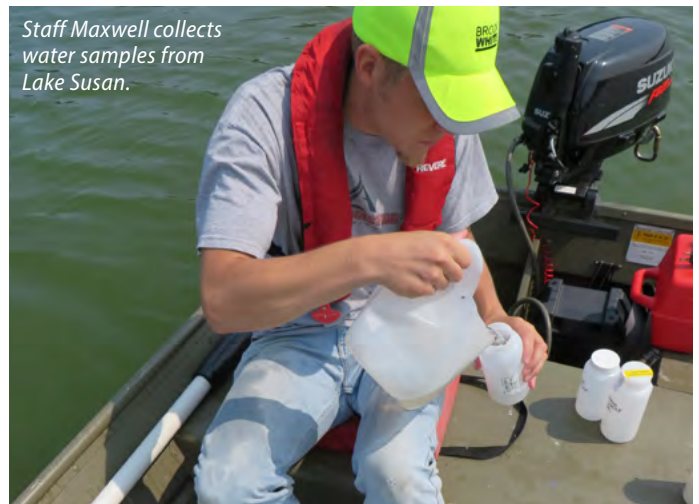
Figure 1. Summary of lake water quality in 2023 within RPBCWD.

During the 2023 monitoring season, 13 lakes and two open-water wetlands were intensively monitored. Regular water quality lake sampling was conducted on each lake approximately every two weeks throughout the growing season (June-September). Surface water samples were collected, analyzed, and compared to standards set by the Minnesota Pollution Control Agency (MPCA) to assess overall lake health. [Figure 1](#) displays lakes sampled in 2023 that met or exceeded the MPCA lake water quality standards.

In 2023, lake water quality remained relatively the same across the district with Lake Ann, Duck Lake, Hyland Lake, Lake Idlewild, Lake Lucy, Rice Marsh Lake, Lake Riley, and Round Lake meeting all three MPCA standards. Following the past aluminum sulfate treatments, both Lake Riley and Rice Marsh Lake continued to meet all MPCA standards and are in the process of being delisted from the MPCA Impaired Waters List for nutrients. Lake Susan had the most degraded water quality of all Riley chain lakes but did improve to meet the total phosphorous standard in 2023. Of the Purgatory Chain of Lakes, Red Rock Lake and Mitchell both improved from 2022 by meeting the TP standard, but neither meet the Chl-a standard. Silver had an increase

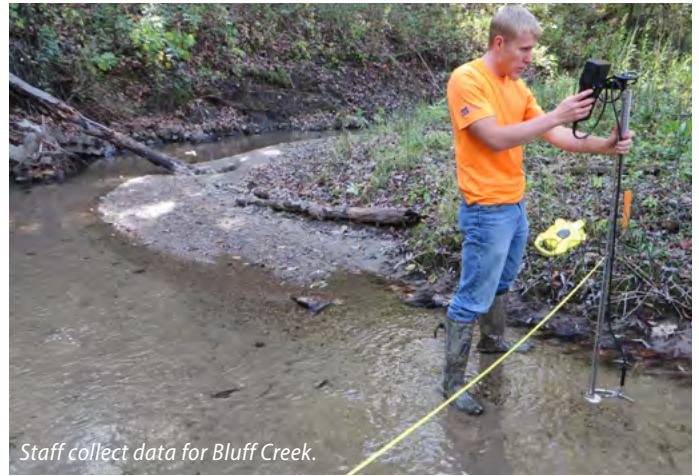
Figure 2. Summary of stream water quality in 2023 within RPBCWD.

2023 stream water quality data from Bluff Creek, Riley Creek, and Purgatory Creek in the Riley Purgatory Bluff Creek Watershed District as compared to MPCA Water Quality Standards. Eighteen water monitoring locations (white circles) were sampled every other week and data from the individual sites were applied upstream to the next monitoring location. The summer season (April-September) eutrophication and total suspended solids water quality standards used in this assessment included: Dissolved Oxygen (DO) daily minimum > 4 mg/L, average Total Phosphorus (TP) < 0.1 mg/L, Total Suspended Solids (TSS) < 10% exceedance of 30 mg/L limit, average Chlorophyll-a (CHLA) < 18 µg/L, average pH < 9 su and > 6 su. The corresponding labels next to each stream section indicate which water quality standards were not met.

The summary for all three creeks is based on water quality parameters developed by the MPCA in 2014 for Eutrophication and TSS as well as impairment status for fish, macroinvertebrates, and E. coli can be seen in [Figure 2](#). In 2023, the continued drought significantly impacted the streams. Of the 18 regular sampling sites, 14 went dry or became stagnant

at some point. From 2022 to 2023, stream water quality was reduced slightly across the district. Excluding the dissolved oxygen impairment, the number of water quality standard exceedances remained relatively the same from 2022. Bluff had 10, Riley has had 13, and Purgatory had 13 water quality standard exceedances. No regular creek sampling sites met all MPCA water quality standards assessed in 2023. Like previous years, TP was the water quality standard causing the most impairments in 2023 with 15 of the 18 sites not meeting the standard. TSS impairments were slightly reduced from 2022, which is likely related to the low flows. In 2023, Riley Creek had the most water quality exceedances with 13. MPCA macroinvertebrate and E. coli impairments included the lower reaches of Riley and Purgatory Creeks. The lower reaches of Riley and Bluff creeks had fish impairments.

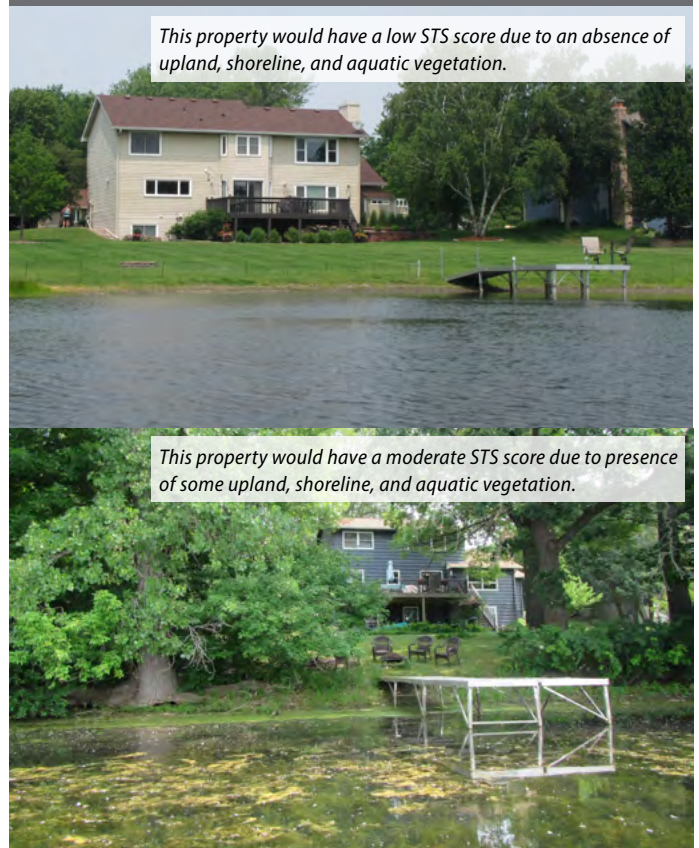
Figure 21. Example of a STS low scoring property (top) and STS high scoring property (bottom).

As with the original STS methodology, RPBCWD staff evaluated shoreland in three zones: upland, shoreline, and aquatic (Figure 20). The score from each zone was equally weighted and combined to provide an overall score for each survey point (in the RPBCWD approach, each individual property served as a survey point). Within each zone, the evaluator scored for three metrics, resulting in a total of nine metrics assessed for each property. The metrics used in the assessment primarily relate to habitat value and include density of trees, shrubs, and natural ground cover; overhanging wood; woody debris within the water, amount of human-built structure (e.g. docks), and openings in aquatic plant beds. See comparison between a low and moderate scoring property in Figure 21.

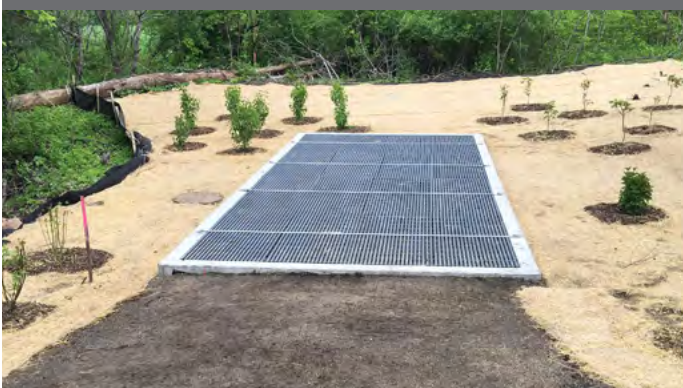
Figure 57. Spent Lime Treatment System

In 2016, an innovative spent lime filtration system was constructed along a tributary stream draining a wetland on the southwest corner of Lake Susan (Figure 57). Based on system performance of the one other experimental spent lime filter site in the eastern Twin Cities area, modeling simulations based on available water quality measurements suggested the Lake Susan system had the potential to remove up to 45 pounds of phosphorus annually from water entering the lake. This would result in improved water quality and recreational opportunities. Spent lime is calcium carbonate that comes from drinking-water treatment plants as a byproduct of treating water. Instead of disposing of it, spent lime can be used to treat stormwater runoff. When nutrient-rich water flows through the spent lime system, the phosphorus binds to the calcium. The water flows

out of the spent lime system, leaving the phosphorus behind. Observation and monitoring data collected by District staff in 2016 - 2018 indicated inconsistent system performance and periods of extended inundation, which deviated from the original design parameters. District staff worked with Barr to review monitoring data and identify potential shortcomings of the system (e.g., monitoring, materials, influent, changed conditions, etc.) It was discovered that the spent lime media appeared to be significantly restricting flow of water through the filter. District and Barr staff conducted field testing of the filtration capacity of the spent lime and discovered that the spent lime structure had degraded into a clay-like consistency, thus essentially preventing water from filtering through the media. During the summer of 2019, District staff completed laboratory column testing for mixtures of spent lime and sand. Column testing indicated that mixing spent lime with sand improves the filtration capacity of the media, while still removing phosphorus. Figure 58 is a photograph of the column testing completed by District staff during 2019. The testing revealed the following key points:

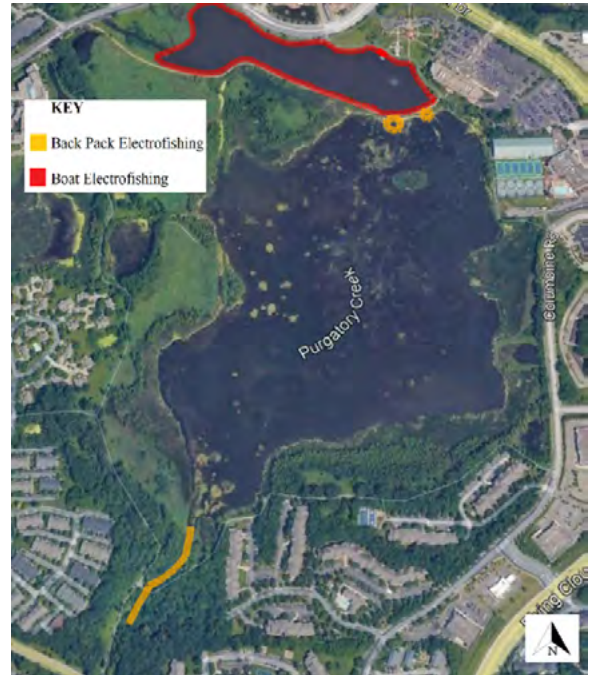
Figure 72. PCRA Spring Removal Site Map

Backpack electrofishing and block nets were utilized in the channel upstream and downstream of the barrier and at the breach in the berm that separates the Upper and Lower Purgatory Creek Recreational Area ([Figure 72](#)). In the past, most of the fish had been captured/removed via backpack electrofishing at the breached berm site. This breach allows water to short circuit the overflow structure. Water is always flowing at this location which leads to carp concentrating in the shallow water near the breach before trying to move upstream. The sheet piling, combined with the consistent flow, has eroded the downstream side of the berm, causing a drop that impedes carp movement. A block net is anchored on the downstream side of the flow at the breach, stretched around the congregating carp, trapping them between the berm and net. During the heavy spawning run, staff repeated the process, sometimes up to three times a day, taking about an hour each time from installation of the net to completion of removal. In 2023 only one successful removal event occurred at the berm. Water levels were either too high or too low for this method to be successful. Additionally, a majority of the carp in this system are now larger in size and able to navigate the berm more easily. Upon visual inspection, it appears that the berm has further eroded and/or subsided, making it easier for fish to move freely

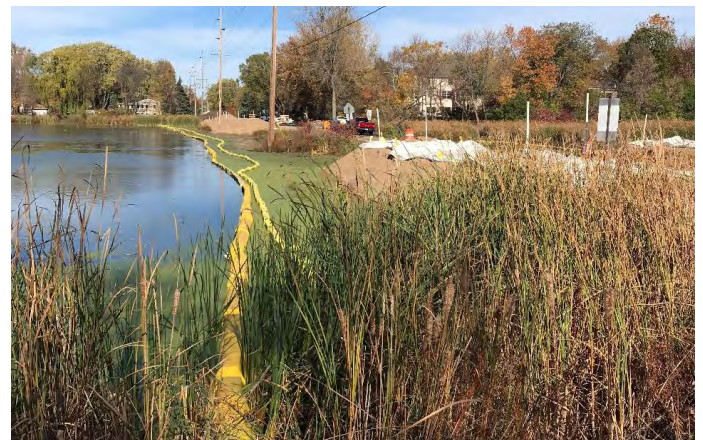
A double row of yellow silt curtains in the water protect the lake from the Duck Lake Road construction zone (fall 2021).

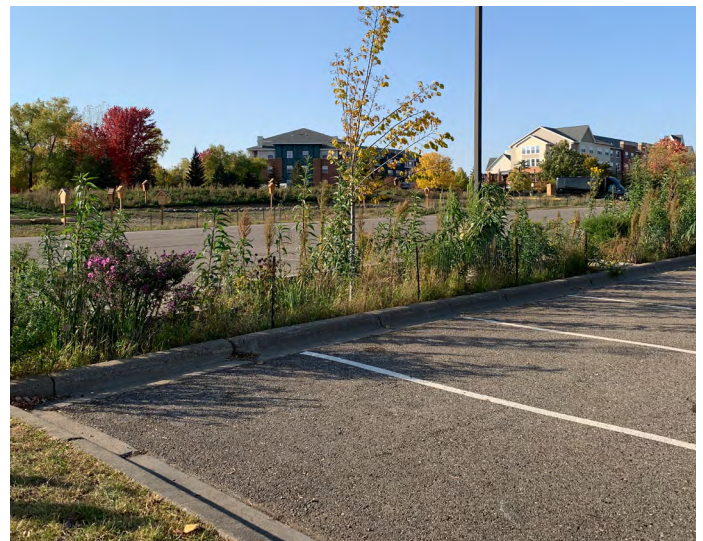
A view of a St. Hubert project tree trench in October 2022.

A [memorandum of conceptual design](#) was prepared to communicate conceptual design options, approximate costs, as well as benefits and limitations of specific practices. The preliminary opinion of cost ranged from \$204,000 to \$277,000. The awarded bid was for \$290,964. Funding is from the RPBCWD levy, St. Hubert Parish Council, the State of Minnesota Watershed Based Implementation Fund, and Carver SWCD. The

project was substantially completed in August of 2021. Three years of maintenance remains on the prairie, rain garden, and tree trench.

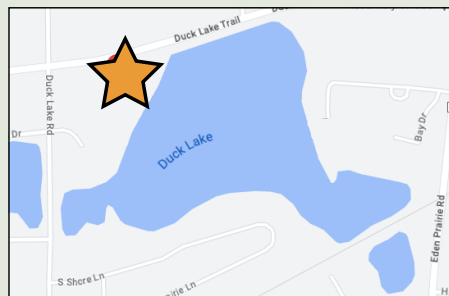
The project was installed in summer of 2023. Work included installation of native plant plugs, installation of native shrubs, application of erosion control fabric to protect soils while plants become established, and temporary fencing to protect young plants from geese. The total grant award for the project was \$5,000 with an additional \$1,500 to help pay for three years of professional maintenance.

Near Duck Lake Trail, the project restored an average of nine feet long a 120-foot stretch of eroded shoreline.

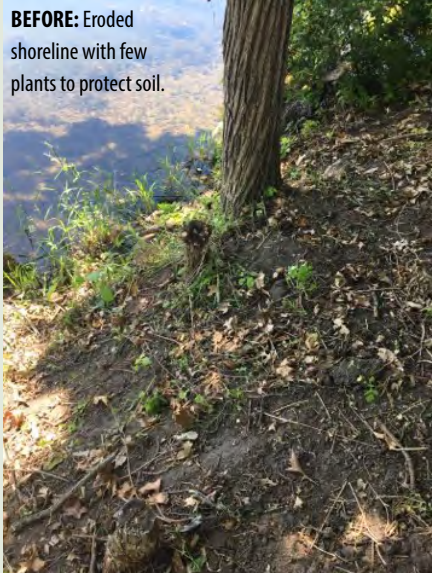
AFTER: A professional landscaper specializing in native plants stabilized the shoreline using coconut coir erosion control blanket. This was followed by installation of native plant plugs and native shrubs appropriate for the site. Temporary fencing was also installed to protect the young plants from geese and other wildlife.

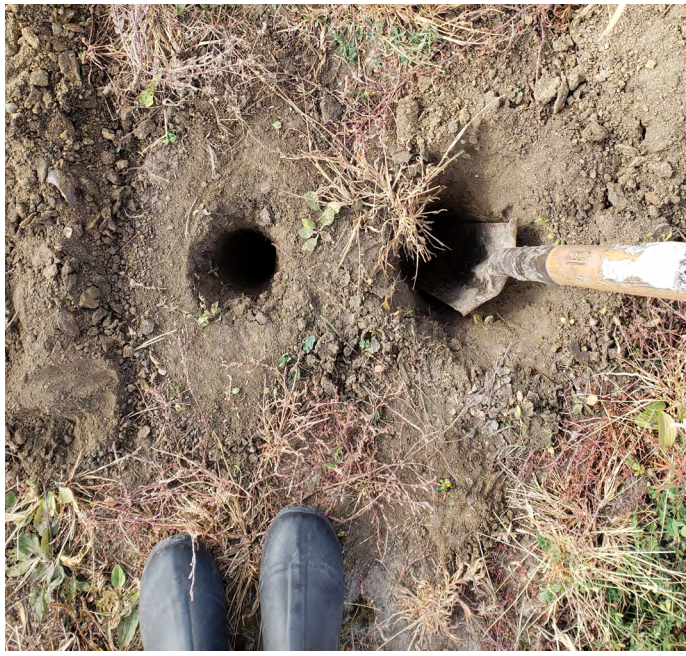
Soil sample collection

Each composite sample consisted of at least two subsamples. Each pair of subsamples were taken 15 feet apart (if taken at an MPD sample point, the same center point was used for both the sampling and infiltration testing). For each subsample, surface debris was removed before digging. With a tile spade, an 8-inch deep hole was dug. From the side of the hole (two inches below surface), a six-by-two-inch sample, the width of the shovel blade, was removed. Any extra soil was removed from the sample so as to make it as uniform as possible. Subsamples were placed together in a clean, five-gallon bucket, mixed thoroughly, and five cups were measured out and double bagged in gallon freezer bags. Samples were labeled with site information, refrigerated and sent to the Cornell University Soils Lab for analysis (all samples sent by end of day, the day after sampling to ensure freshness of the soil). A penetrometer was used to measure surface and subsurface compaction at each subsample site. Penetrometer readings were included with the soil samples to be analyzed by the soils lab.
