# Purgatory Creek

*Purgatory Creek has three headwaters: Lotus Lake in Chanhassen, Silver Lake in Shorewood, and wetlands in Minnetonka. After these forks join, the creek flows through the Purgatory Recreation Area and Staring Lake before eventually reaching the Minnesota River.*

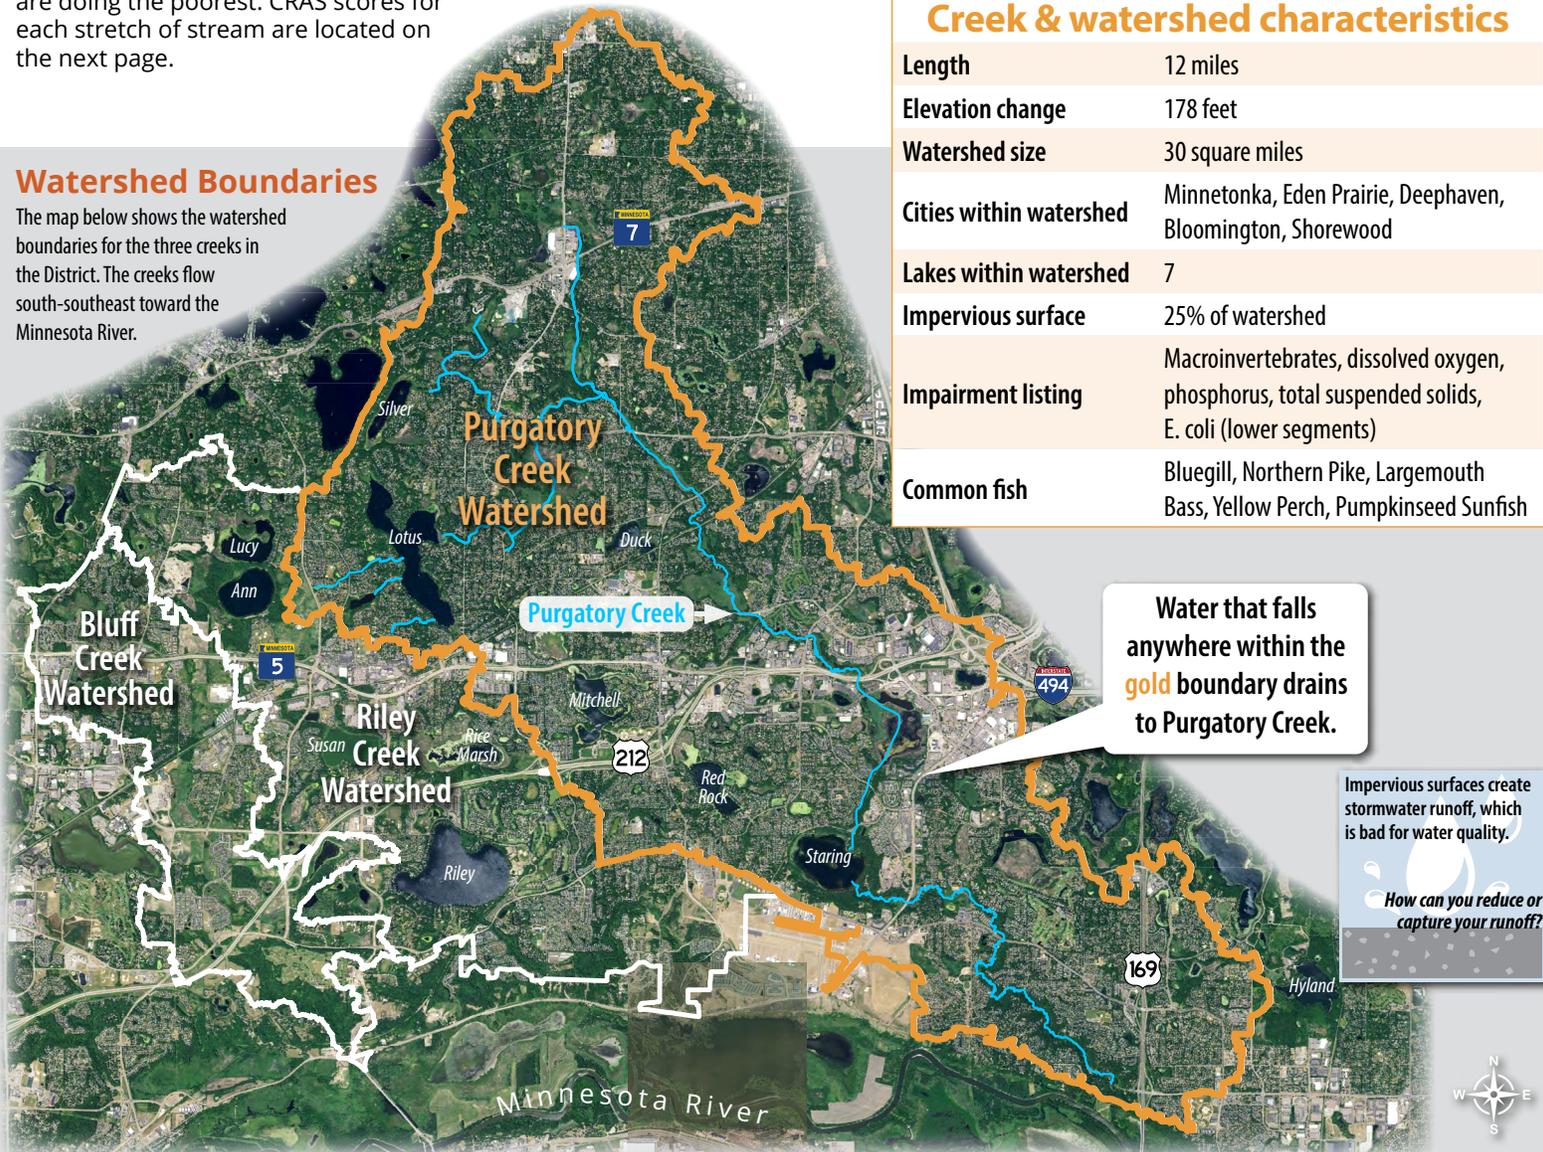
## Watershed Boundaries

The map below shows the watershed boundaries for the three creeks in the District. The creeks flow south-southeast toward the Minnesota River.

Water that falls anywhere within the orange boundary drains to Purgatory Creek.

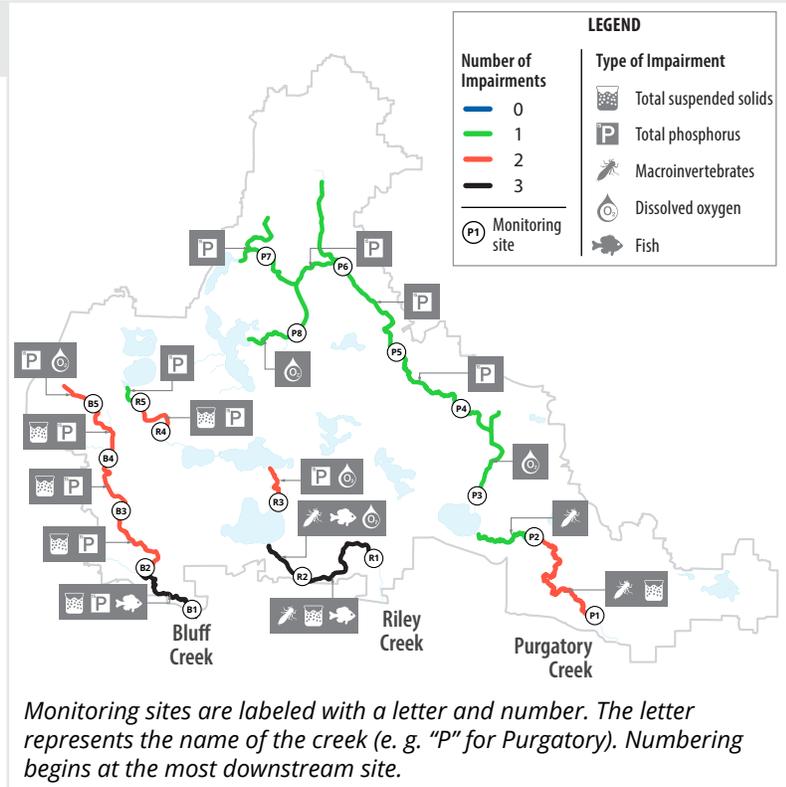
## Stream Water Quality Monitoring

In 2022, District staff collected and analyzed water samples every two weeks — April through September — to determine the average water quality of Bluff, Riley, and Purgatory creeks.

In 2022, drought significantly impacted the streams. Of 18 regular sampling sites, 11 went dry or became stagnant at some point. From 2021 to 2022, stream water quality remained relatively the same across the district. Excluding the dissolved oxygen impairment, the number of water quality standard impairments increased slightly from 2021 to 2022. Similar to previous years, total phosphorus was the water quality standard causing the most impairments in 2022 with 12 of 18 sites not meeting the standard.

Number of impairments in each stream over the last two years.

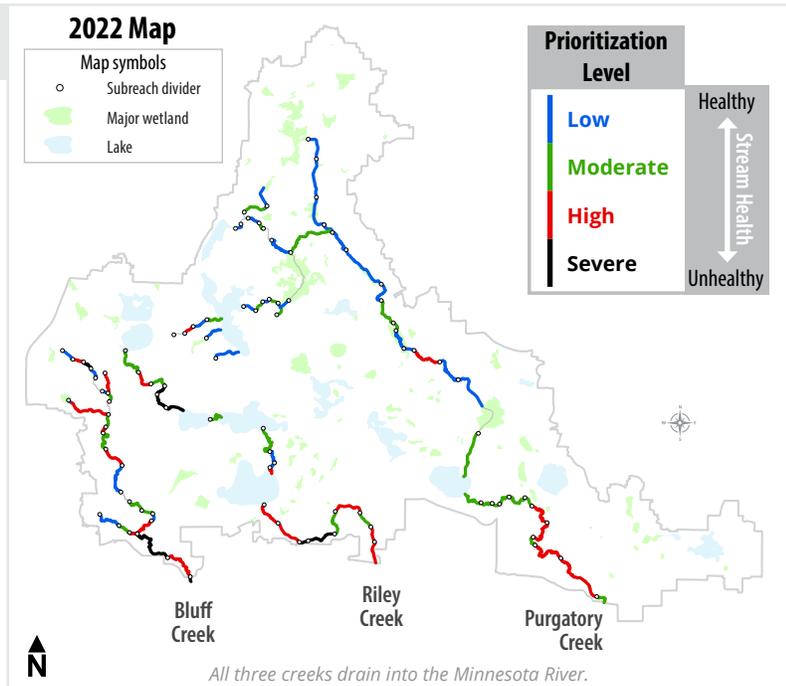
## CRAS Scores for Stream Restoration Planning

The District developed the Creek Restoration Action Strategy (CRAS) to prioritize creek reaches, sub-reaches, or sites, in need of stabilization and/or restoration. The District identified eight categories of importance for project prioritization:

These categories were scored using methods developed for each category based on a combination of published studies and reports, erosion inventories, field visits, and scoring sheets from specific methodologies. Final tallies of scores for each category, using a two-tiered ranking system, were used to prioritize sites for restoration/remediation. More information on CRAS can be found on the District website [rpbcmd.org](http://rpbcmd.org).

As the creeks approach the Minnesota River to the south, the land grows steeper and more vulnerable to erosion, which is why you see more red and black near the bottom of the map. The District is working with its partners to conduct restoration projects in these lower stretches of the creeks to protect water quality here and downstream.

District staff have monitored Purgatory Creek since the 1970s. The District developed a tool to assess the creek: the Creek Restoration Action Strategy (CRAS). The CRAS uses water quality data, as well as information on erosion and habitat, to rank which creek stretches (sections) are doing the best and which are doing the poorest. CRAS scores for each stretch of stream are located on the next page.
