2023 Water Resources Report

Josh Maxwell, *Water Resources & Fisheries Manager*
Andrew Hartmann, *Water Resources Technician*

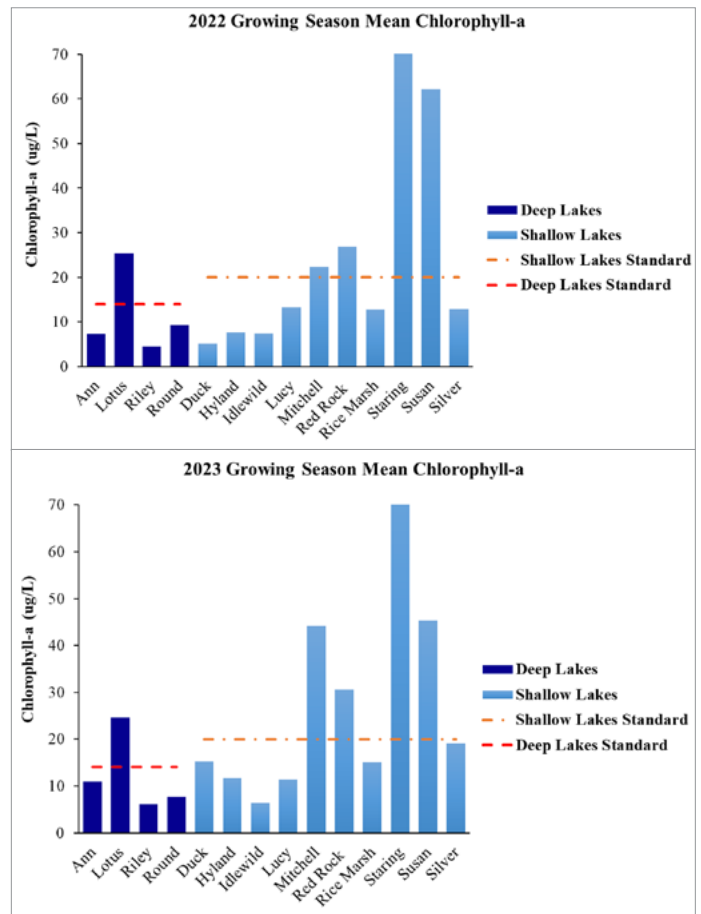
Lakes growing season (June-September) mean chlorophyll-a concentrations (µg/L) for shallow (lakes <15 ft. deep, >80% littoral area-light blue bars) and deep lakes (lakes >15 ft. deep, <80% littoral area-dark blue bars) in the Riley Purgatory Bluff Creek Watershed District during 2021 and 2022. The dashed lines represent the Minnesota Pollution Control Agency water quality standards for Chlorophyll-a for shallow (<20 µg/L-orange dashed line) and deep lakes (<14 µg/L-red dashed line).

treatment, Lake Riley had the lowest summer Chl-a average of all lakes sampled in 2023 at 6.1 ug/L. (4.5 ug/L in 2022, 2.3 ug/L in 2021, and 2.8 ug/l in 2020). Similarly, Round Lake has also met the standard since the first alum treatment in 2012. Lotus Lake did not meet the standard in 2023 and had Chl-a average concentrations at 24.6 ug/L (consistent with 25.4 in 2022 and 25.3 in 2021).

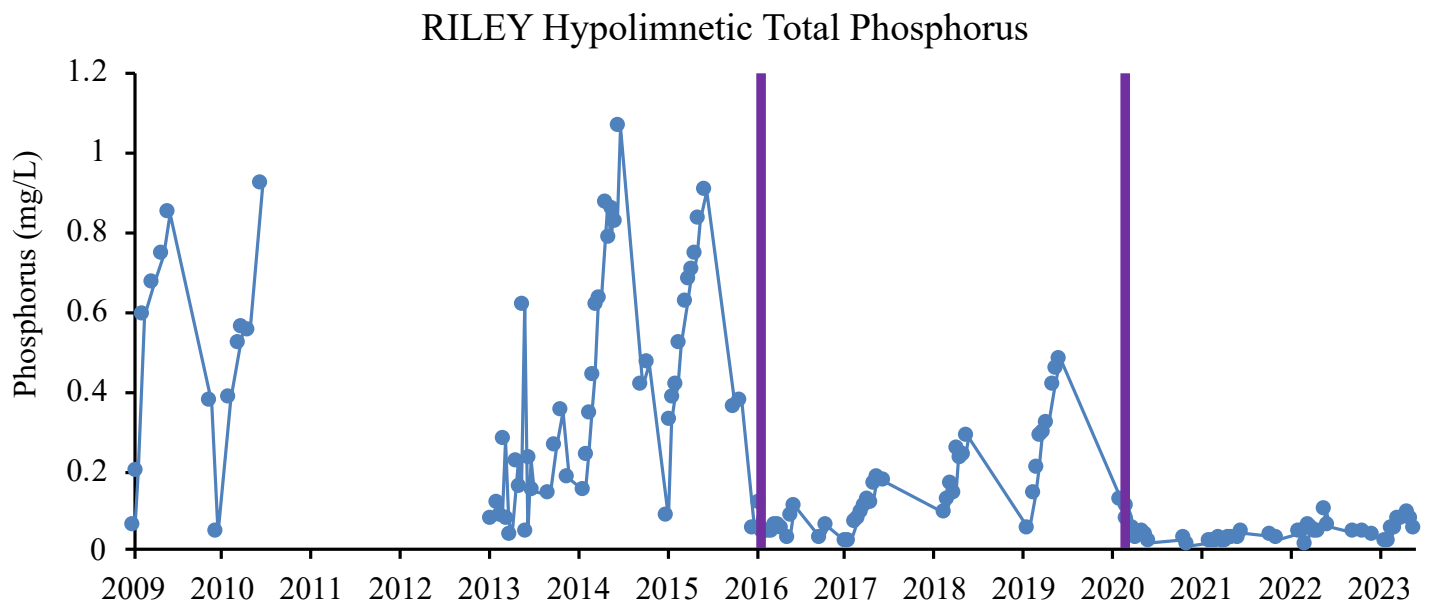
Figure 10. Lake Riley Total Phosphorus Levels pre and post-alum treatment.

Total phosphorus levels (TP) in Lake Riley between April 22, 2009, and September 12, 2023. The aluminum sulfate (alum) treatments occurred on May 5, 2016, and June 11, 2020 (indicated by vertical bar). The upper graph displays TP levels (mg/L) measured from 0-2 m composite samples and the lower graph displays the TP levels (mg/L) measured from samples taken 0.5-1 m above the sediment near the deepest point in the lake. The MPCA water quality standard for TP is represented in the upper graph by the horizontal red line (0.04 mg/L).

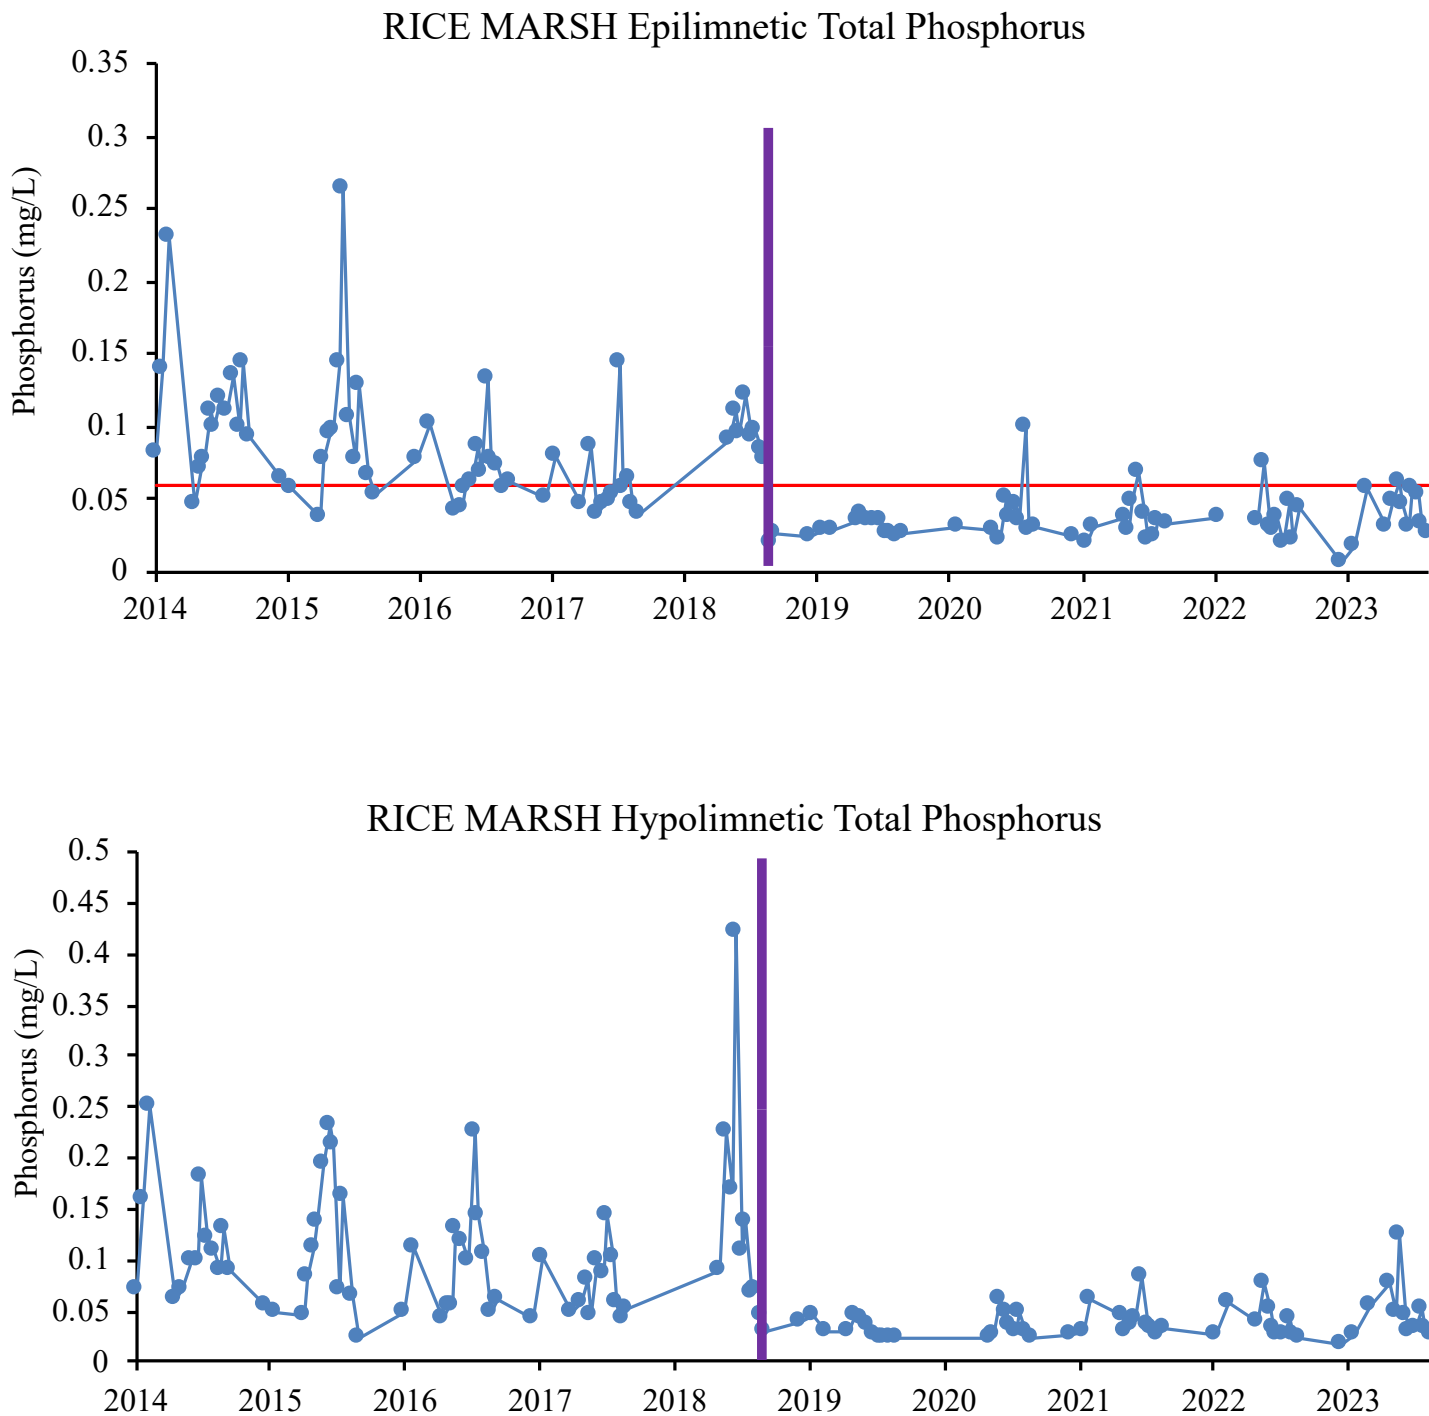
Figure 11. Rice Marsh Lake Total Phosphorus Levels pre and post-alum treatment.

Total phosphorus levels (TP) in Rice Marsh Lake between January 31, 2014, and September 14, 2023. The aluminum sulfate (alum) treatment occurred on September 21, 2018 (indicated by vertical bar). The upper graph displays TP levels (mg/L) measured from 0-2 m composite samples and the lower graph displays the TP levels (mg/L) measured from samples taken 0.5-1 m above the sediment near the deepest point in the lake. The MPCA water quality standard for TP is represented in the upper graph by the horizontal red line (0.06 mg/L).

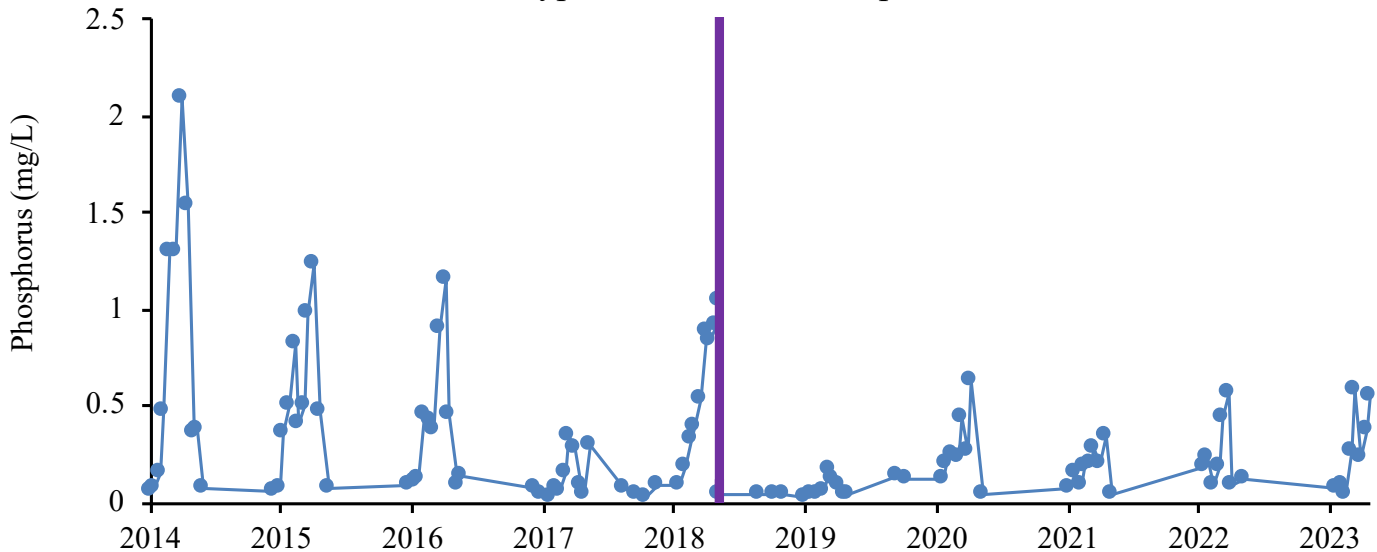
Figure 12. Lotus Lake Total Phosphorus Levels pre and post-alum treatment.

Lotus Epilimnetic Total Phosphorus

Lotus Hypolimnetic Total Phosphorus

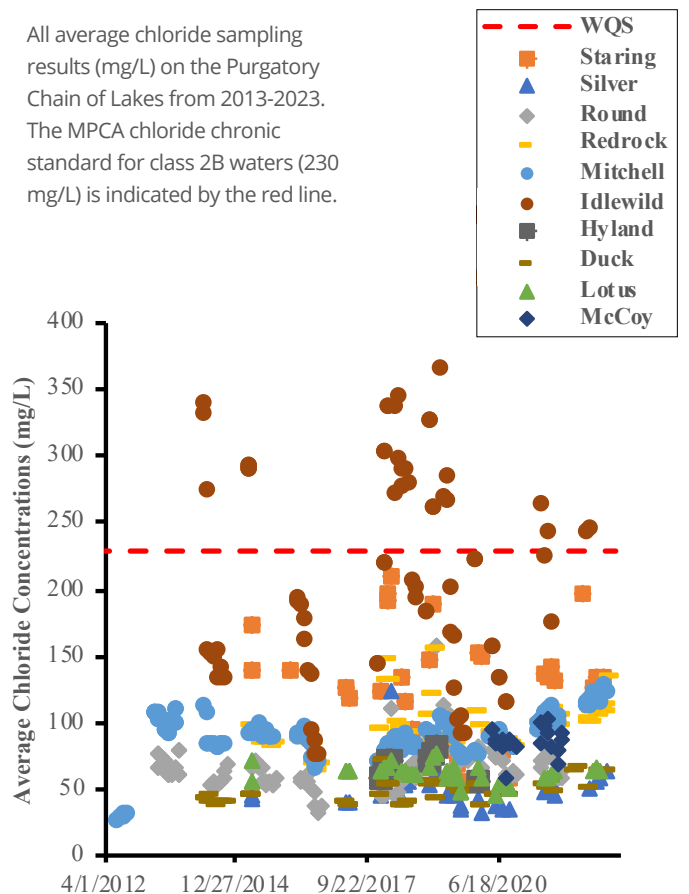
Figure 15. Purgatory Creek Chain of Lakes average chloride levels 2013-2023.

impervious area near the City of Eden Prairie City Center. The only other lake in the Purgatory Chain that had chloride concentrations above the standard was Staring Lake in 2018, 2022 and 2023. Previously, multiple lake bottom concentrations exceeded the standard, however the average (top/bottom) did not. In 2023, one sample average on 3/28/23 did not meet the MPCA standard (390 mg/L). The remainder of the PCL lakes had Cl levels below the MPCA water quality standard and have stayed relatively consistent within lakes year-to-year. There are however signs of slight increases in the past two to three years. In the RCL system, no lake exceeded the water quality standard from 2013-2022. In 2023, both Rice Marsh Lake and Lake Susan exceeded the standard on multiple dates. Both lakes are downstream of Highway 5 and are smaller in size which may explain partially why they do not meet the standard. Unfortunately, Susan, Rice Marsh, and Riley have been on an increasingly alarming trend for the past three years which, if continued, could lead to all lakes exceeding the standard soon. Rice Marsh Lake had the highest average chloride concentration in RCL, measuring 306 mg/L (3/28/2023). At the top of RCL, Lucy and Ann have remained relatively flat with low concentrations near 50 mg/L but have seen subtle increases as well.

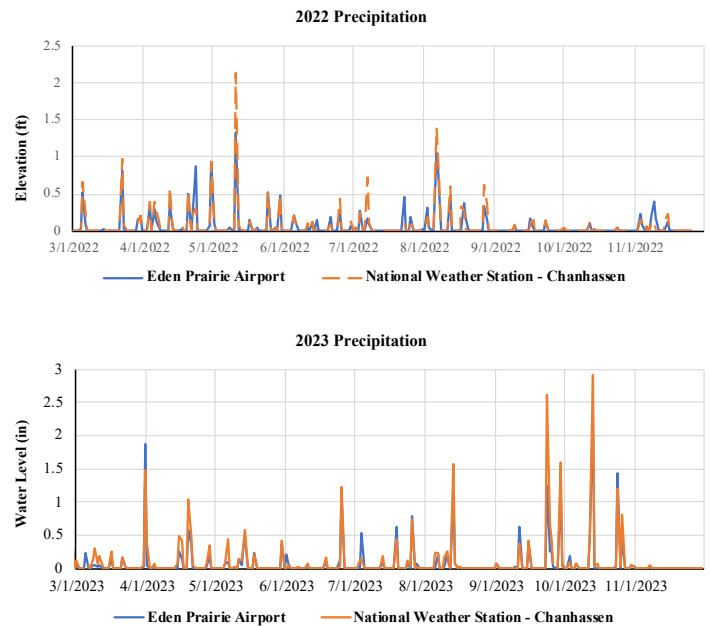
2022 and 2023 precipitation daily totals in inches for Flying Cloud Airport in Eden Prairie, MN and the National Weather Service Station in Chanhassen, Minnesota.

Precipitation data from the Flying Cloud Airport (Pioneer Trail, Eden Prairie) and the National Weather Service Station (Lake Drive West, Chanhassen) was used for precipitation data throughout the following report. [Figure 19](#) displays daily precipitation totals across the two stations from March 1 through December 1 in 2022 and 2023. Overall, precipitation levels were very low in 2023, and the District continued to be in drought condition. During this period, rainfall at the Flying Cloud Airport and National Weather Service Station totaled 20.73 inches (16.78 inches in 2022 and 19.12 inches in 2021) and 26.82 inches (23.49 inches in 2022 and 19.95 inches in 2021) respectively. In 2023, the max rainfall event at Flying Cloud Airport occurred on 10/13/2023 at 2.33 inches of rain (5/11/22, 1.32 inches in 2022) of rain. At the National Weather Service Station, the max rainfall total occurred on 10/13/2023, totaling 2.92 inches of rain (5/11/2022, 2.13 inches). The 2023 autumn rains helped increase water levels going into winter.

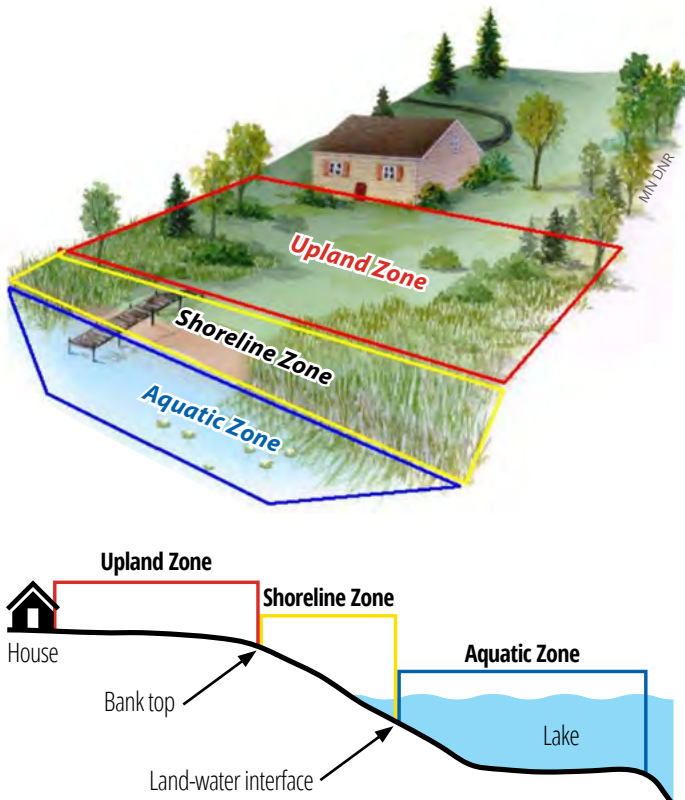
Figure 20. Score The Shore (STS) property zones (MN DNR) shown with a bird's-eye view (top) and side view (bottom).

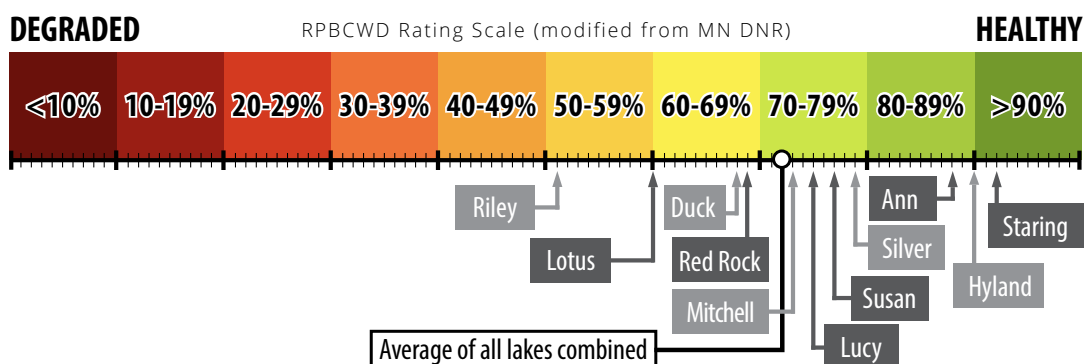
Figure 24. Comparison of RPBCWD Score The Shore weighted lake scores along the modified rating scale.

can be seen in the closeness in scoring between the weighted lakewide average score and DNR lakewide average score for less developed lakes such as Ann and Staring. These lake scoring differences had some of the least variability between methods at 3 percent and 5 percent respectively. If additional DNR surveys are performed on other lakes in the future, it could provide enough data for more in-depth comparisons between the DNR and RPBCWD scoring approaches.

Several lakes (Duck, Lotus, Red Rock, and Riley) have a lower weighted average than the weighted average for all lakes. This is likely due to these lakes containing a higher proportion of developed property and subsequently a higher percentage of deteriorated shoreline. All lakes had a weighted average that was higher than their property average. Susan had the highest difference, with a weighted average 26 percent higher than the individual property score. Lake Susan has one side of the lake dominated by natural parkland and the other side as heavily developed private property. Lake Lucy has a similar case, with a property average of 62 and a weighted average of 75. For these lakes, the individual property score is skewed and the average is a gross underestimation of the overall shoreline health. All other lakes had a difference of 11 percent or less. Lake Riley is the most developed lake within the district and had similar scores comparing the DNR and weighted method (four percent difference). Both Lotus and Mitchell scores were significantly different between the district and DNR scoring with differences greater than 15 percent.
