Lake Susan

Lake Susan Water Quality by the Numbers

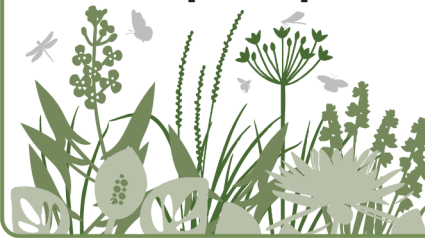
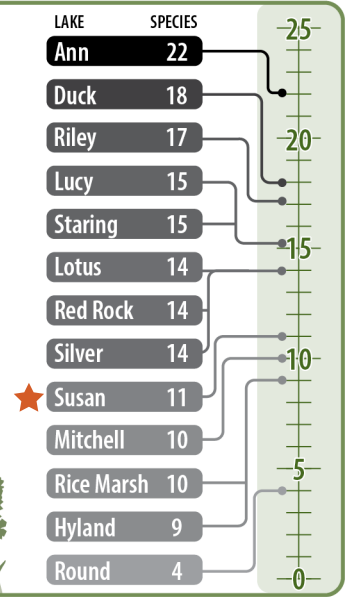
Native Aquatic Plant Diversity

How does **Lake Susan** compare to **other lakes** in the District in **number of native plant species?**

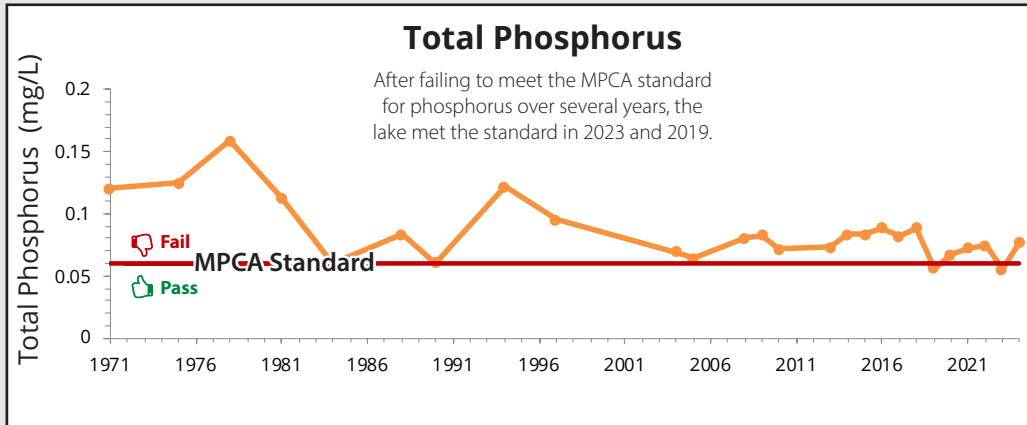
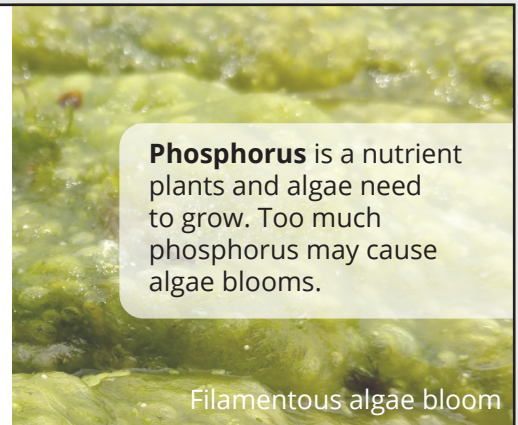
Phosphorus is a nutrient plants and algae need to grow. Too much phosphorus may cause algae blooms.

The graphs below show water quality trends over time with the red line representing the MPCA standard for shallow lakes. In 2024, Lake Susan failed to meet two clean water standards set by the MPCA.

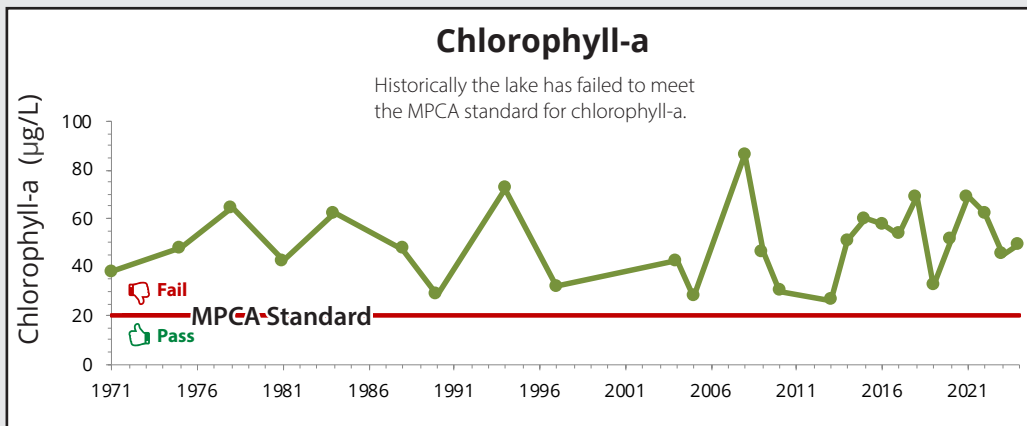
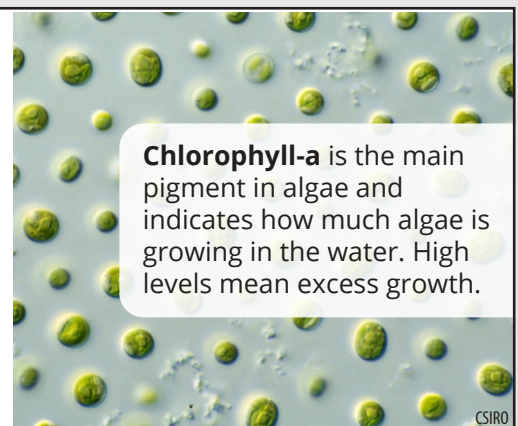
Chlorophyll-a is the main pigment in algae and indicates how much algae is growing in the water. High levels mean excess growth.

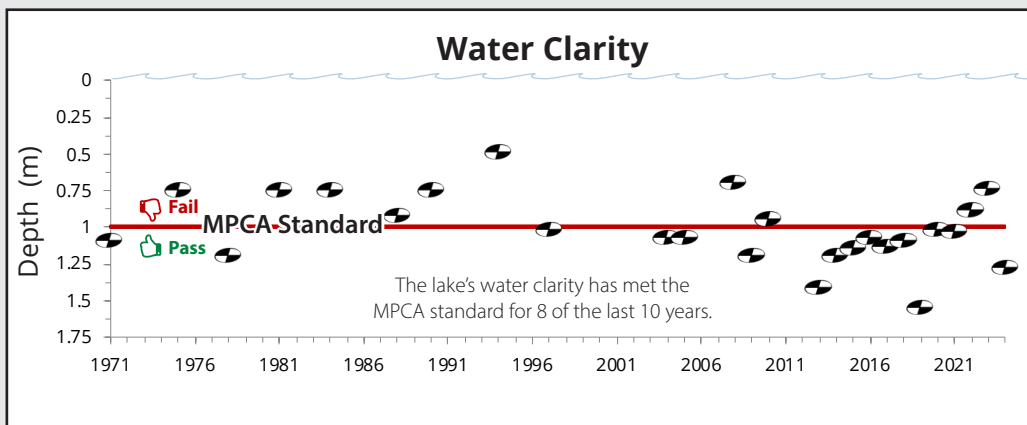
Water clarity is measured by lowering a Secchi Disk into the water. The depth at which the disk is no longer visible is the water's clarity measurement.
