# North Lotus Lake Park

## Water Quality Improvement Project

RILEY  
PURGATORY  
BLUFF CREEK  
WATERSHED DISTRICT

Proposed  
Preliminary  
Concept  
July 2026

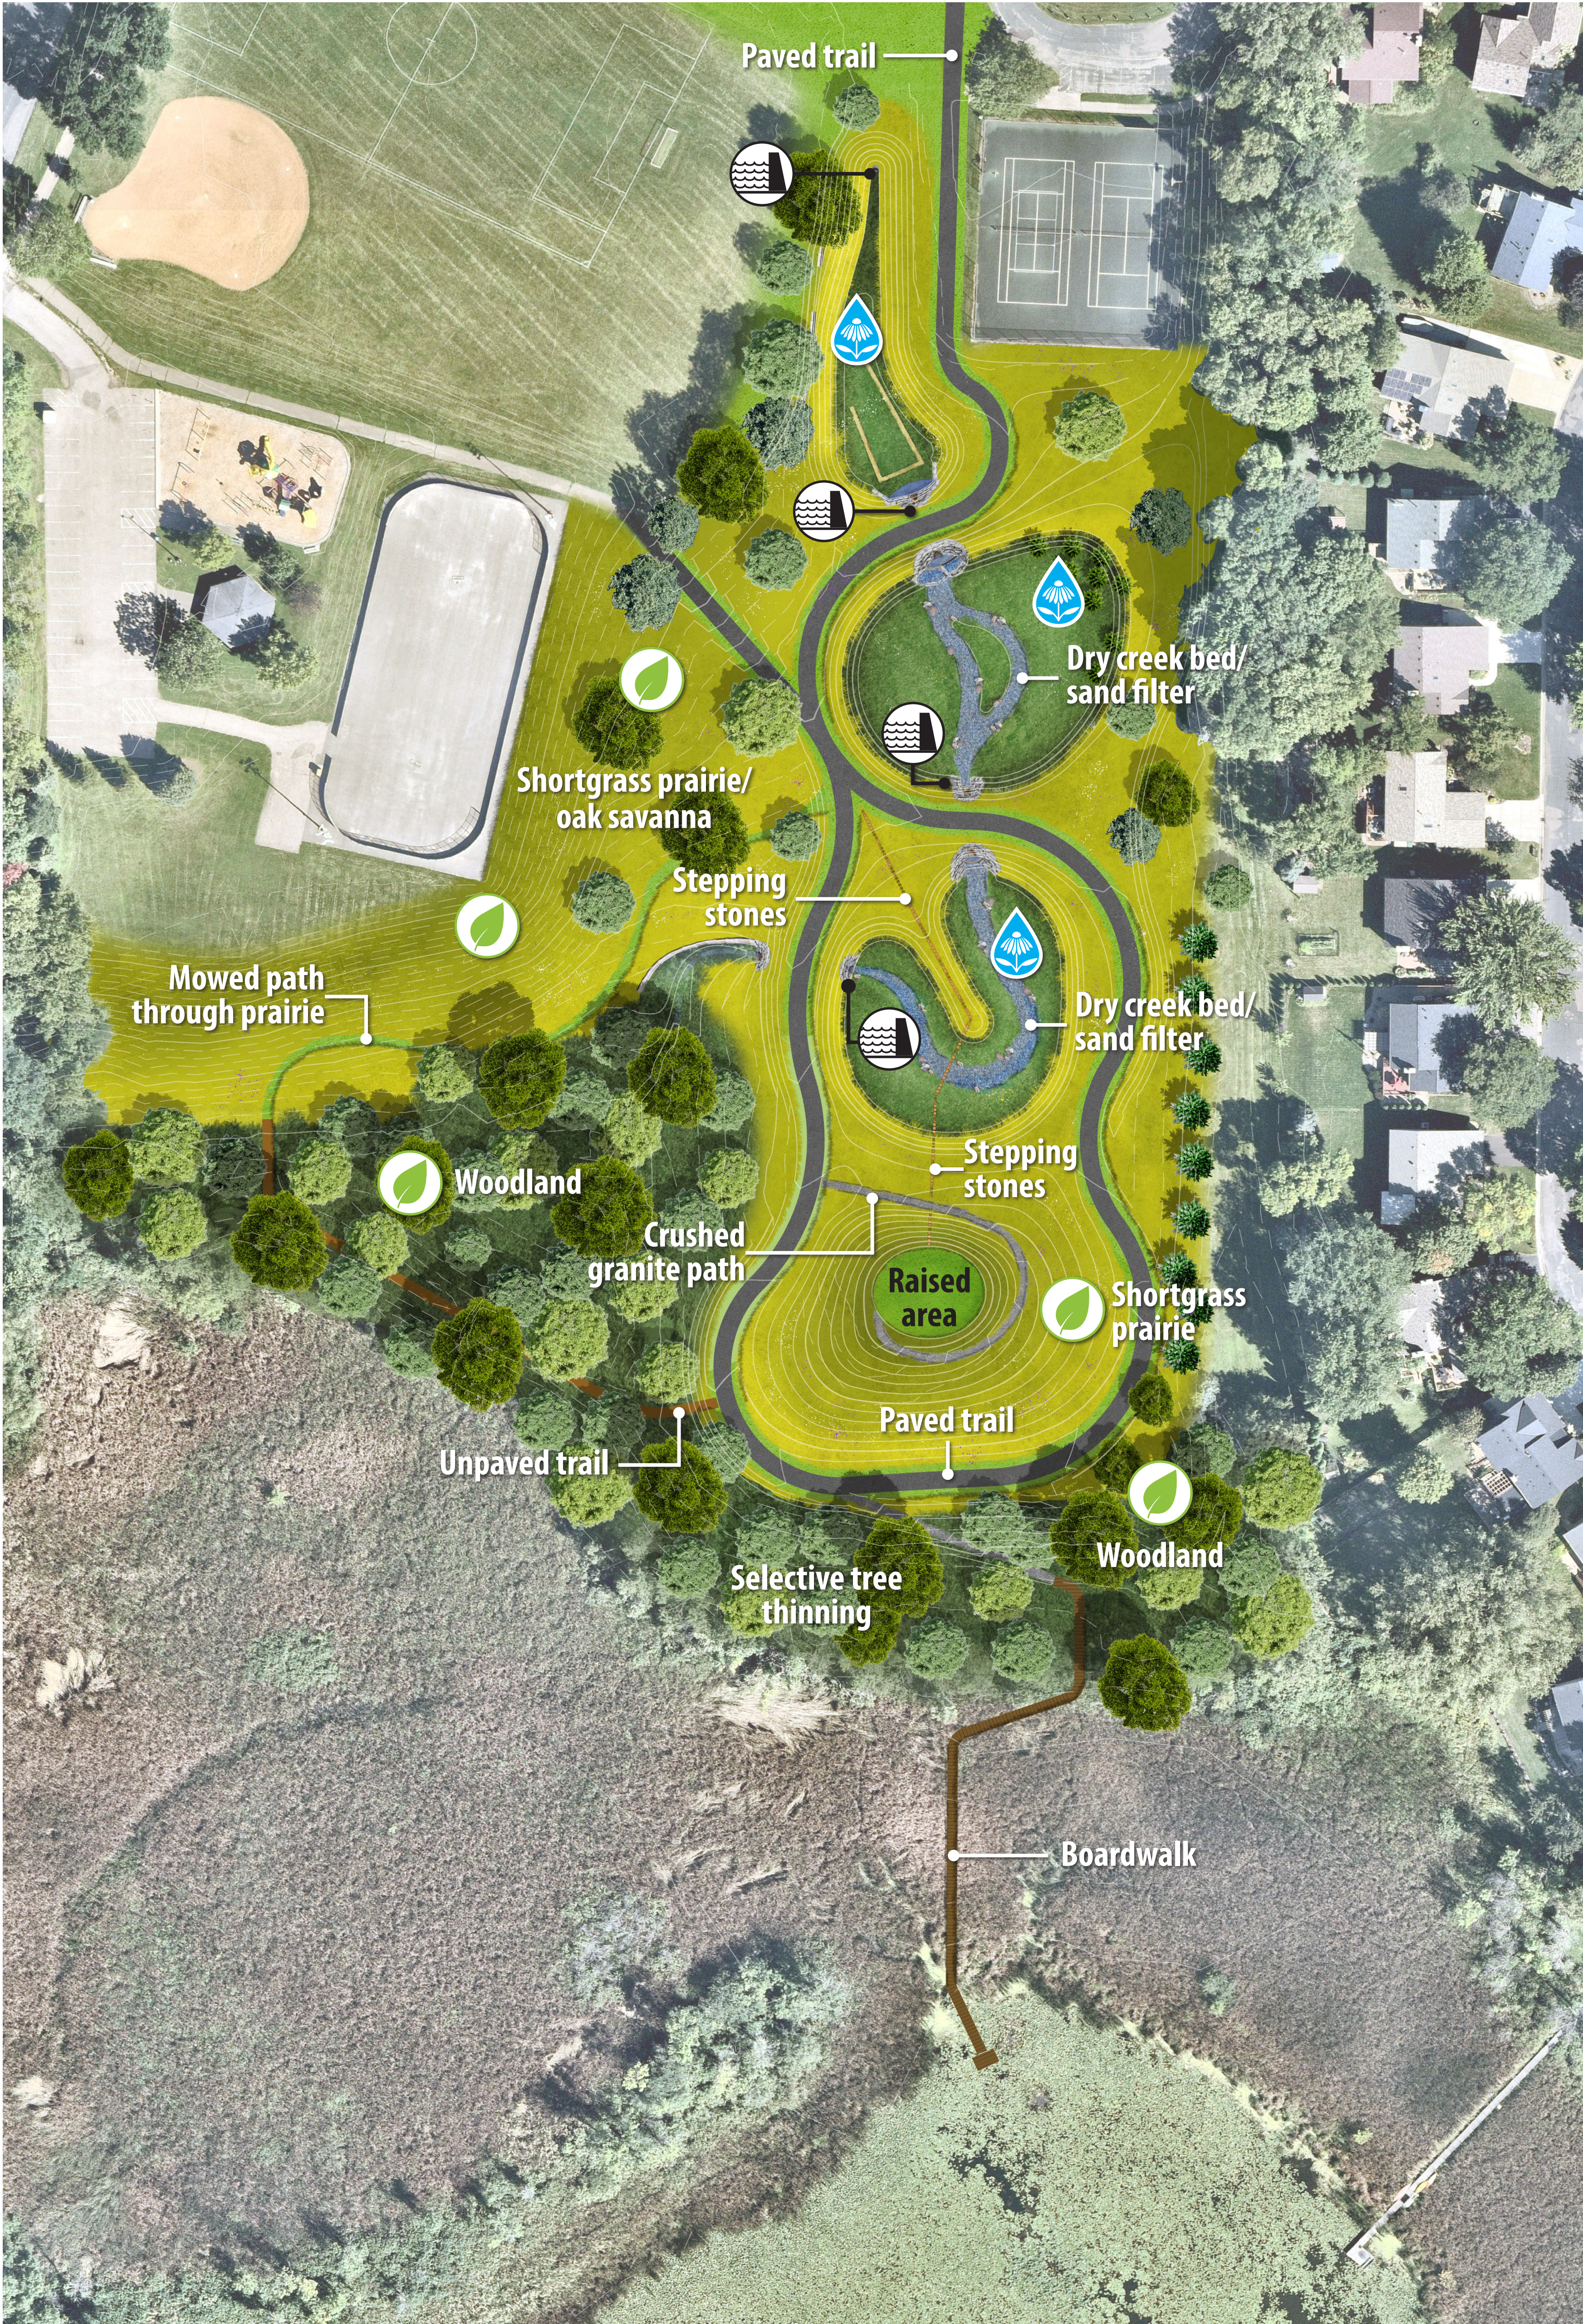
Stormwater basin/  
wet meadow

Weir/spillway

Habitat  
restoration

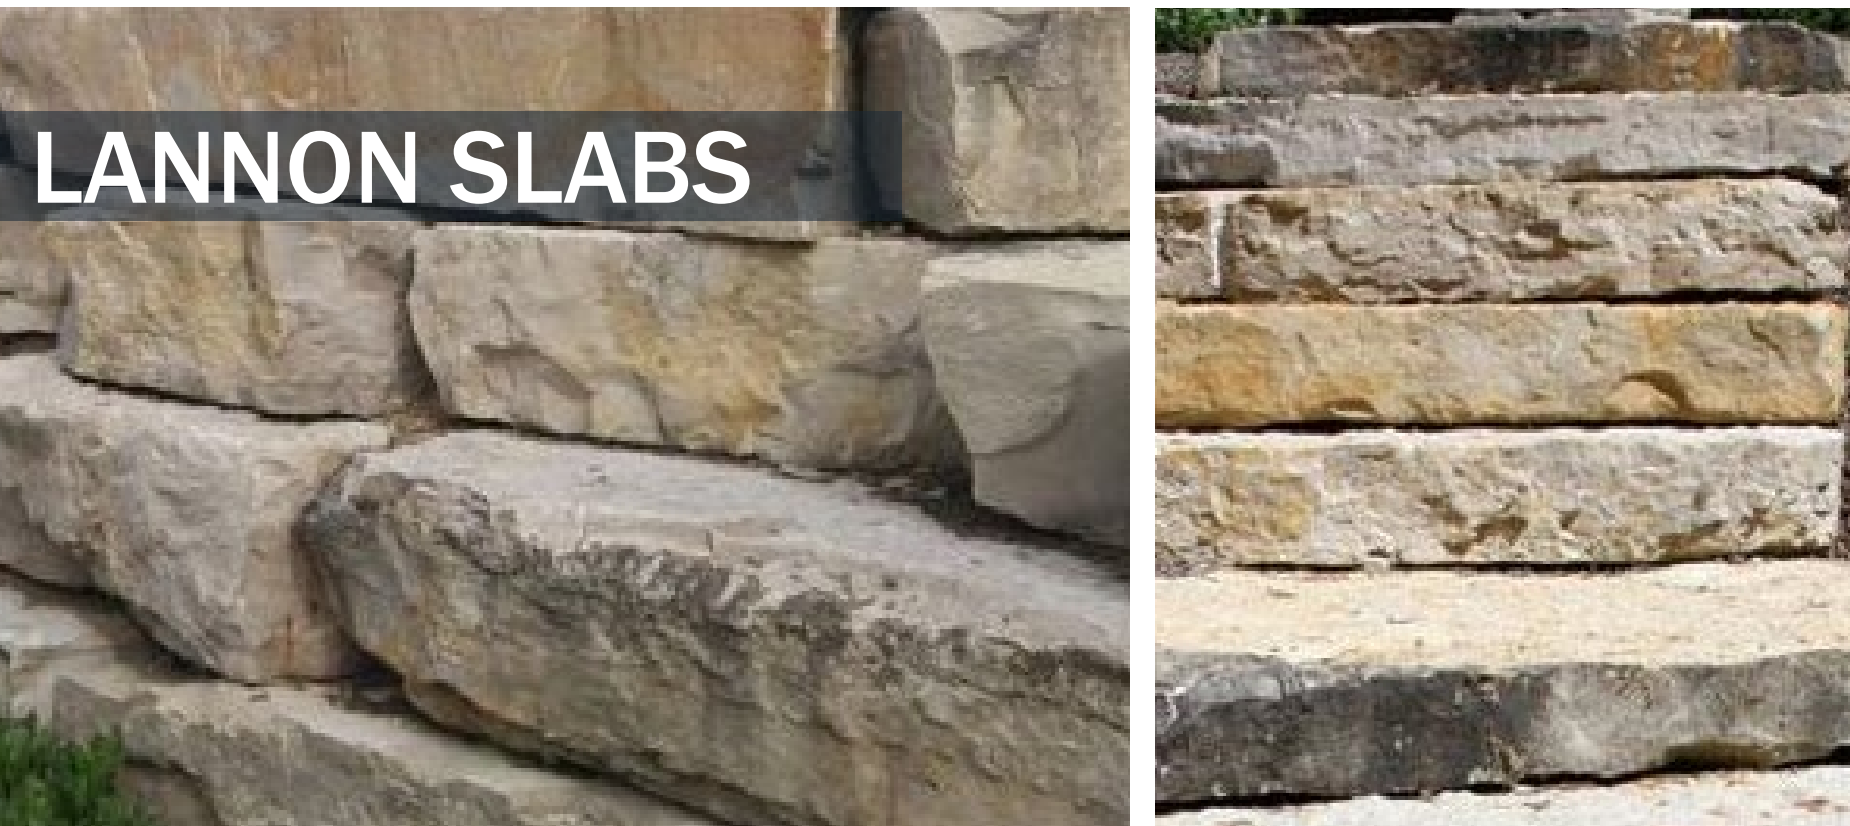
**LANNON SLABS**  
Basin Retaining Walls and Headwalls  
Lannon is a harder limestone that will hold up to flowing water longer than buff limestone

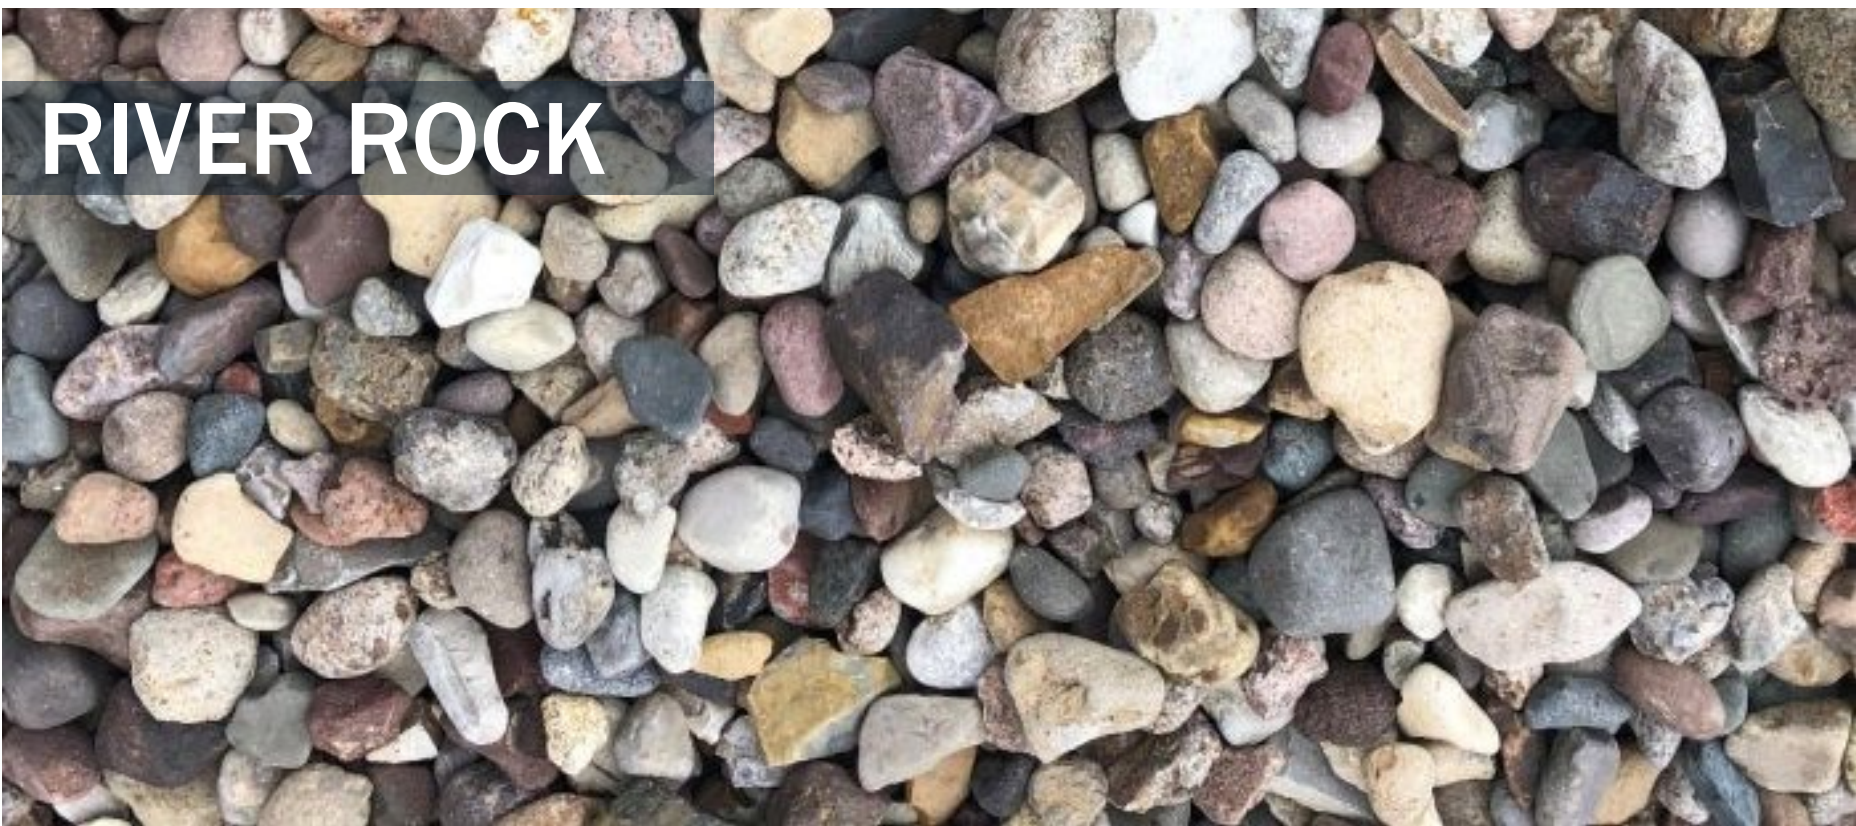
**RIVER ROCK**  
Dry Creek Bed Surfacing

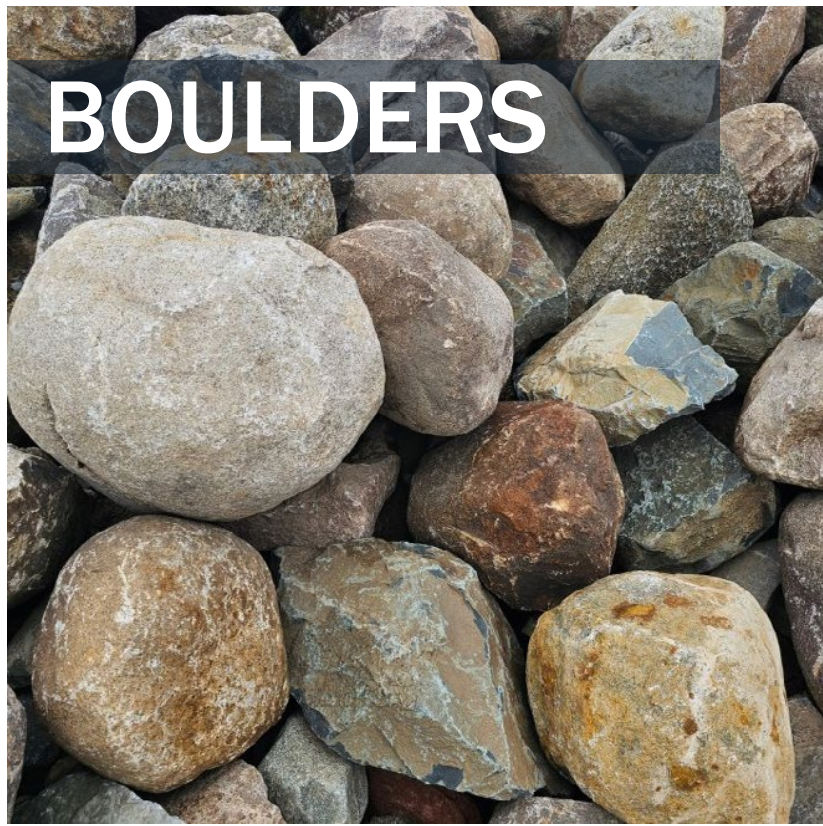
**BOULDERS**  
Dry Creek Bed Accents

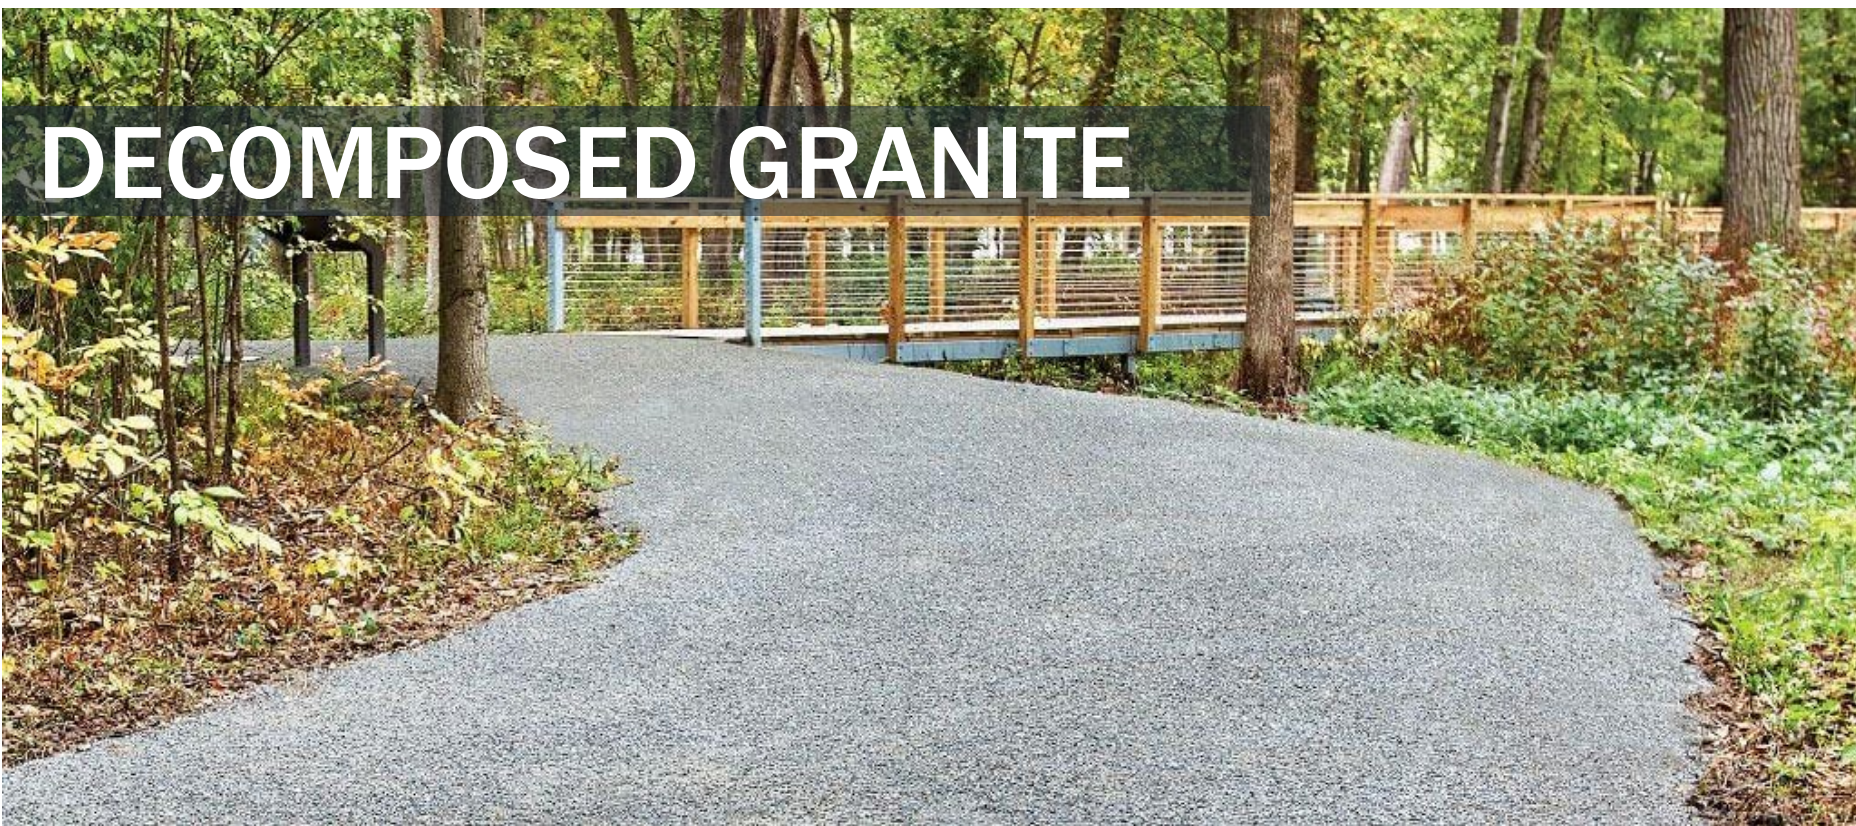
**DECOMPOSED GRANITE**  
Trail Surfacing  
A combination of granite aggregate and fines bound with a natural stabilizer to create an ADA accessible surface

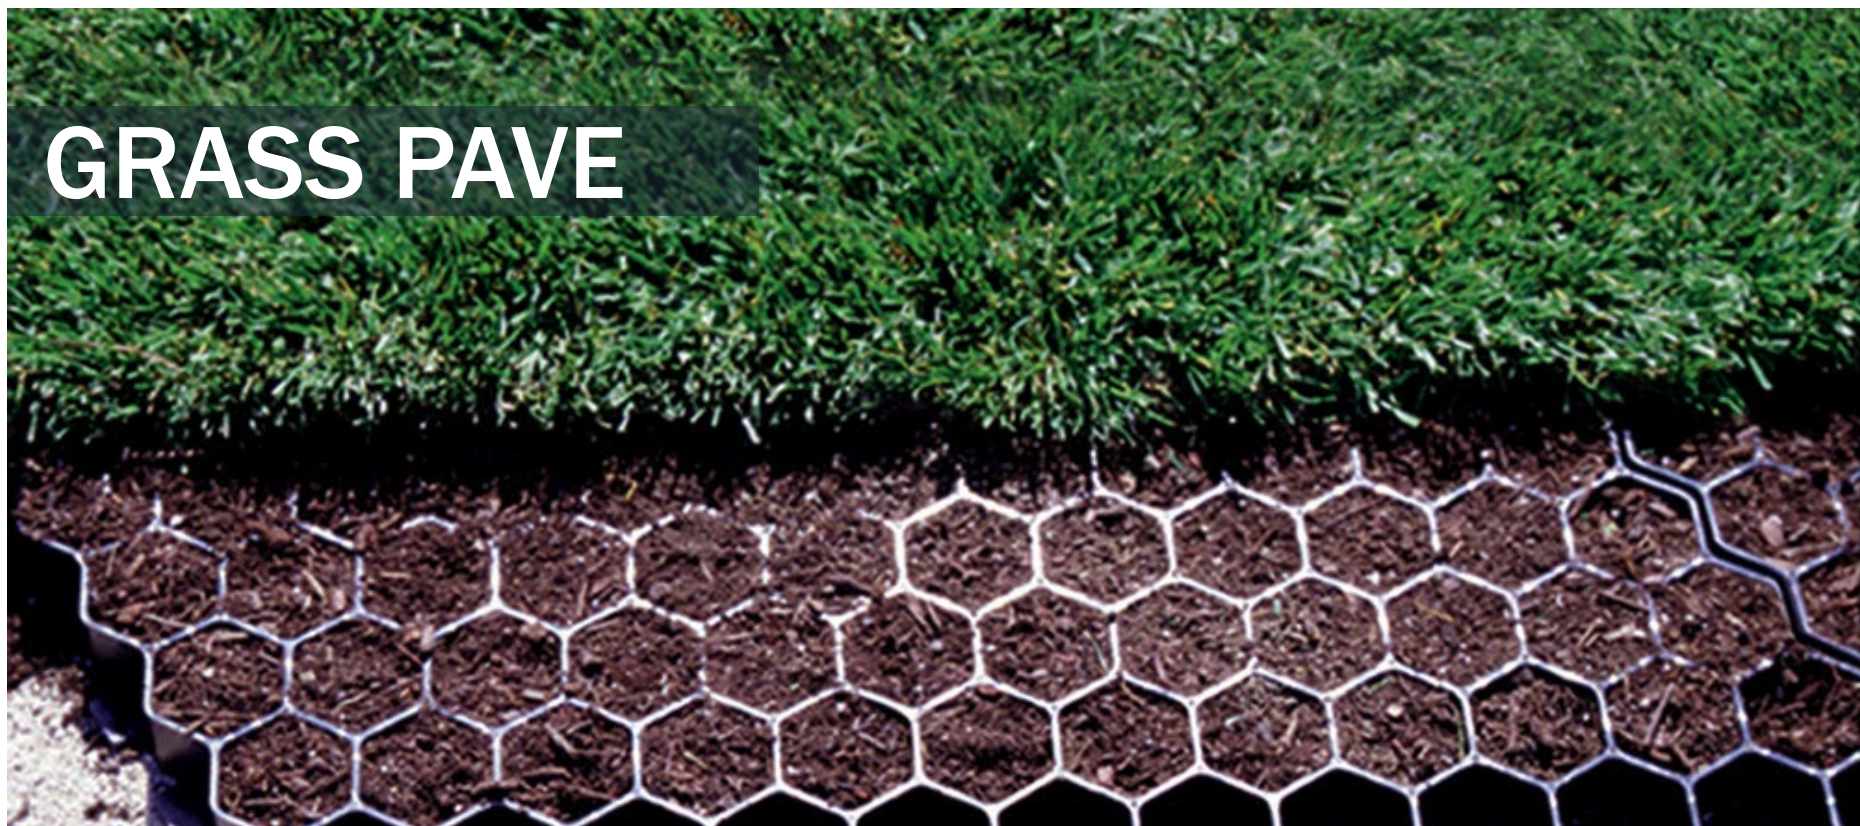
**GRASS PAVE**  
Overlook Surfacing  
Stable, ADA accessible grass surface

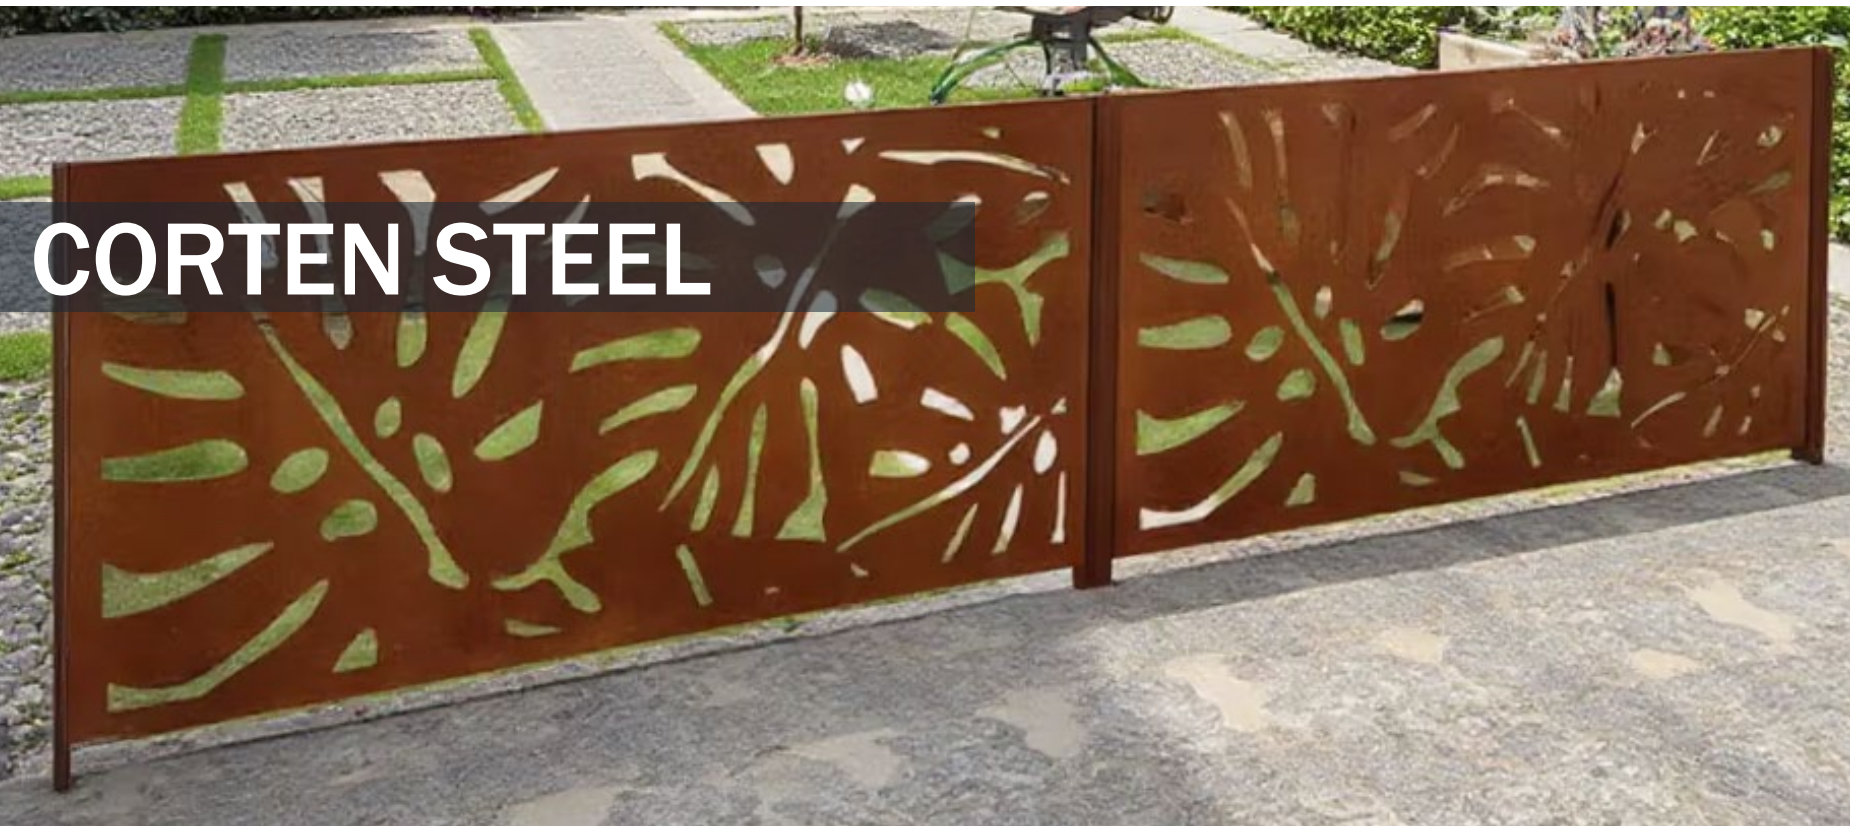
**CORTEN STEEL**  
Basin 2 and 3 Weir  
Corten steel laser cut with RPBCWD logo

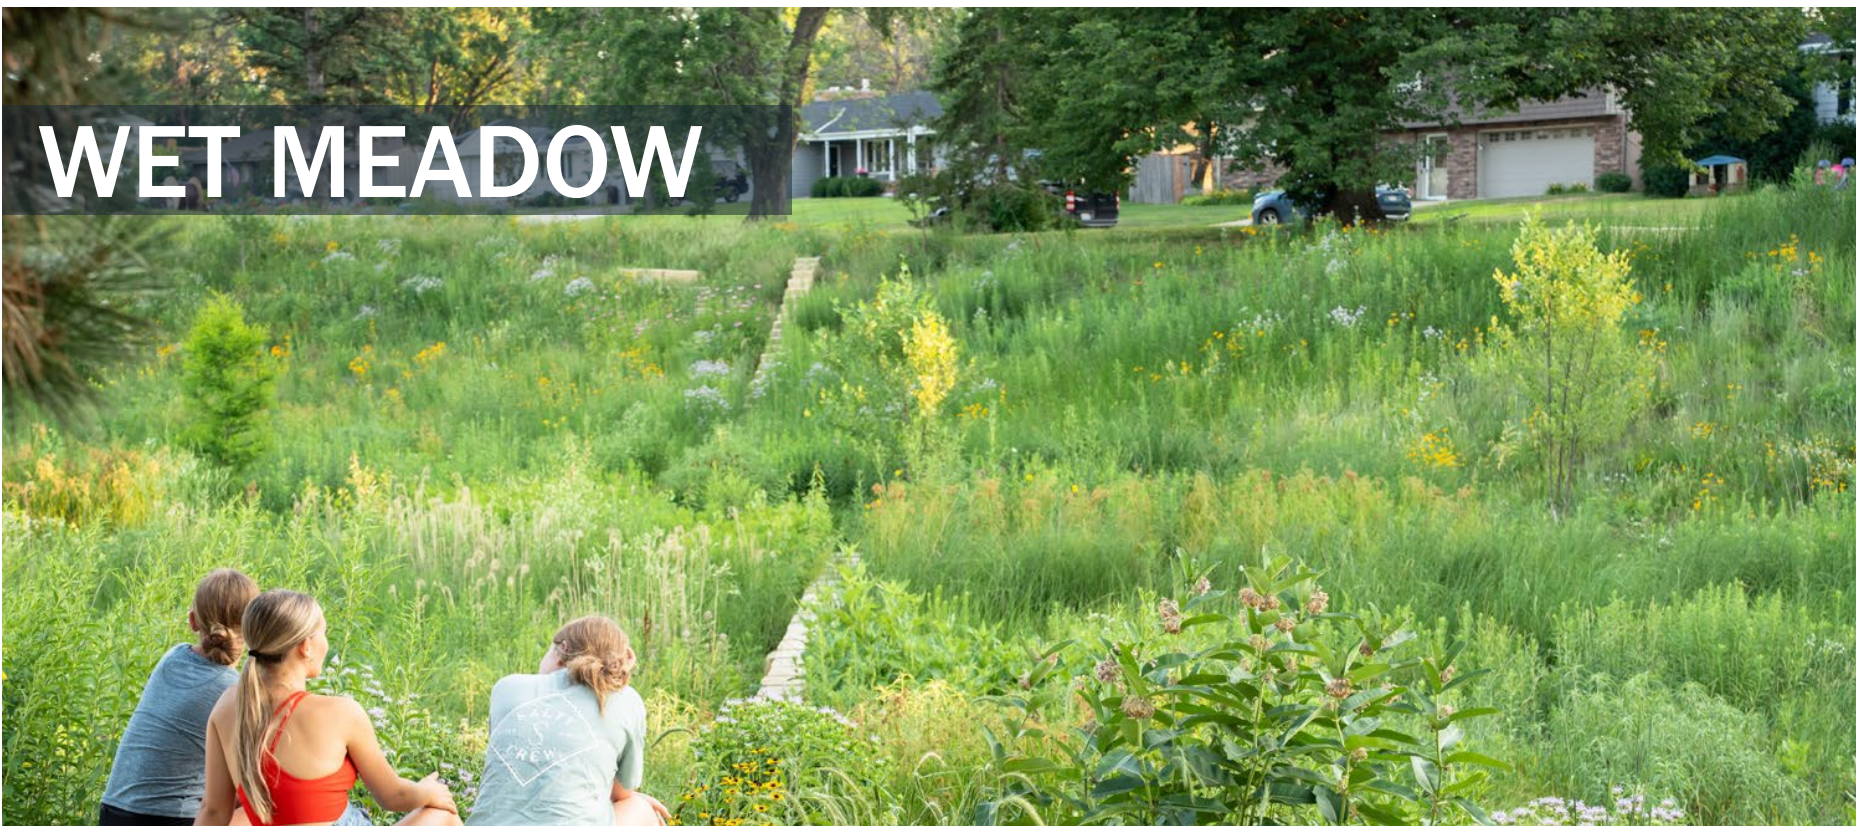
**WET MEADOW**  
Semi-Formal  
Stormwater basins planted with massed perennials

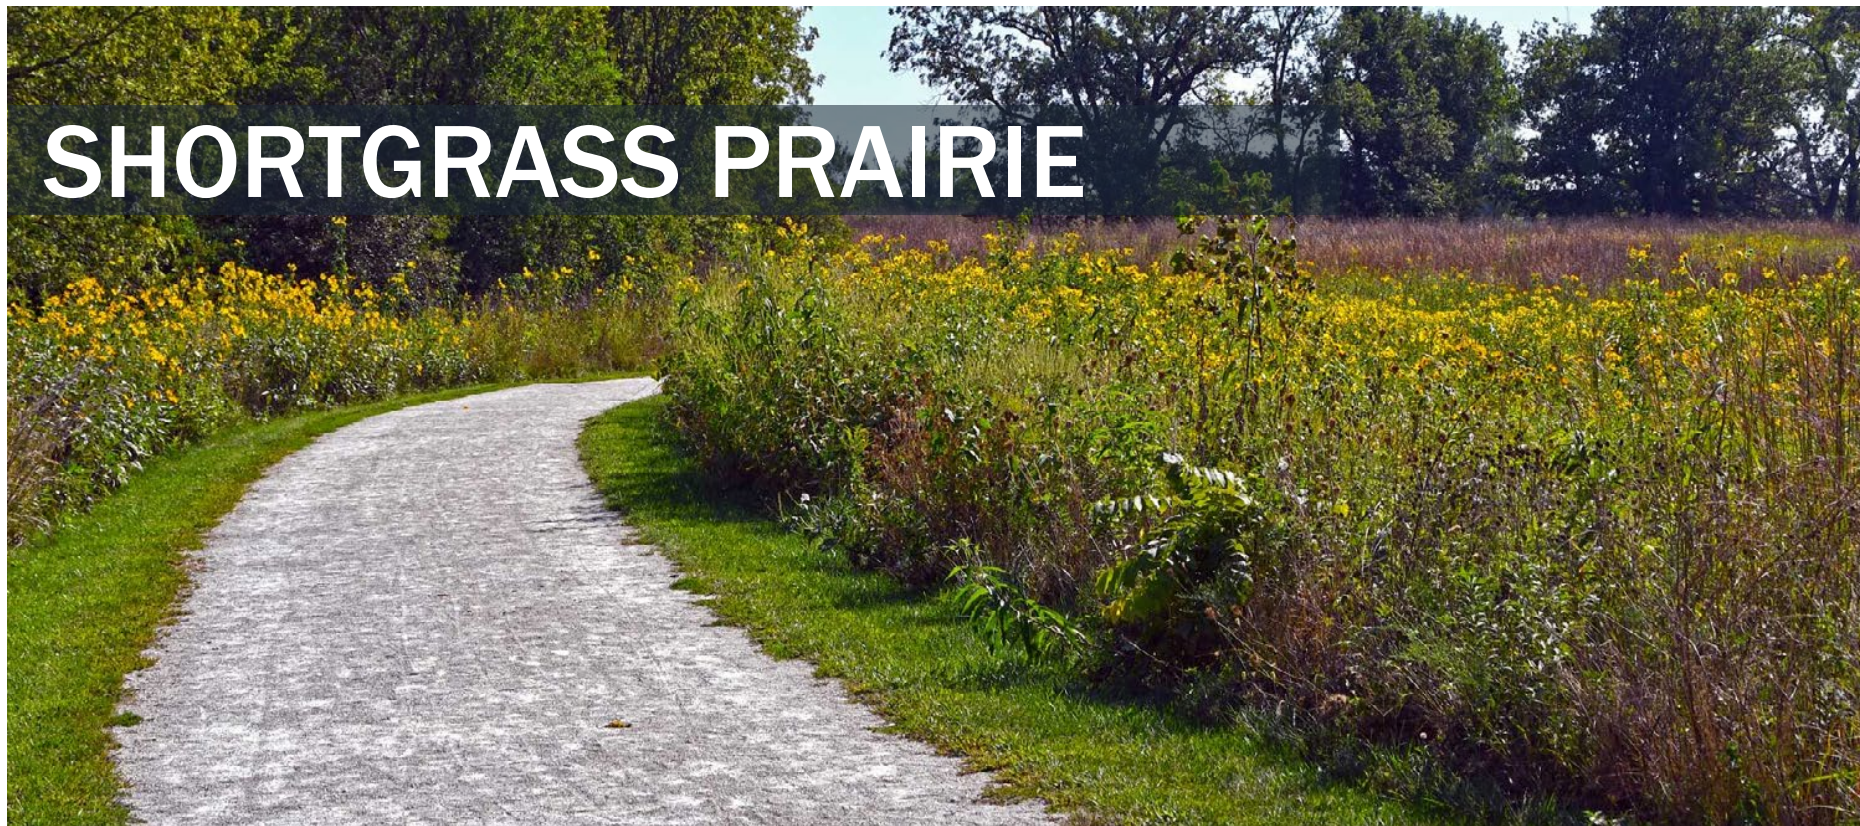
**SHORTGRASS PRAIRIE**  
Natural  
Prairie with clean edges and mown trail shoulders
