Red Rock Lake

Red Rock Lake Water Quality by the Numbers

2025

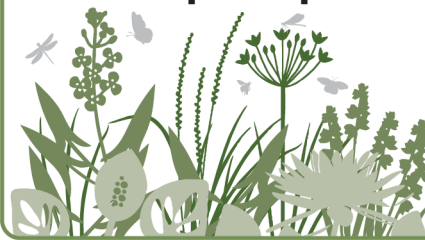
Native Aquatic Plant Diversity

How does Red Rock Lake compare to other lakes in the District in number of native plant species?

Plant update: In 2025, an RPBCWD consultant conducted a point intercept survey to evaluate plant diversity and density. Dominant species were coontail, yellow water lily, and leafy pondweed. In spring of 2025, RPBCWD treated 12.8 lake acres to control invasive curly-leaf pondweed.

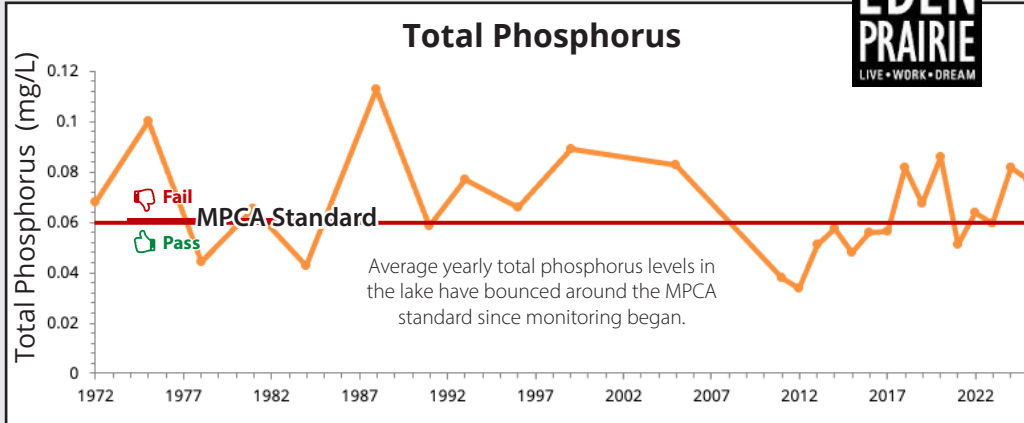
Phosphorus is a nutrient plants and algae need to grow. Too much phosphorus may cause algae blooms.

The graphs below show water quality trends over time with the red line representing the MPCA standard for shallow lakes. For the last few years, the City of Eden Prairie has collected water quality data for Red Rock Lake.
