Staring Lake

Staring Lake Water Quality by the Numbers

2025

Water Quality
Report Card

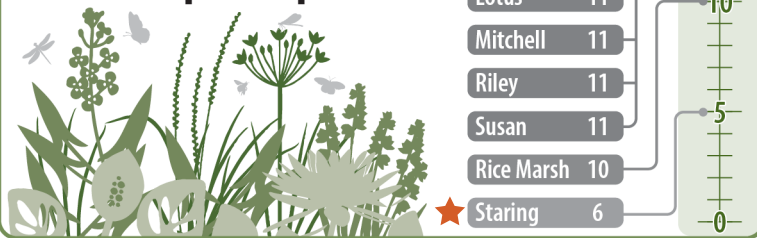
Native Aquatic Plant Diversity

How does Staring Lake compare to other lakes in the District in number of native plant species?

Plant update: Treatments were used to control invasive Eurasian Watermilfoil in 2022 and 2025, and Curly-leaf Pondweed in early 2024. In 2025, a survey showed presence of 6 native species, with Eurasian Watermilfoil and Curly-leaf Pondweed at low abundance.

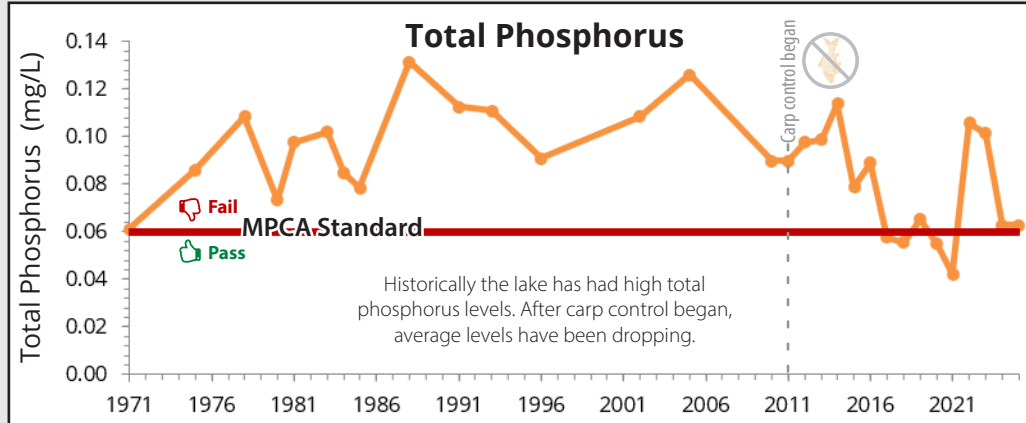
Phosphorus is a nutrient plants and algae need to grow. Too much phosphorus may cause algae blooms.

The graphs below show water quality trends over time with the red line representing the MPCA standard for shallow lakes. Over the last decade, **Staring Lake** has failed to consistently meet clean water standards set by the MPCA.

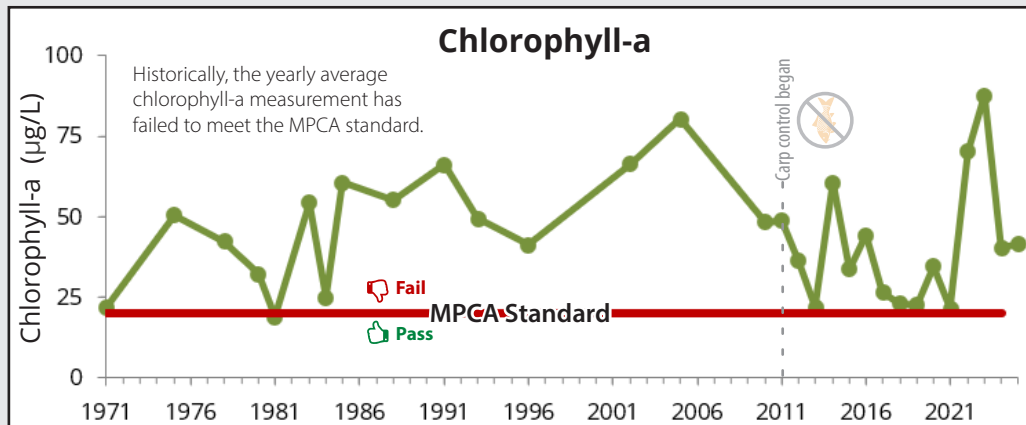
Chlorophyll-a is the main pigment in algae and indicates how much algae is growing in the water. High levels mean excess growth.
