# Water Resources Report

RILEY PURGATORY BLUFF CREEK WATERSHED DISTRICT  
2017 ANNUAL REPORT

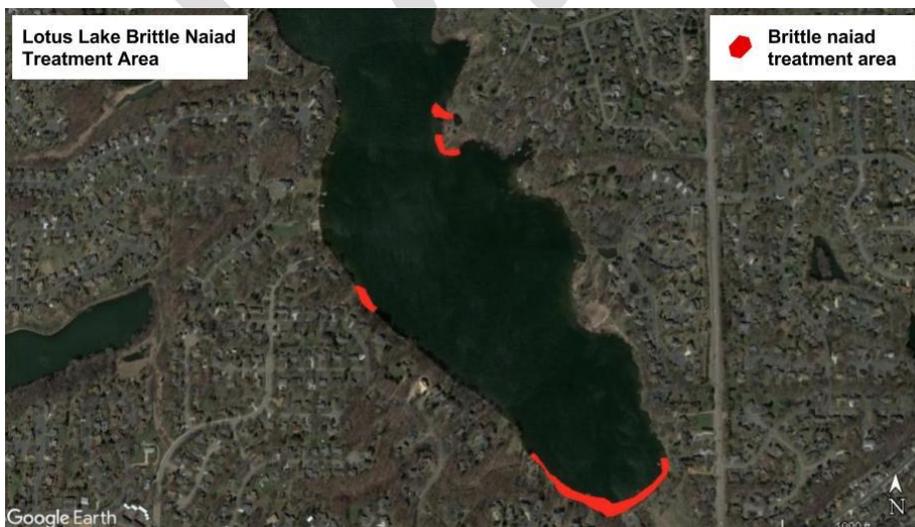
**Figure 5.2-3 2017 Lotus Lake Brittle Naiad Treatment Areas**

On September 26, 2017, during a routine boat launch AIS inspection, staff observed brittle naiad (*Najas minor*) located on both sides of the public boat access on the south side of Lotus Lake. Brittle Naiad is a species native to Europe, western Asia, and northern Africa that has been introduced to the United States. The concern with Brittle Naiad is that it can form dense mats that can outcompete native plants. These dense communities can disrupt fish and waterfowl habitat, choking out plants which animals depend on for survival and potentially decreasing dissolved oxygen levels upon its decomposition. With that said, brittle naiad is a very new AIS and not much is known about its effects especially in Minnesota. Brittle naiad is a fairly resilient plant; it can survive in some polluted and eutrophic waters and can reproduce by fragmentation. Staff reported the occurrence of brittle naiad to Aquatic Invasive Species Specialist Keegan Lund of the MN DNR. Staff extended the inspection to a full scan of the lake, mapping the position of every observed brittle naiad occurrence with a handheld GPS. An effective treatment area was determined from the GPS points (Figure 5.2-3). That fall, PLM Lakes and Land Management Corp applied herbicide to treat for brittle naiad in the lake within the affected areas (area totaling 2.42ac, Figure 5.2-3). Brittle naiad was also found at one location on Lake Ann the previous month during a regular vegetation survey conducted by FWSS (August 2<sup>nd</sup>, Figure 5.2-4). Only a small cluster of plants were discovered across the lake; these plants were treated immediately with hopes to eliminate the plant before it could become established. A 0.25ac treatment plot was designated and treated with herbicide (Figure 5.2-4).

The red polygons indicate the areas treated with herbicide during the fall of 2017 for brittle naiad. The total area treated was 2.42ac.

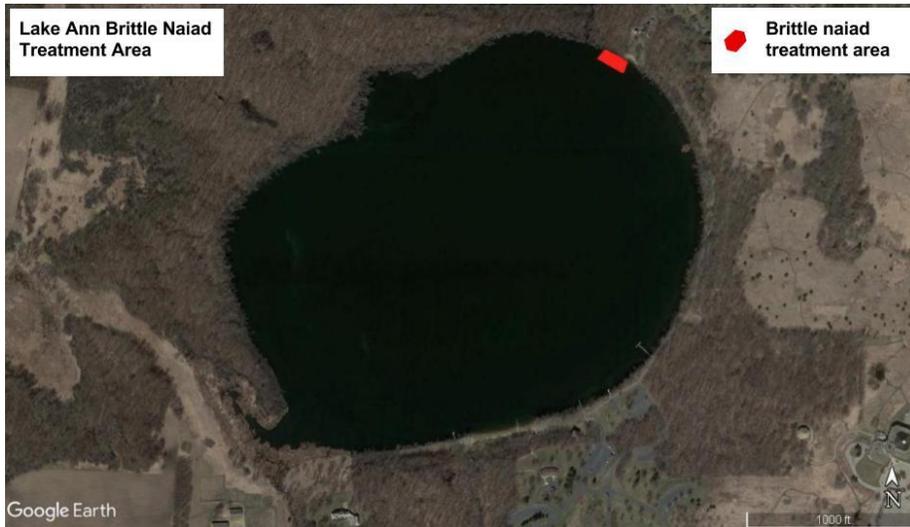
**Figure 5.2-4 2017 Lake Ann Brittle Naiad Treatment Area**

The red polygon indicates the 0.25ac brittle naiad herbicide treatment area during late summer of 2017.

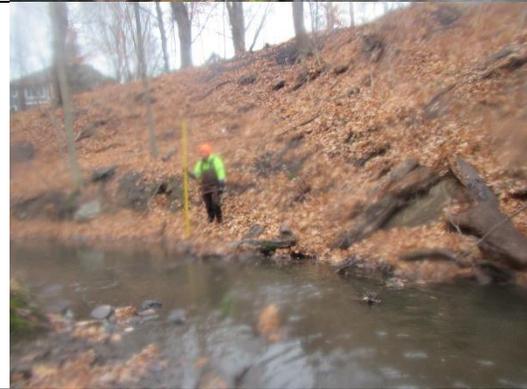
Towards the beginning of the subreach, staff observed some erosion measuring up to 5ft high by 30ft along the right bank (IMG\_2157). There were boulders in and along the channel throughout the start of the subreach (IMG\_2157). The substrate was primarily composed of gravel and sand, with some silt occurring in the few pooling areas, and some cobble present within the riffles. Just downstream there was another stretch of erosion along the right bank, measuring 4ft high by 20ft (IMG\_2158). Staff continued to see woody debris in-stream, including a small woody debris dam (IMG\_2159). At this point there was some more erosion along the left bank measuring 3.5ft high (IMG\_2159, IMG\_2160). Continuing downstream, staff observed a stretch of cutting measuring 0.25ft high which was continuous along the right bank (IMG\_2161). However, due to the presence of moss, the right bank was stable, despite the continuous cut bank. The stream then came up to a culvert under a driveway along the outside bend of the left bank as it shifted south (IMG\_2162). The culvert was nearly full of sediment and the immediate sediment as seen in IMG\_2163 was extremely soft muck/silt. The stream channel then shifted south and there was yet another stretch of erosion along the left bank, 3ft high by 30ft (IMG\_2163). A considerable amount of sandy/silt deposition can also be seen in IMG\_2163 on the opposing right bank. The stream at this point was 0.94ft deep by 11ft wide. At the start of the Bearpath golf course, staff encountered another woody debris dam (IMG\_2165) which was causing some erosion measuring 3ft high by 10ft along the left bank. The golf course was adjacent to the left bank at this point; the grass was mowed to the stream edge (IMG\_2165). Staff observed one final patch of erosion on the right bank before entering the next subreach (IMG\_2166). The stream at this point measured 1.24ft deep by 6.4ft wide.

<p><b>IMG_2157</b></p> <p>Erosion, 5ft by 30ft, RB.</p>

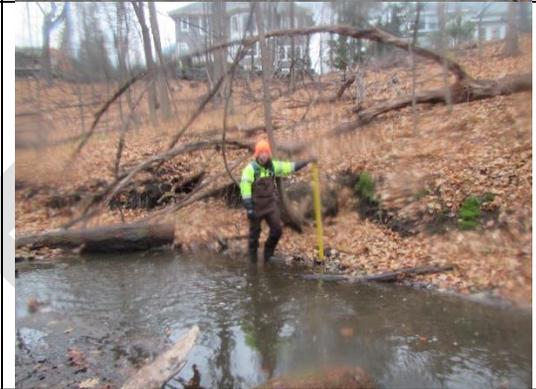
<p><b>IMG_2158</b></p> <p>Erosion, 4ft by 20ft, RB.</p>

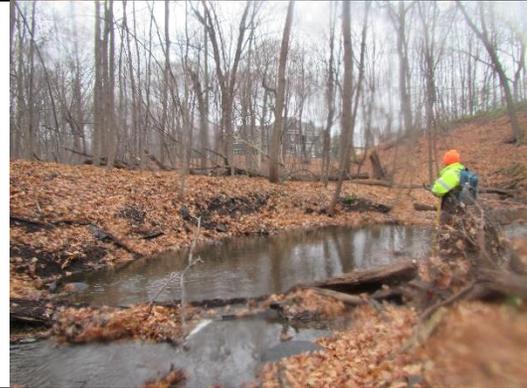
<p><b>IMG_2159</b></p> <p>Woody debris dam; bank erosion, LB.</p>

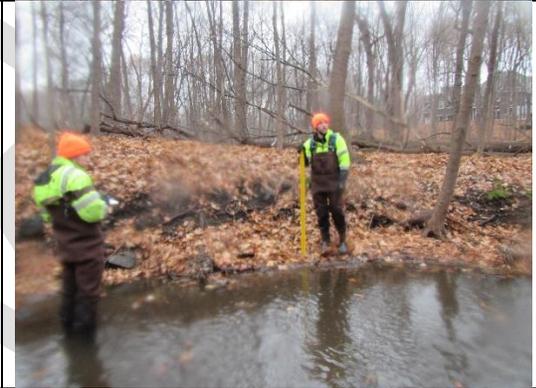
<p><b>IMG_2160</b></p> <p>Erosion, 3.5ft high, LB.</p>

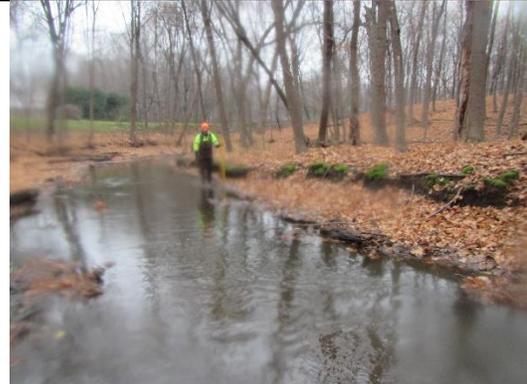
<p><b>IMG_2161</b></p> <p>General erosion, 0.25ft high, RB; moss on banks.</p>

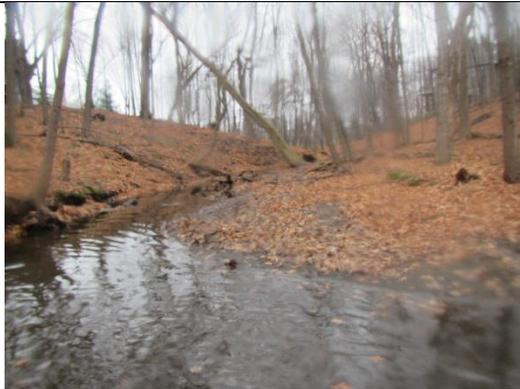
<p><b>IMG_2163</b></p> <p>General stream picture; erosion measuring 3ft high by 30ft, LB.</p>

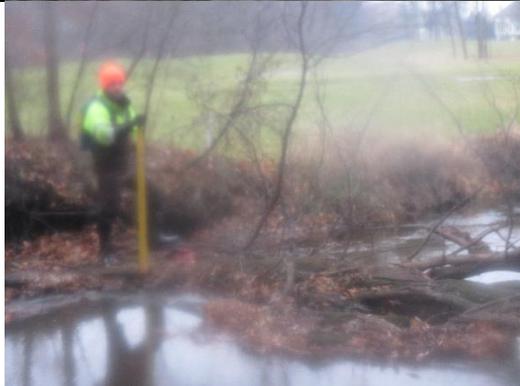
<p><b>IMG_2165</b></p> <p>Woody debris dam causing erosion, 3ft by 10ft, LB.</p>

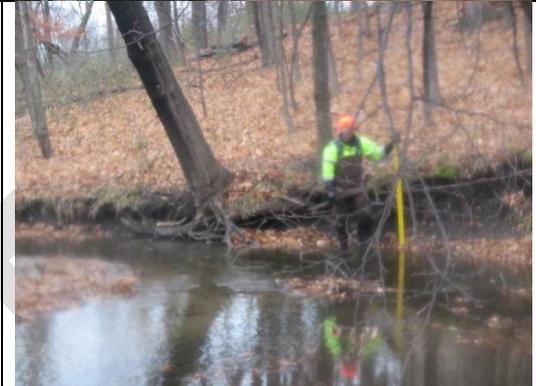
<p><b>IMG_2166</b></p> <p>Erosion near end of subreach, RB.</p>

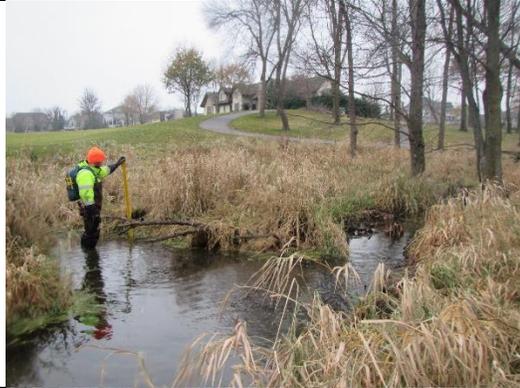
island in the channel measuring 75ft long by 20ft wide (IMG\_2175). Continuing downstream, the surrounding land-type began to shift to from grassy wetland back to mixed grass/forest (IMG\_2176). Staff observed a large cement structure (IMG\_2176) set back about 15ft from the left bank; its purpose was not identified. At this point, the golf course was set back about 15ft to 45ft from the right bank, and houses were set back about 90ft to 120ft from the left bank. The channel was still very connected to the floodplain at this point with small, isolated ponds being common along the channel. With an increase in canopy cover came an increase in woody debris within the stream with multiple piles of woody debris present (IMG\_2178, IMG\_2179). Near the second woody debris pile, a smaller riffle was present which was one of the few present in this subreach. The riffle then emptied into a deeper pool which measured 2.3ft in depth. Just downstream of the riffle and pool, erosion was observed on the left bank, measuring 2ft high and stretching for about 100ft (IMG\_2181). Staff then found a dumpsite containing organic yard waste on the left bank behind a residence (IMG\_2182). The stream then transitioned back to a grassy wetland landscape for about 210ft before the wooden walking/golf cart bridge at the end of the subreach (IMG\_2183). The stream was very connected to the floodplain at the bridge with ambiguous stream/channel edges. The in-stream sediment was very mucky just upstream of the bridge.

<p><b>IMG_2175</b></p> <p>Grass/sedge island, 75ft by 20ft; US.</p>

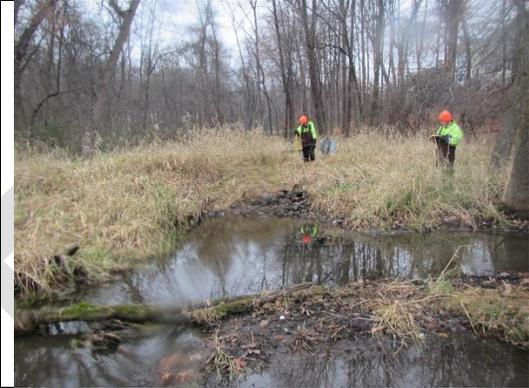
<p><b>IMG_2176</b></p> <p>Large cement structure; LB.</p>

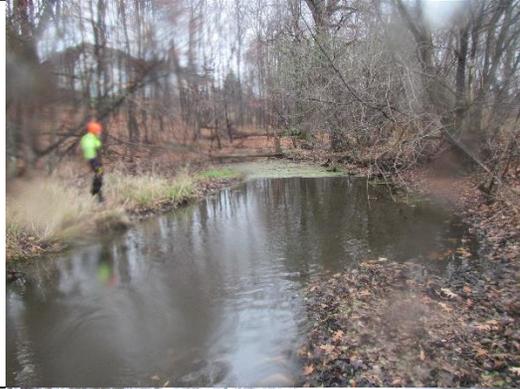
<p><b>IMG_2177</b></p> <p>General stream picture.</p>

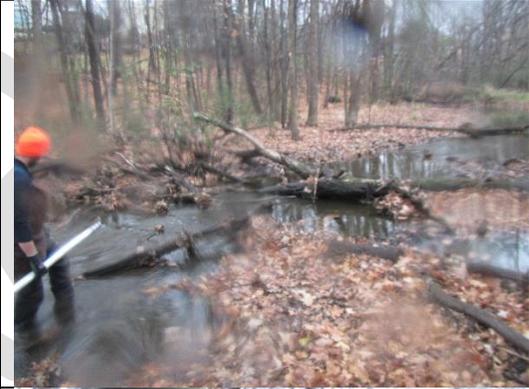
<p><b>IMG_2178</b></p> <p>Woody debris.</p>

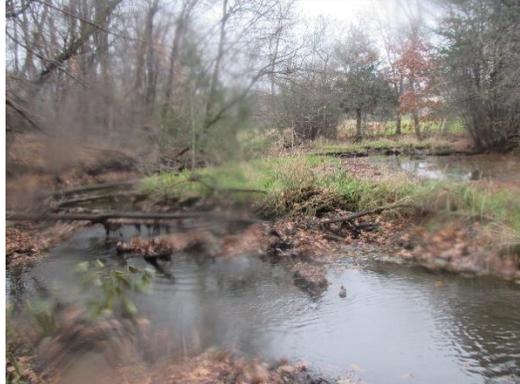
<p><b>IMG_2179</b></p> <p>General stream picture; woody debris.</p>

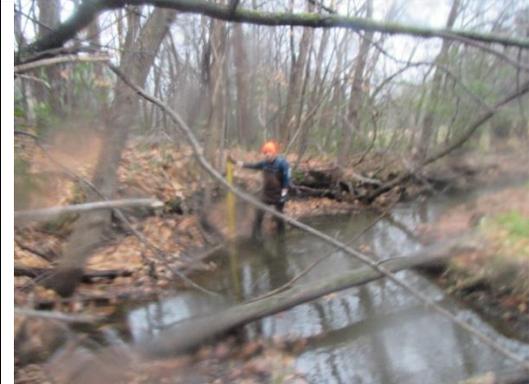
<p><b>IMG_2181</b></p> <p>Erosion on LB, 2ft high by 100ft.</p>

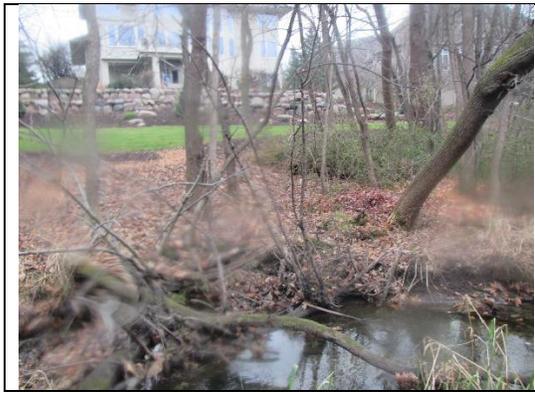
**IMG\_2182**

Yard waste dump site, LB.

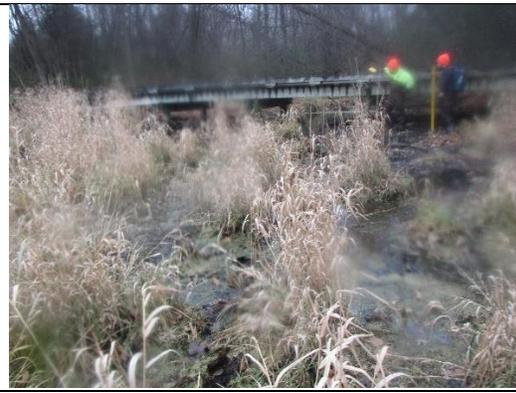
**IMG\_2183**

Walking/cart bridge across stream; mucky sediment; end of subreach.

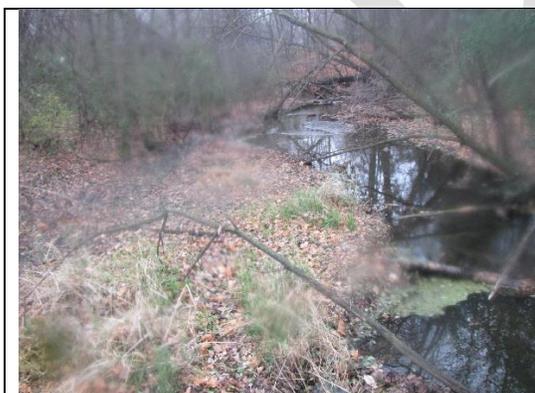
**IMG\_2184**

Staff encountered a fair amount of woody debris immediately following the start of the subreach (IMG\_2184). Like the previous subreach, vegetation was observed growing in-stream. Upon construction of the Bearpath Trail bridge, a large amount of riprap was placed for bank stabilization (IMG\_2185). Additional boulders were placed for bank protection and used to create an artificial riffle downstream of the bridge as well (IMG\_2186, IMG\_2187). About 45ft downstream of the bridge, staff observed some exposed erosion blankets on the right bank behind the boulders (IMG\_2187). Continuing downstream, a plugged stormwater culvert was found on the right bank which was causing some minor erosion (IMG\_2188). Following the District's regular creek sampling site (R3), the surrounding slopes began to flatten out. Staff observed some erosion and undercutting along the left and right banks that measured 1ft high and continued for 50ft as the stream shifted south (IMG\_2189). Staff ended this subreach at the walking bridge/cart path seen in IMG\_2190. The stream widened for a short stretch here before narrowing again.

General stream picture; woody debris.

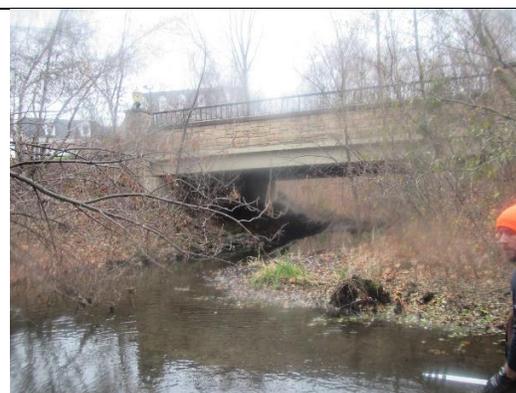
**IMG\_2185**

Bearpath Trail.

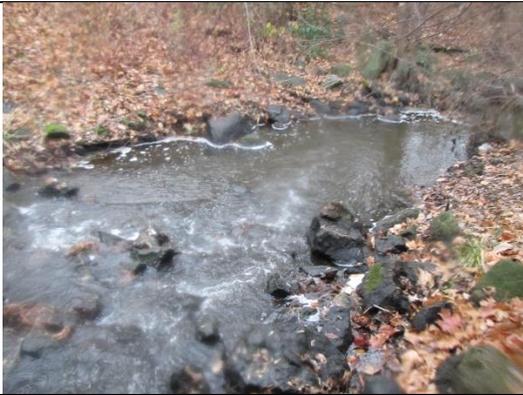
<p><b>IMG_2186</b></p> <p>Boulder riffle; boulders placed for bank stabilization.</p>

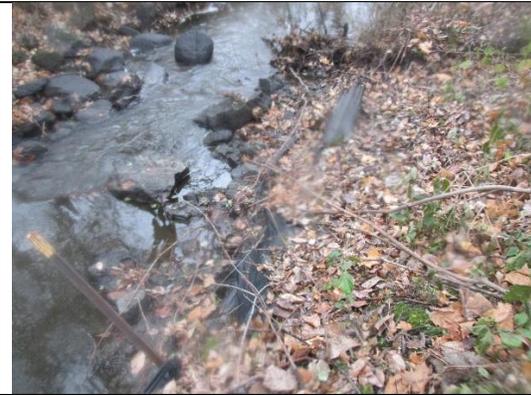
<p><b>IMG_2187</b></p> <p>Boulder riffle; exposed erosion blanket, RB.</p>

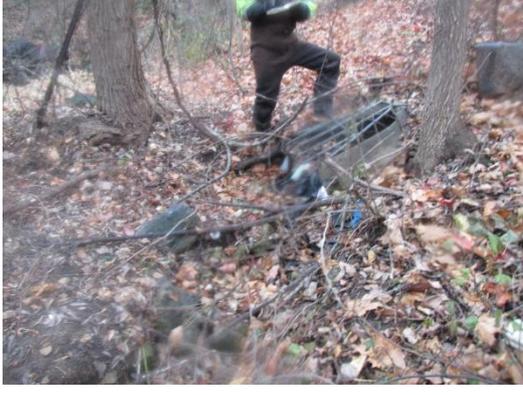
<p><b>IMG_2188</b></p> <p>Stormwater culvert causing minor erosion, RB.</p>

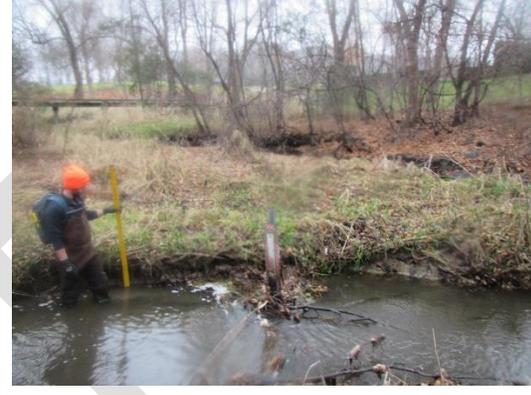
<p><b>IMG_2189</b></p> <p>Erosion along left bank, 1ft by 50ft.</p>

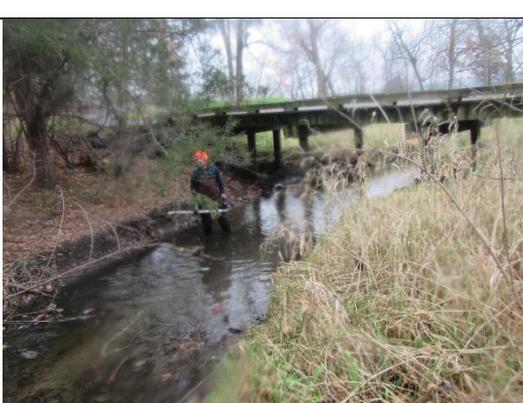
<p><b>IMG_2190</b></p> <p>Walking bridge/cart path over stream; end of subreach.</p>

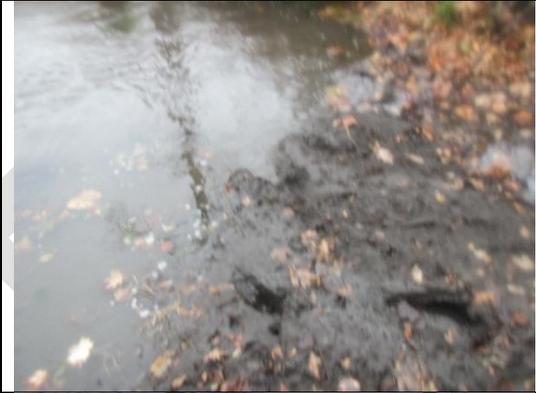
considerable silt deposition in the stream and along the right bank as seen in IMG\_2192. As the stream turned east, there was a stretch of erosion along the outside bend of the right bank measuring 3ft high by 100ft long (IMG\_2193). This erosion reached past the next wooden bridge/cart path (IMG\_2194). Downstream of the bridge was another stretch of erosion along the left bank measuring 2ft high by 20ft (IMG\_2195). At this point, the riparian zone was non-existent; the top of the bank was sparsely covered by patchy, mowed grass (IMG\_2195). The next length of erosion staff observed was on the left bank, measuring 4.5ft high by 40ft as the stream shifted south, heading towards Riley Lake Road (IMG\_2196). The right bank was eroding as well, the erosion measuring 2.5ft by 30ft (IMG\_2197). There were more silt deposits observed here along the left bank (IMG\_2198). Just past the deposition, the outside bend of the left bank was bare and looked unstable (IMG\_2198). The stream shifted south, and staff observed the culvert underneath Riley Lake Road (IMG\_2199). Staff crossed Riley Lake Road and ended the walk at Lake Riley (IMG\_2200, IMG\_2201).

<p><b>IMG_2192</b></p> <p>Silt deposition DS of culvert.</p>

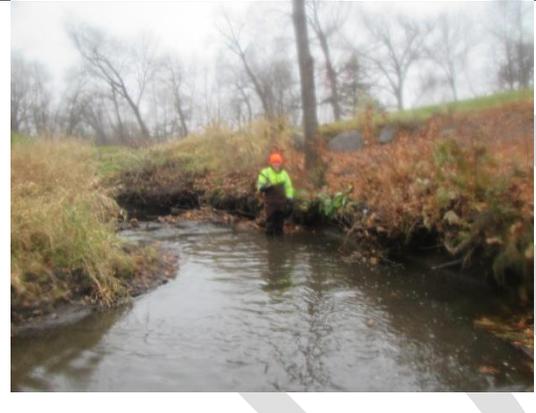
<p><b>IMG_2193</b></p> <p>Erosion 3ft high by 100ft, RB.</p>

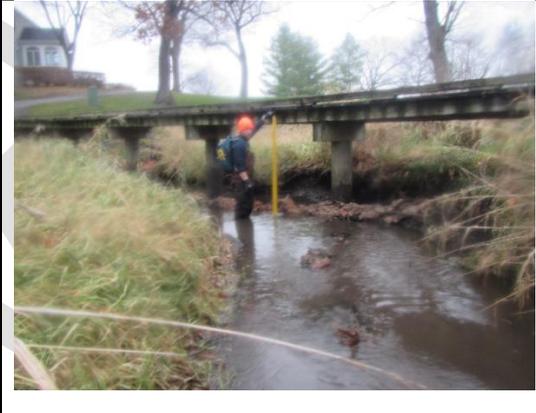
<p><b>IMG_2194</b></p> <p>Walking bridge/cart path; erosion, RB.</p>

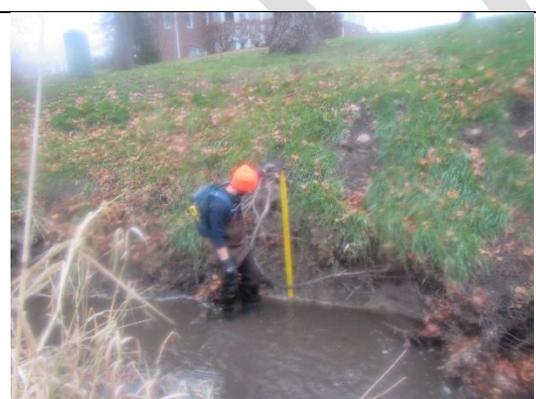
<p><b>IMG_2195</b></p> <p>Erosion 2ft high by 20ft, LB; grass mowed to channel.</p>

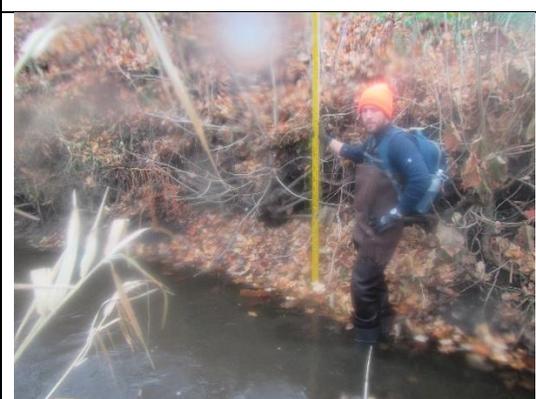
<p><b>IMG_2196</b></p> <p>Erosion 4.5ft by 40ft, LB.</p>

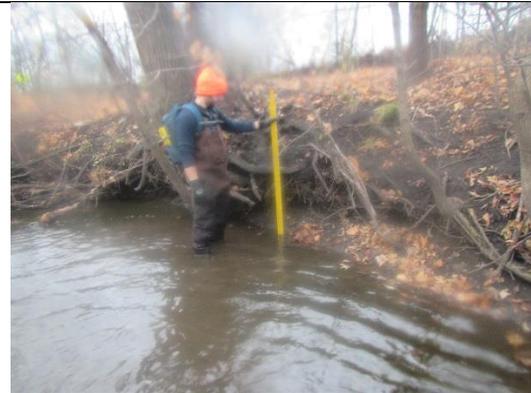
<p><b>IMG_2197</b></p> <p>Erosion 2.5ft by 30ft, RB.</p>

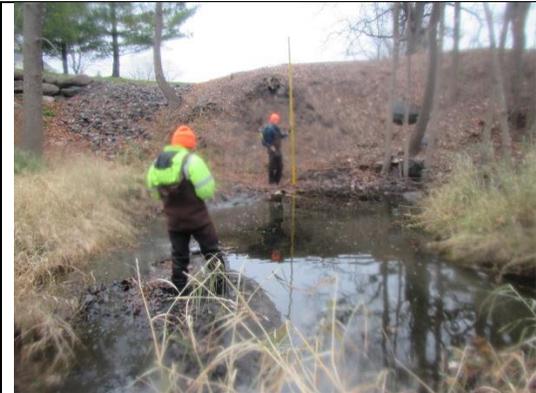
<p><b>IMG_2198</b></p> <p>Silt deposition and bare banks, LB.</p>

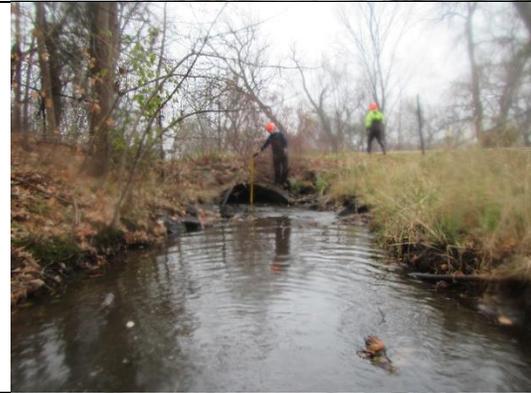
<p><b>IMG_2199</b></p> <p>Culvert under Riley Lake Road.</p>

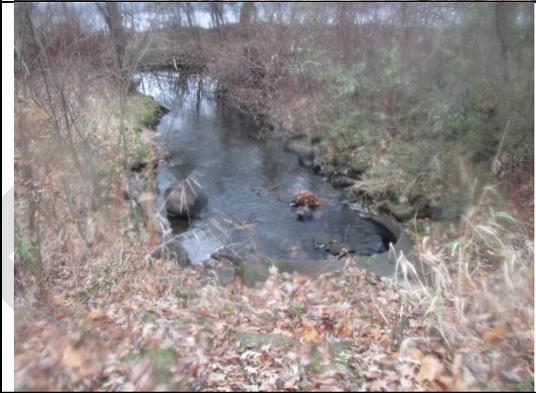
<p><b>IMG_2200</b></p> <p>DS side of culvert under Riley Lake Road.</p>

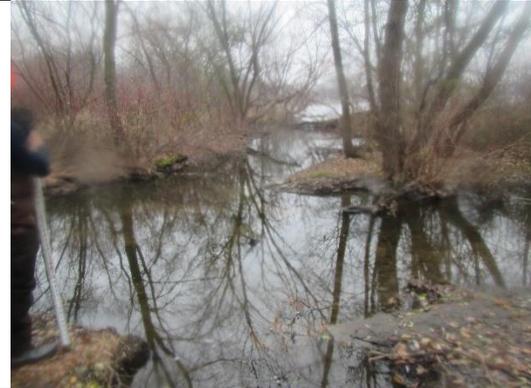
<p><b>IMG_2201</b></p> <p>Lake Riley, end of reach.</p>

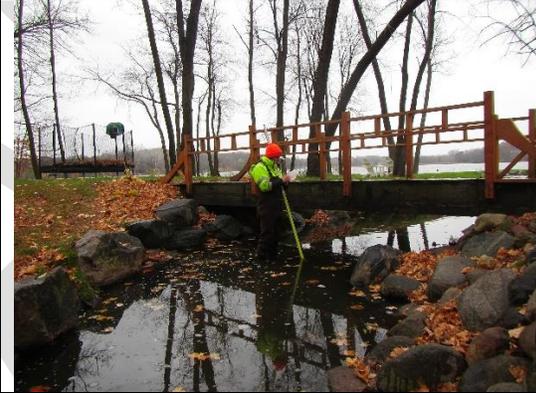
<p><b>IMG_2076</b></p> <p>Bridge just US of Lotus.</p>

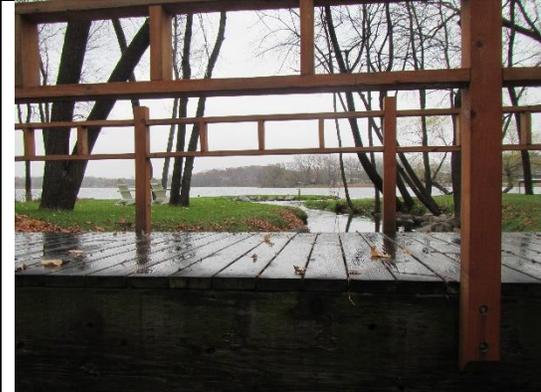
<p><b>IMG_2077</b></p> <p>Bridge US of Lotus; lawns mowed to creek edge.</p>

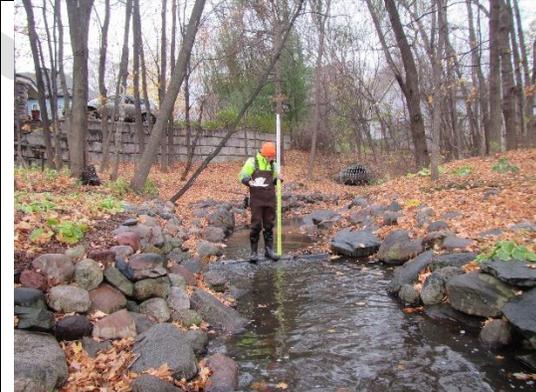
<p><b>IMG_2078</b></p> <p>Placed boulders lining creek banks; check dam, US.</p>

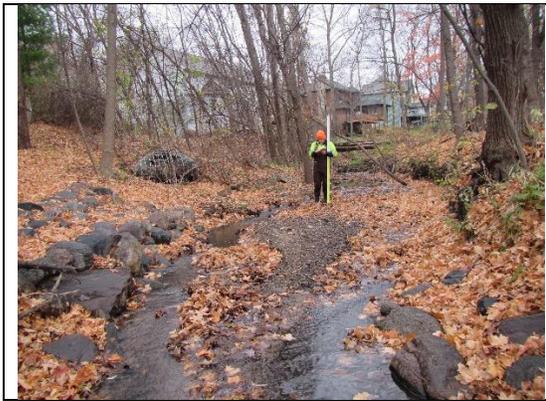
**IMG\_2079**

Deposition island of sand and gravel; SW culvert on RB, US.

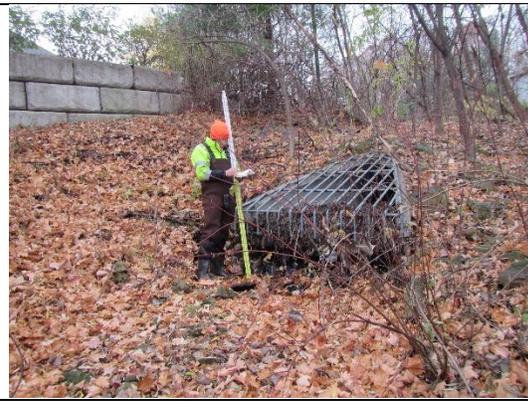
**IMG\_2080**

Staff began the creek walk at Lotus Lake and walked upstream (all photos taken upstream unless noted otherwise). While accessing the creek from Shadowmere Drive, staff observed a large stormwater pond just south of the creek, which collected runoff from the cul-de-sac. The pond had a large overflow structure that drained to the creek (IMG\_2075). Staff noticed trash and debris around this pond as well as erosion around the inlet pipe entering the pond. The channel was surrounded by deciduous forest, but the riparian width was initially narrow, 0-15ft from residential properties along both banks. This changed about half way through the subreach, when the riparian width along the left bank increased to 30-150ft. Initially, the slope gradients of both banks were flat, but quickly increased to include slope gradients greater than 10%. Just upstream of Lotus, a walking bridge spanned the stream, joining the two adjacent properties (IMG\_2076). Leaf litter was the predominant substrate throughout the subreach at the time of the creek walk. Boulders were placed along both stream banks, from the lake to upstream of the bridge, to reduce erosion. The adjacent properties had mowed lawns down to the stream edge (IMG\_2077, IMG\_2078). After the boulders, there was a check dam with landscape fabric covering it in the stream (IMG\_2078). Upstream of the check down was a large sand/gravel deposition island just beneath the stormwater pond outlet culvert (IMG\_2079). The outlet culvert itself was undercut, exposing an erosion blanket, and was clogged with detritus (IMG\_2080).

SW culvert from pond; undercut and clogged with debris; RB, US.

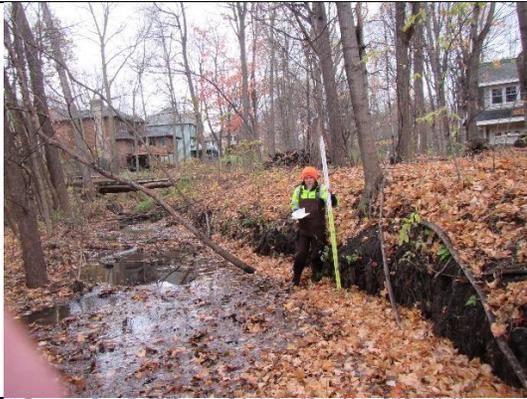
**IMG\_2081**

Continuing upstream, staff observed continuous erosion on the left bank, measuring up to 3ft high (IMG\_2081). The in-stream sediment to this point consisted of gravel/sand in the riffles, sand/gravel in the runs, and sand/silt in the pools. Staff then encountered another bridge, made of large logs and boards (IMG\_2082). Underneath the bridge there was significant undercutting occurring around the footings. After the bridge, the right bank was eroded, measuring about 6ft high, and was covered with an erosion blanket (IMG\_2083). The channel around this section measured about 0.2ft deep and 4ft wide. Further upstream, staff observed erosion on the left bank measuring up to 4ft high stretching for 20ft (IMG\_2085). At this point, there was some chain link fencing in the stream that may have been used to help stabilize the bank (IMG\_2084). Upstream of the fencing, a resident had placed flat rock along both banks which was sloughing into the creek in some locations (IMG\_2086). Hostas lined the upper banks above the rock and with bare soil beneath them. A third wooden walking bridge spanned the channel at this point (IMG\_2086). At the next property line, there were three plastic drain pipes entering the stream from adjacent homes on the right bank (IMG\_2087).

Continuous,  
3ft erosion,  
LB, US.

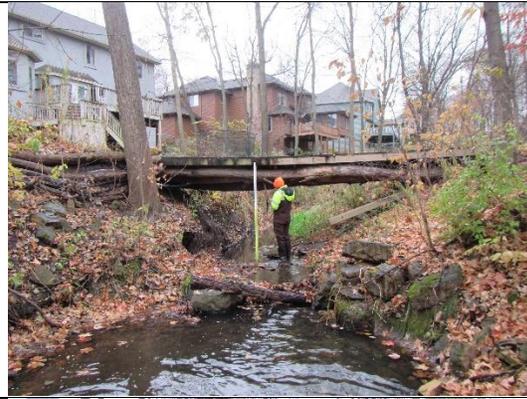
**IMG\_2082**

Log bridge  
over creek,  
US.

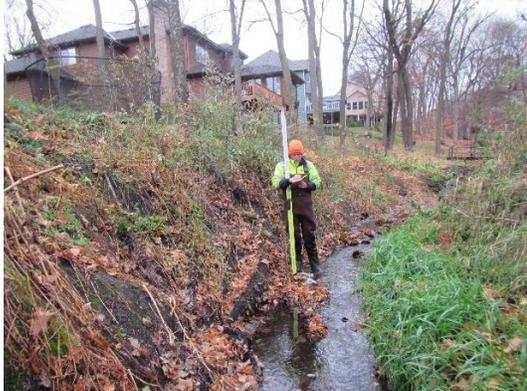
**IMG\_2083**

Erosion  
covered by  
erosion  
blanket; RB,  
US.

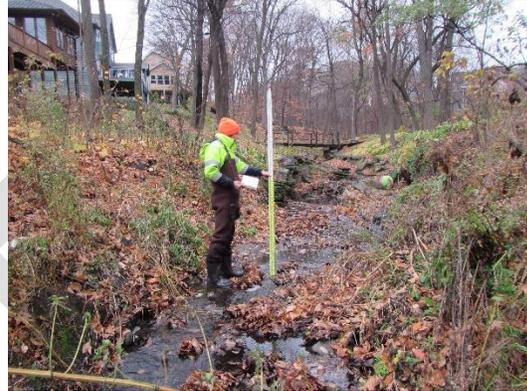
**IMG\_2084**

Wire  
fencing in  
stream; US.

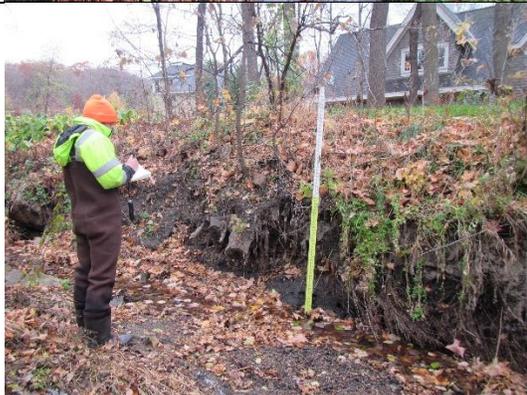
**IMG\_2085**

Erosion on  
LB.

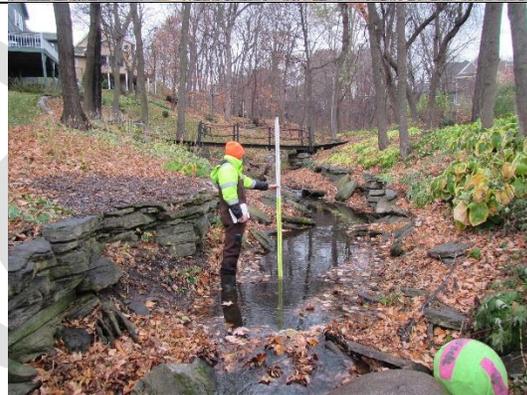
**IMG\_2086**

Rock lining  
stream;  
hostas on  
banks; 3<sup>rd</sup>  
bridge  
across  
stream; US.

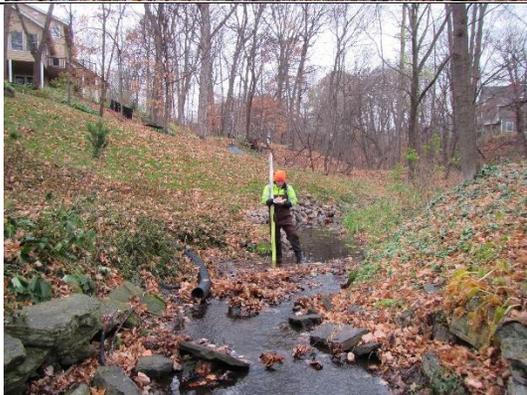
**IMG\_2087**

Plastic drain  
pipes; RB,  
US.

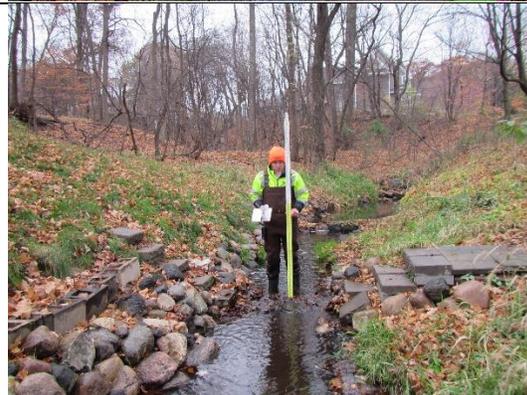
**IMG\_2088**

At this point, the bank slope gradient became more variable; some slopes reached gradients steeper than 40%. Moving upstream, there was a man-made stream crossing with stairs made from pavers (IMG\_2088). The pavers were in-stream and restricting flow. Just upstream of the crossing was a small boulder check dam (IMG\_2088). Upstream of the check dam was a large rock riffle (IMG\_2089). The riparian width increased about 50ft on both sides. The stream turned south, and staff observed another check dam (IMG\_2090). There was a stormwater culvert and a small, black, plastic drainage pipe entering the channel on the left bank (IMG\_2090). North of the stormwater culvert was a large pond that was separated from the creek by a narrow berm. Erosion measuring up to 3ft high extended 30ft upstream from the culvert (IMG\_2090). Continuing upstream, the left bank gradient increased, reaching slopes of 60% to 70%, while the right bank flattened (less than 5%, IMG\_2091). There was also erosion along the left bank, measuring 1.5ft high (IMG\_2091). The riparian zone then increased in size along both banks. Staff started to observe horse tail reed in large densities lining both banks (IMG\_2091). Staff soon encountered the first mass wasting site observed in this tributary on the left bank, measuring 15ft tall by 20ft (GPS point: PT2DE1, IMG\_2092). The estimated bank-full measurement at this point was 2ft deep by 9ft wide.

Man-made  
stream  
crossing;  
boulder  
check dam;  
US.

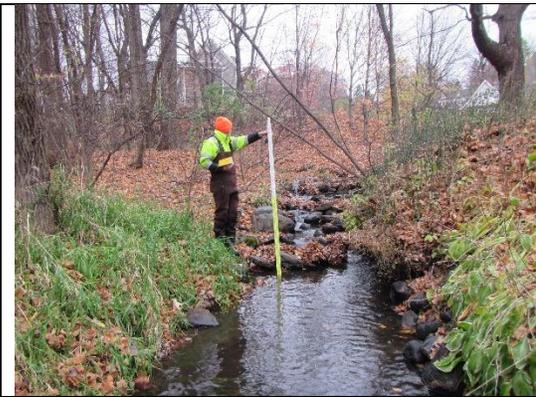
<p><b>IMG_2089</b></p> <p>Large rock riffle; US.</p>

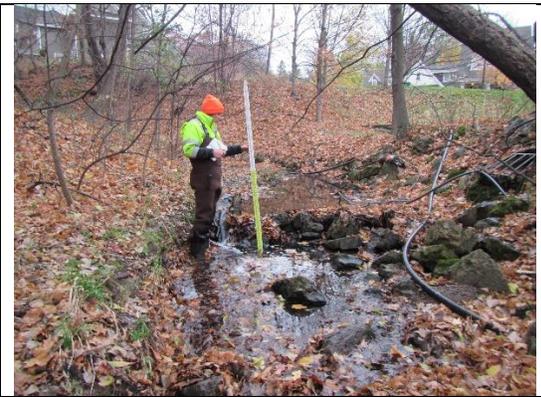
<p><b>IMG_2090</b></p> <p>Large rock riffle; black pipe and SW culvert entering channel on LB; US.</p>

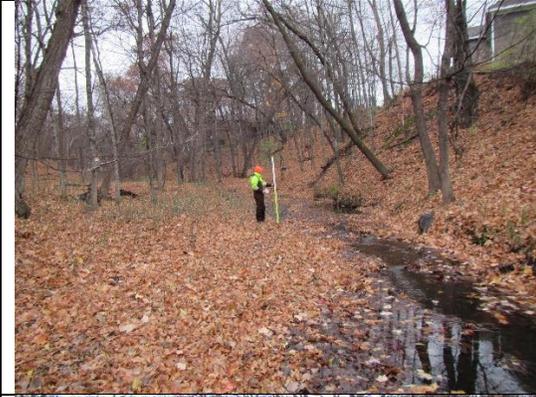
<p><b>IMG_2091</b></p> <p>Native vegetation; increased slope gradient on LB; US.</p>

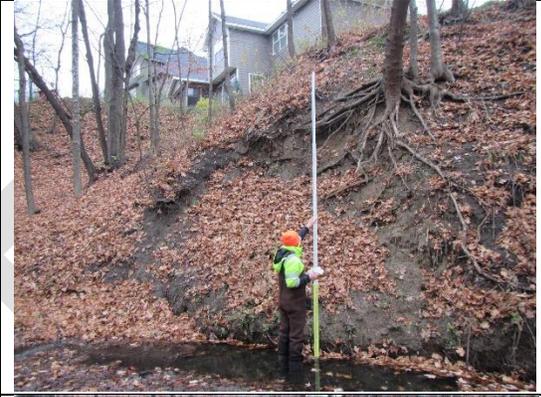
There were two areas exhibiting mass wasting within this reach. One was in subreach PT2D, measuring about 15ft tall by 20ft wide. The other was located in PT2B where a stormwater culvert on the left bank was severely eroded and created a large scour hole. The lower quarter of PT2D was very incised 3-5ft. Landscaping rock was utilized in this section to stabilize the banks (often failing) and “beautify” the stream. Above the rock, banks were mowed to the edge and/or planted with hostas etc. PT2A was not scored because it was a pond. PT2B was very silted and was incised 3-4 feet. PT2C was a restored by the city of Chanhassen and looked good.

<p><b>IMG_2092</b></p> <p>Mass wasting site PT2DE1; LB, US.</p>

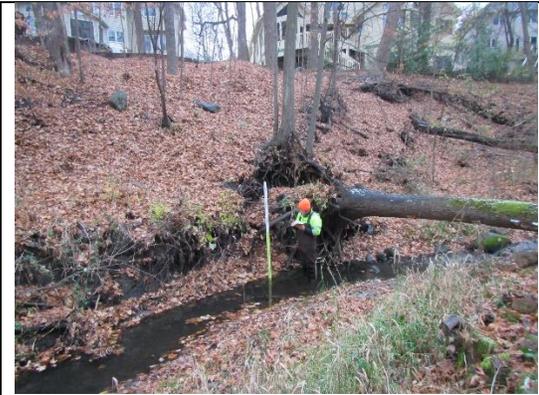
<p><b>IMG_2097</b></p> <p>Erosion 5ft by 20ft, RB; US.</p>

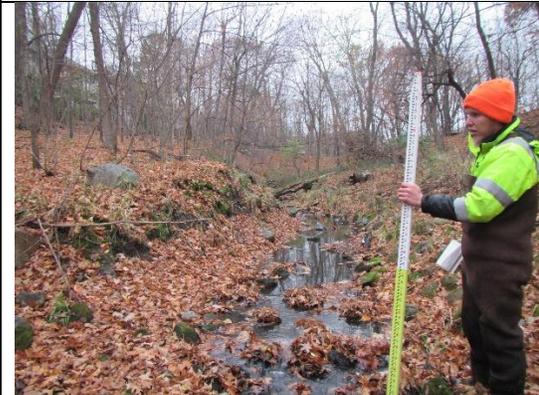
<p><b>IMG_2100</b></p> <p>Erosion 3ft to 5ft high, RB; hard-armored RB; US.</p>

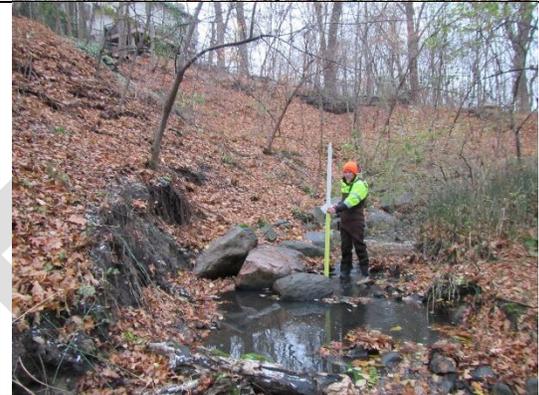
Continuing upstream, there was a former channel setback from the left bank. Just upstream, erosion was occurring on the right bank measuring 5ft high by 20ft (IMG\_2093, IMG2094). Woody debris increased moving upstream (IMG\_2095). There was also a manhole access point on the left bank (IMG\_2096). Across the stream from the manhole cover was some erosion around a fallen tree's roots, measuring 5ft high by 20ft (IMG\_2097). The estimated bank-full at this point was 2.2ft deep by 10ft wide. Continuing upstream, a remnant channel was observed along the right bank next to a large boulder riffle within the channel (IMG2\_098). Further upstream, there was a stretch of erosion measuring 3ft to 5ft high along the RB, opposite a hard-armored left bank (IMG\_2100). Staff noticed another black, plastic drainage pipe on the right bank (IMG\_2101). At this point, the stream shifted north, and the outside bend of the right bank was lined with large boulders. The boulders on the downstream end of the placement had fallen into the stream and large amount of erosion was occurring on the right bank above them (IMG\_2102).

<p><b>IMG_2102</b></p> <p>Erosion, RB; large boulders in—stream; US.</p>

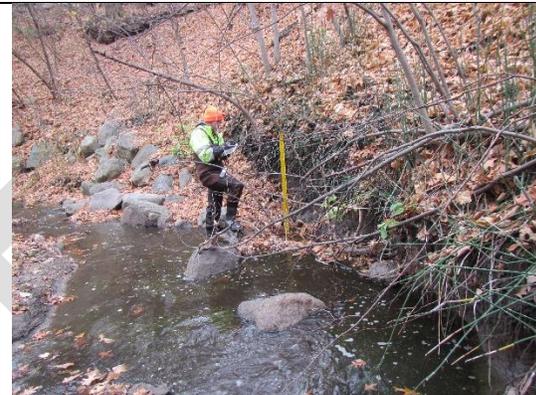
<p><b>IMG_2152</b></p> <p>Erosion 4ft high by 20ft, RB.</p>

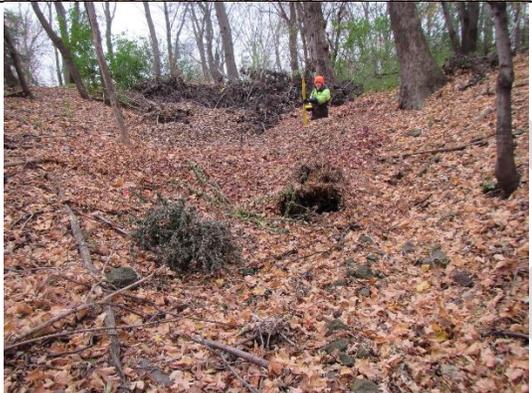
**IMG\_2110**  
Large dump site/wood pile blocking stream.

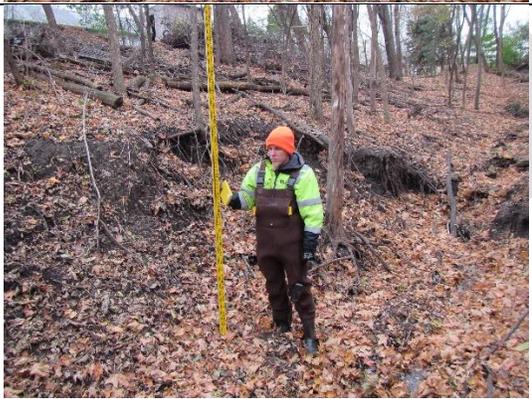
Where the stream started flowing, the left bank was incised 3ft to 6ft high, stretching for about 100 yards (IMG\_2112). The sediment in this subreach was predominantly a silt and sand mixture, some areas containing gravel (IMG\_2113) Gravel and sand were the predominant substrate in the riffles. Staff also observed boulders sparsely located in and along the channel throughout the subreach. There was a lot of woody debris and detritus throughout the subreach (IMG\_2114). Continuing downstream, the stream was incised 4ft to 5ft high for 100ft on the left bank (IMG\_2114) and for 50ft on the right bank. Most of the soil around the creek and on the banks was bare, with limited vegetative cover. Staff then walked a stretch of creek that was rather straight, with a very low, wide channel (IMG\_2115). The creek shifted south. There was a large woody debris pile just upstream of a small, wooden walking bridge crossing the channel (IMG\_2116). Just after the bridge, staff observed another woody debris jam which was creating a mini waterfall (IMG\_2117); there was also erosion along the right bank measuring 0.8ft high (IMG\_2117).

**IMG\_2112**  
Start of stream flow; erosion on RB, 3ft to 6ft high for 100yd.

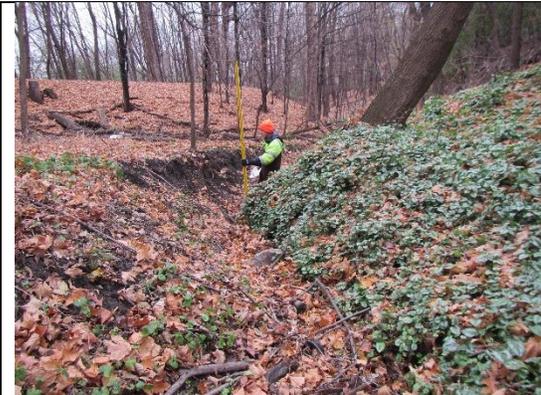
<p><b>IMG_2114</b></p> <p>Erosion 4ft to 5ft high for 100ft, LB.</p>

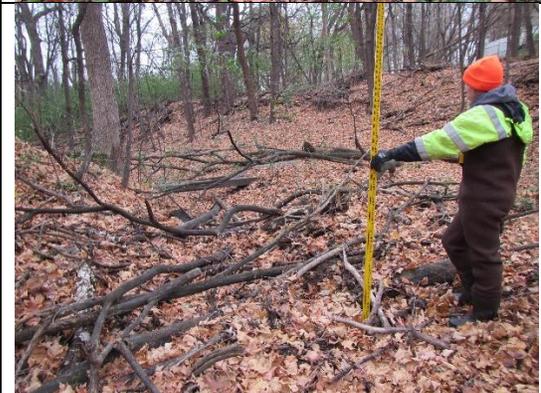
<p><b>IMG_2116</b></p> <p>Large woody debris pile US of small wooden bridge over stream.</p>

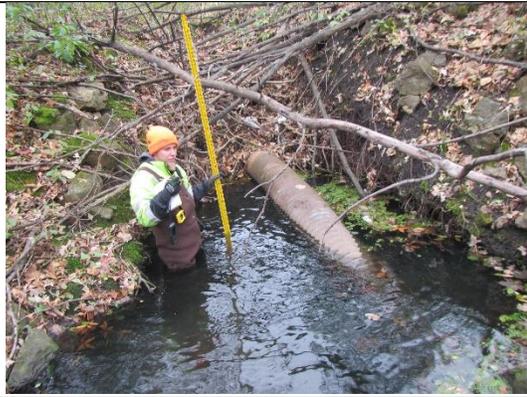
**IMG\_2121**

Mass wasting site PT2BE1; stormwater culvert on LB.

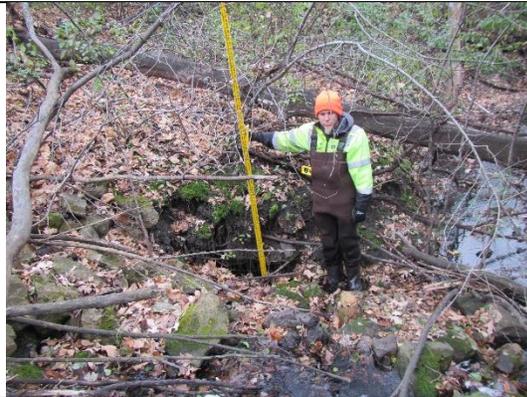
**IMG\_2122**

Mass wasting site PT2BE1 (continued).

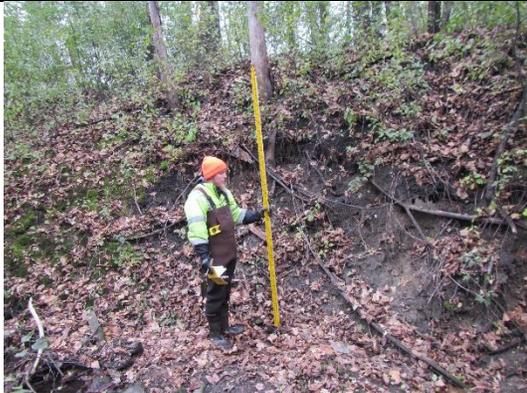
**IMG\_2123**

Erosion on LB, 6ft by 12ft.

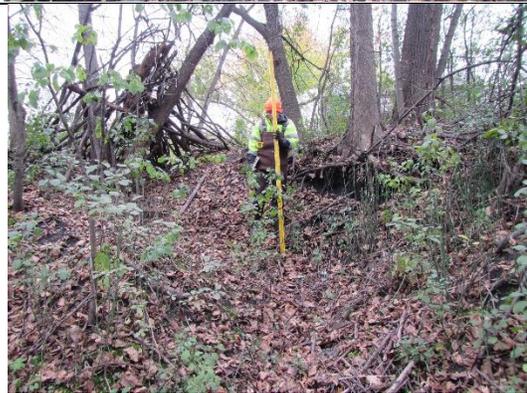
**IMG\_2125**

Partially eroding ravine, LB.

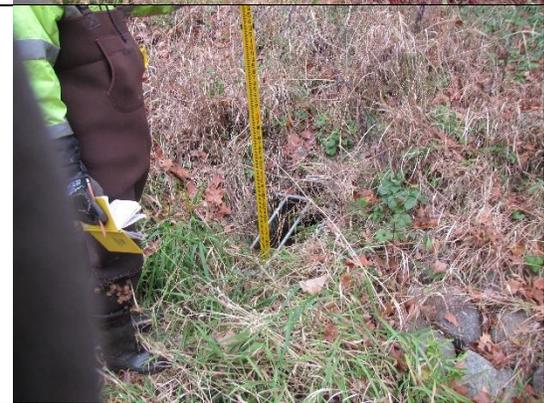
<p><b>IMG_2138</b></p> <p>Stormwater culvert leaving channel, LB.</p>

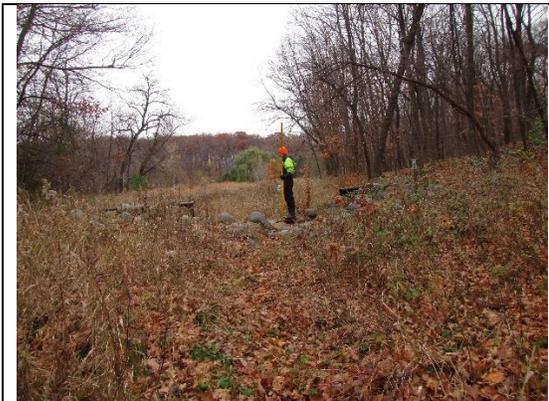
<p><b>IMG_2139</b></p> <p>Fourth weir structure.</p>

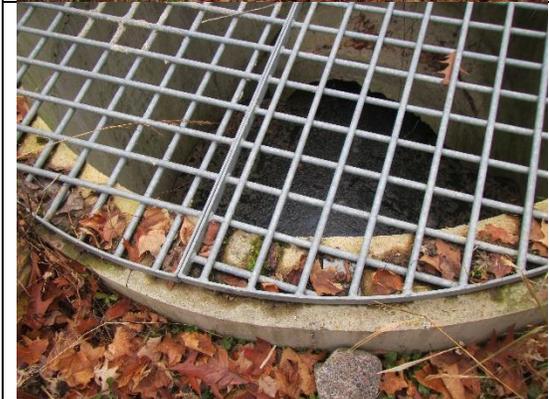
<p><b>IMG_2141</b></p> <p>Overflow structure; piped creek inside structure.</p>

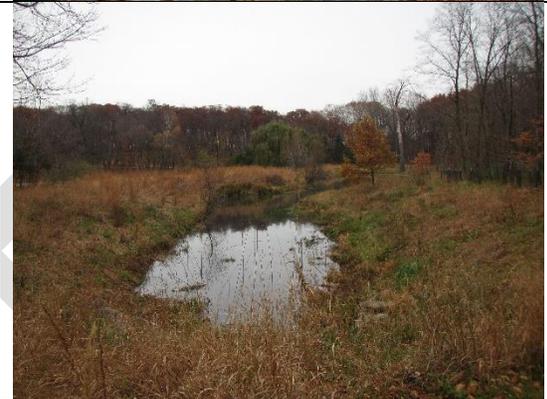
<p><b>IMG_2142</b></p> <p>Stream daylighting into diked pond.</p>

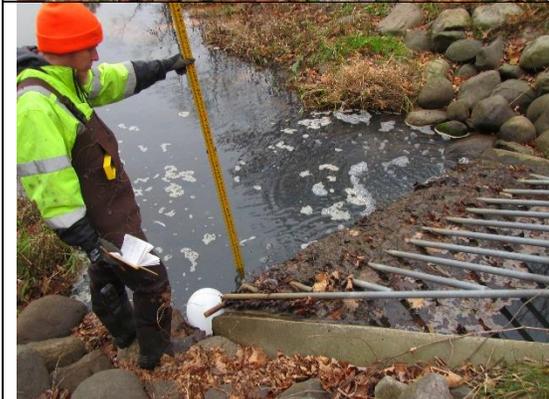
<p><b>IMG_2143</b></p> <p>Inlet culvert entering pond clogged with debris.</p>

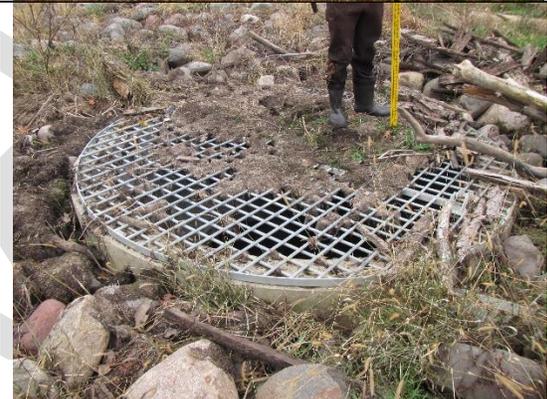
<p><b>IMG_2144</b></p> <p>Overflow structure at west end of pond.</p>

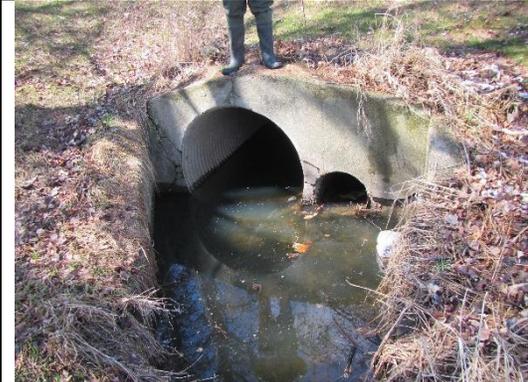
<p><b>IMG_0406</b></p> <p>Culvert draining into Lotus Lake; US.</p>

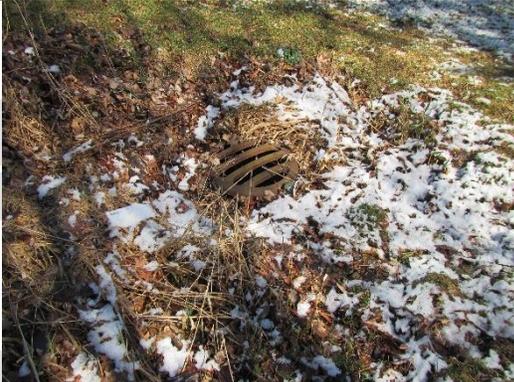
<p><b>IMG_0407</b></p> <p>Storm drain leading to Lotus.</p>

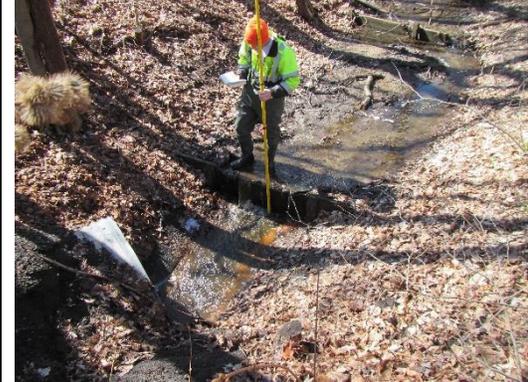
Staff began this walk at the culvert and storm drain just east of Frontier Trail, at the west upper bank of Lotus Lake (IMG\_0406, IMG\_0407). Staff continued across Frontier Trail to the culvert on the upstream side (IMG\_0408, IMG\_0409); here they observed two wooden weir structures holding back about 0.3ft of water

<p><b>IMG_0408</b></p> <p>Wooden Weirs (x2).</p>

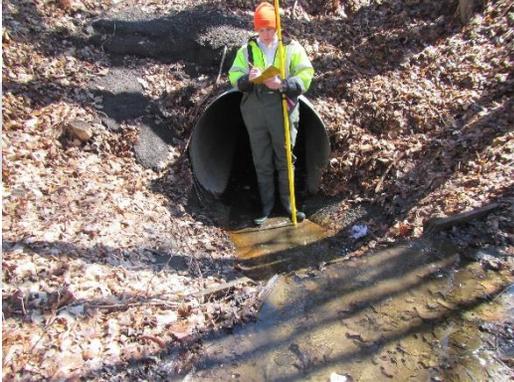
<p><b>IMG_0409</b></p> <p>Culvert under Frontier Trail.</p>

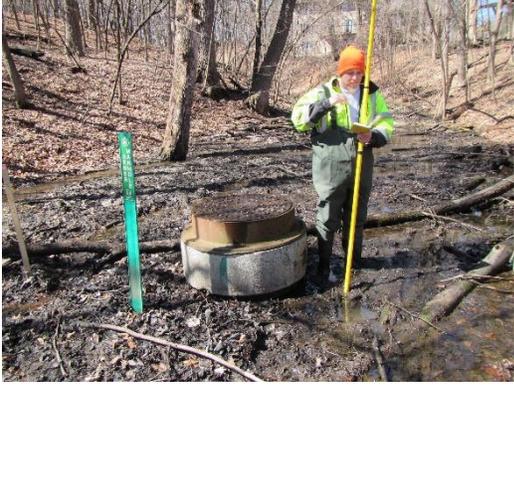
<p><b>IMG_0411</b></p> <p>Raised manhole within channel.</p>

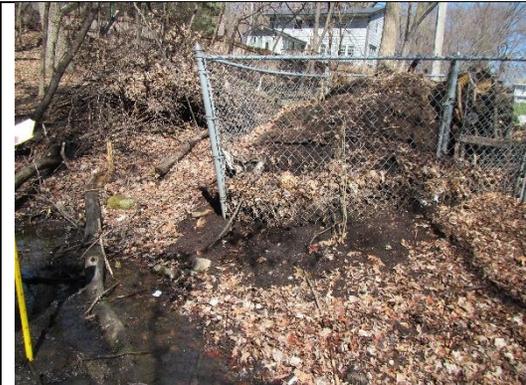
There was little bank erosion and the channel was stable (moderate/high). Near Frontier Trail on the left bank was a compost pile spilling into the stream. Smaller yard waste dump sites were found along the reach. There was potential for erosion on the banks of the middle section of the reach, most of the soil there was bare and fallen trees were scattered along the steep slopes of this area.

<p><b>IMG_0412</b></p> <p>Compost pile falling into stream, LB.</p>

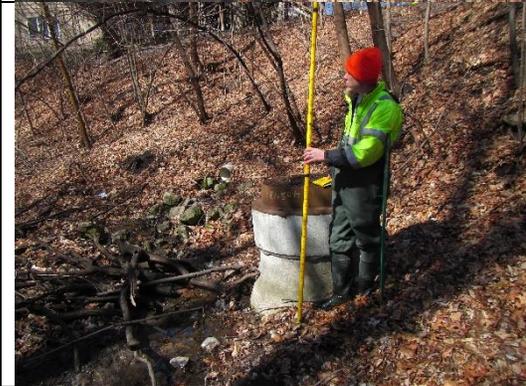
<p><b>IMG_0414</b></p> <p>Second raised manhole, LB.</p>
