# Water Resources Report

RILEY PURGATORY BLUFF CREEK WATERSHED DISTRICT  
2017 ANNUAL REPORT

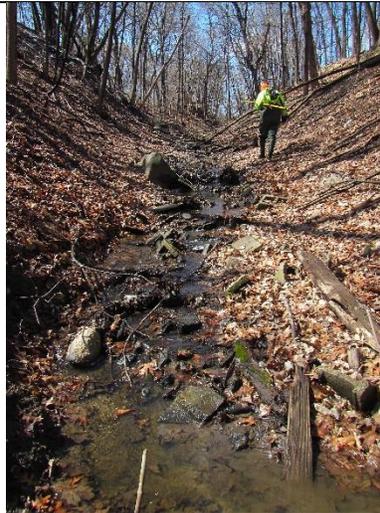
**IMG\_0417**

The channel continued to lack sinuosity and channel development (riffle/run/pool) as staff moved upstream. The stream was very straight but contained both riffles and runs. One of the riffles encountered by staff had cinder blocks and scrap wood discarded in it (IMG\_0417). About 45ft upstream of this riffle was a third manhole (IMG\_0418). Continuing upstream, staff observed a storage shed on the upper slopes of the right bank (IMG\_0419); the shed could potentially fall into the channel if the steep bank gave way. Towards the end of the reach, herbaceous ground cover was growing on the banks. Staff encountered a small, wooden bridge across the stream and a fourth manhole access just upstream (IMG\_0420). There was a heavy amount of woody debris at this point in the walk (IMG\_0420, IMG\_0422). On the right bank a 4in PVC pipe was entering the channel from the residence above, possibly a sub pump pipe (IMG\_0421). After passing the last manhole and heavy woody debris, staff approached the end of the reach and the culvert running below a walking path from Kerber Pond (IMG\_0423); the area around the culvert had eroded away. At the outlet of the pond, staff observed an overflow structure (IMG\_0424). At the west end of the pond was a wetland drainage area which drained into the pond (IMG\_0427). Just south of the pond outlet and the pond was a second, small stormwater pond (IMG\_0428, IMG\_0429).

Riffle with cinder blocks and discarded wood.

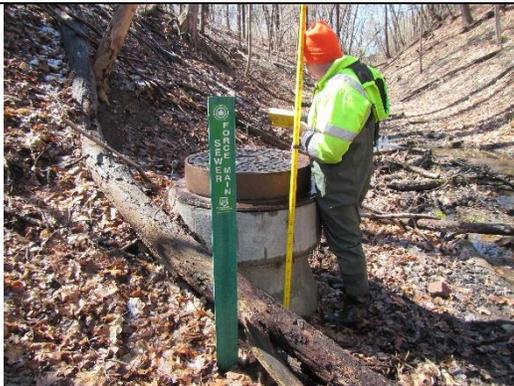
**IMG\_0418**

Third raised manhole, RB.

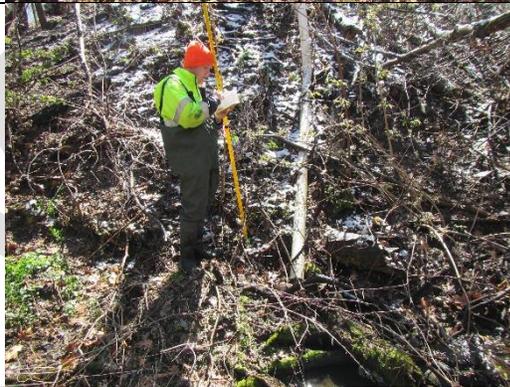
**IMG\_0421**

4in PVC pipe entering stream from home above, RB.

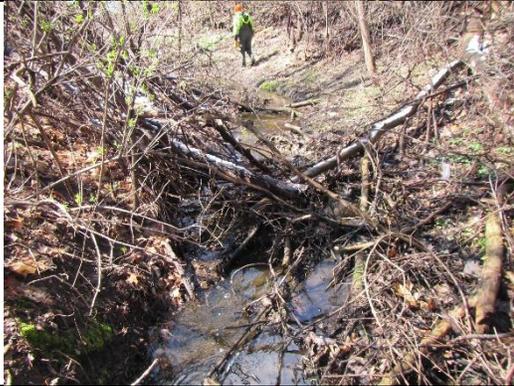
**IMG\_0422**

Heavy woody debris.

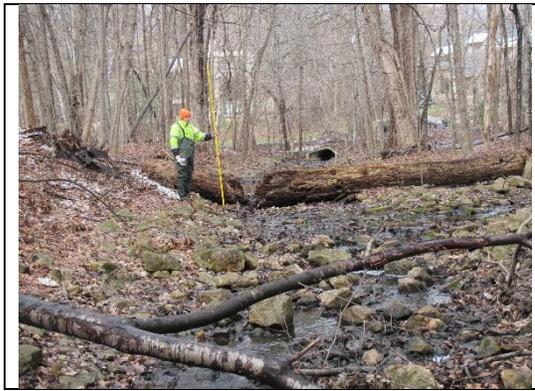
**IMG\_0360**

Tributary converges on stream; large downed tree; boulders in-stream (GPS-115).

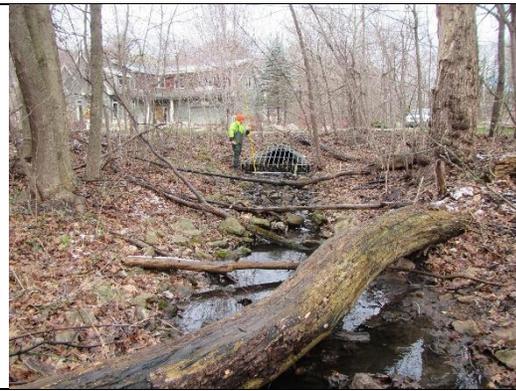
**IMG\_3061**

DS culvert under Frontier Trail.

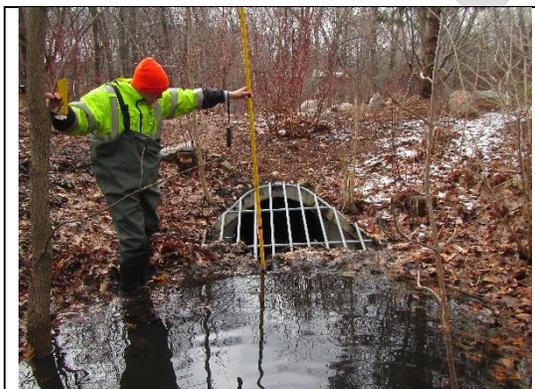
**IMG\_0362**

US culvert under Frontier Trail, clogged with debris.

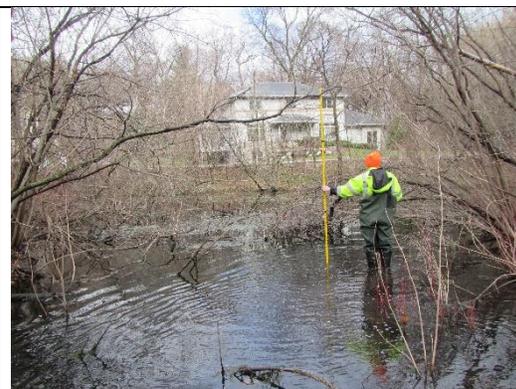
**IMG\_3063**

Pooling water/small pond draining into creek.

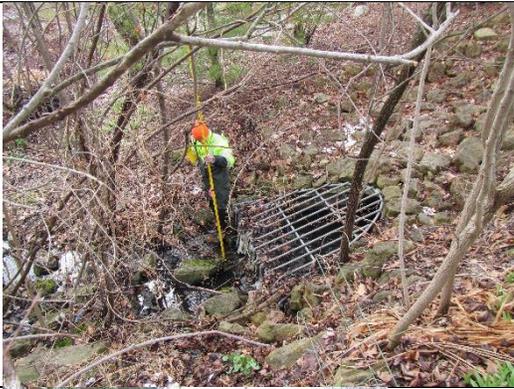
**IMG\_3064**

Culvert draining into first pond.

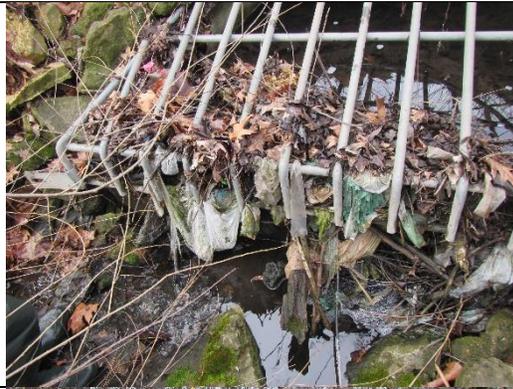
**IMG\_3065**

Culvert above first pond, clogged with debris and garbage.

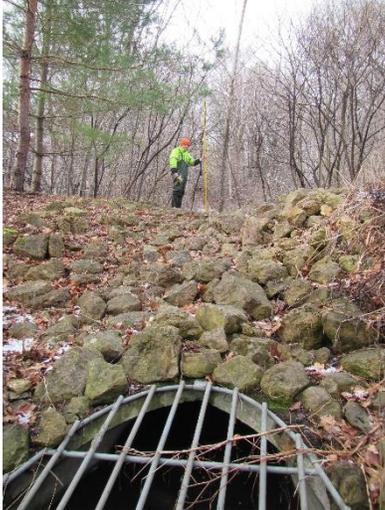
**IMG\_0366**

Placed boulders on berm above culvert.

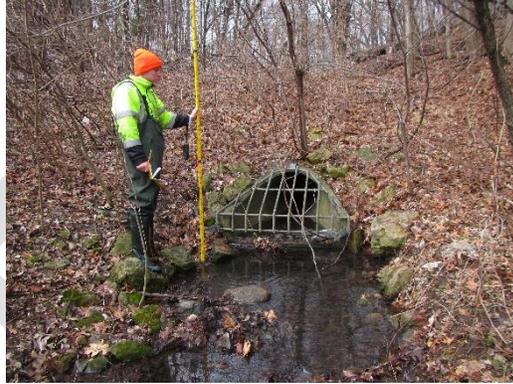
**IMG\_0367**

Culvert draining into second pond.

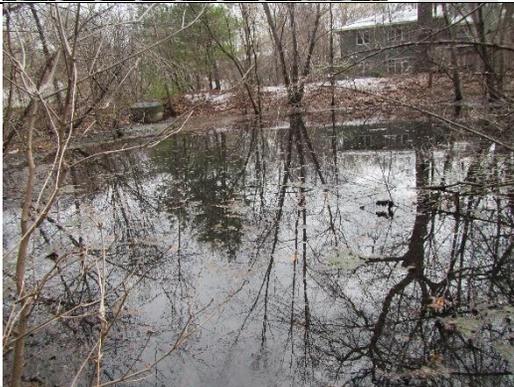
**IMG\_0368**

Second pond draining into creek, DS.

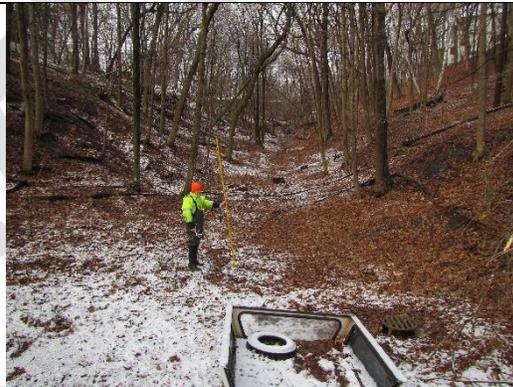
**IMG\_0369**

Stream bed above second pond; no flow/water; garbage in channel; grated overflow drain.

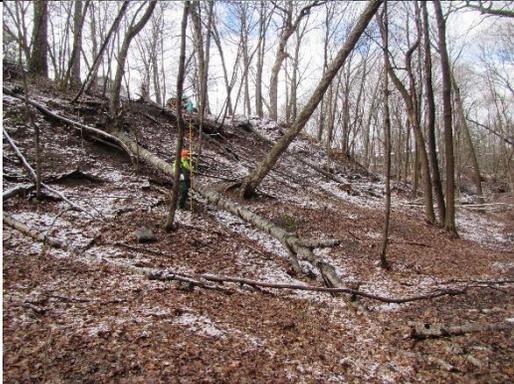
**IMG\_0370**

Fallen trees above dry channel, RB.

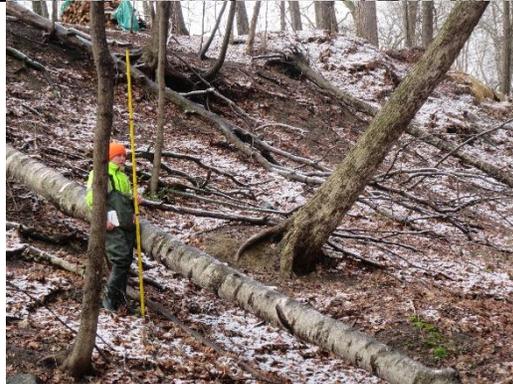
**IMG\_0371**

Fallen trees above dry channel, RB.

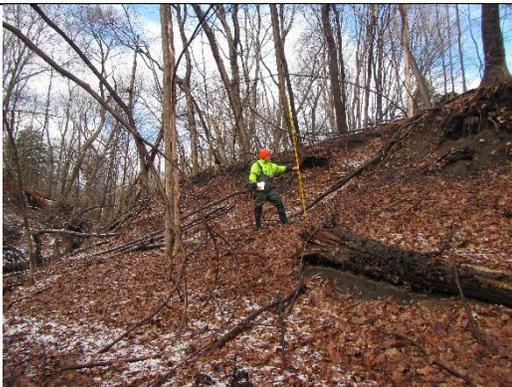
<p><b>IMG_0372</b></p> <p>Scarp/mass wasting along left bank.</p>

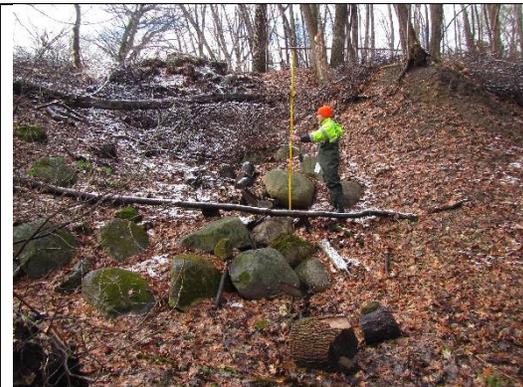
<p><b>IMG_0373</b></p> <p>Large boulders and dump pile, RB.</p>

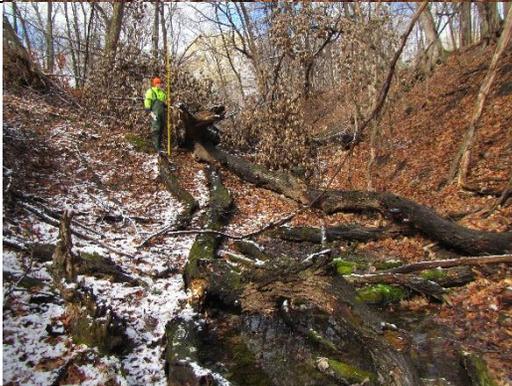
<p><b>IMG_0374</b></p> <p>Large earth berm and fallen tree across channel.</p>

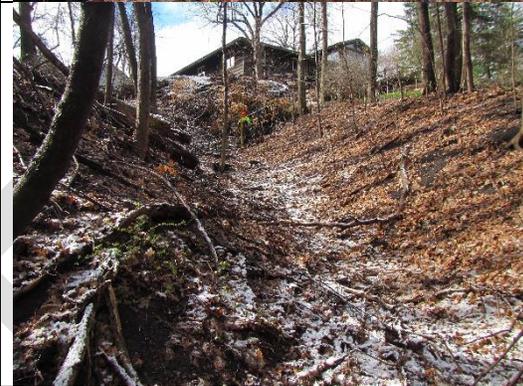
<p><b>IMG_0375</b></p> <p>Large ravine entering channel from right bank; dumpsite at top of ravine.</p>

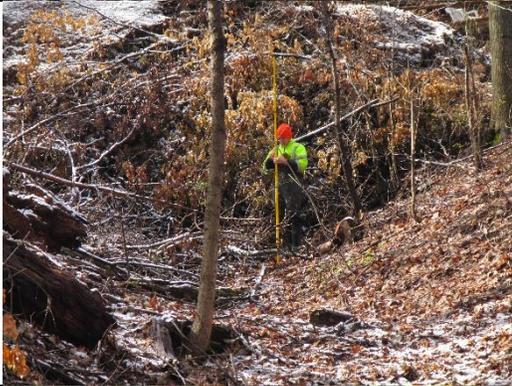
<p><b>IMG_0376</b></p> <p>Dump pile at top of large ravine, right bank.</p>

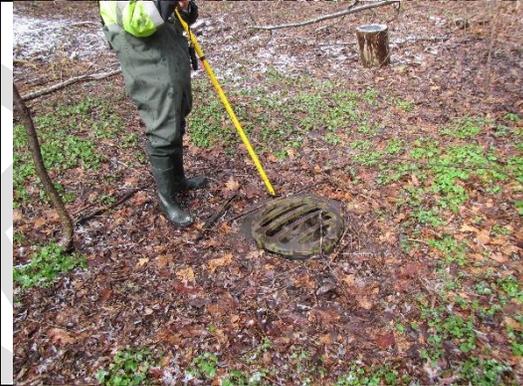
<p><b>IMG_0377</b></p> <p>Storm drain pipe leading to culvert above ponds downstream.</p>

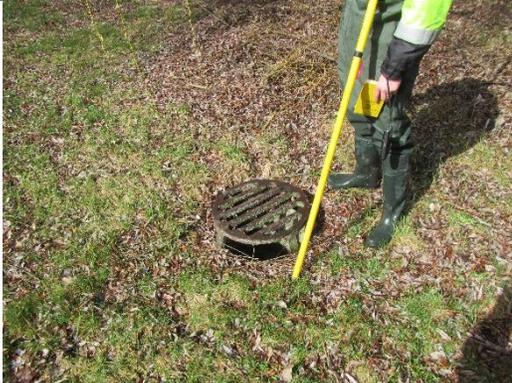
<p><b>IMG_0378</b></p> <p>Second storm drain pipe.</p>

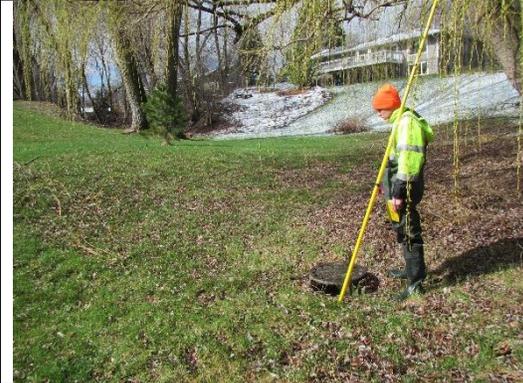
<p><b>IMG_0379</b></p> <p>Second storm drain pipe.</p>

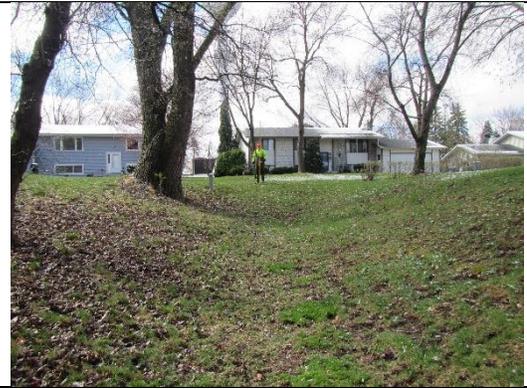
<p><b>IMG_0380</b></p> <p>End of reach at Santa Fe Trail.</p>		
--	---	--	--

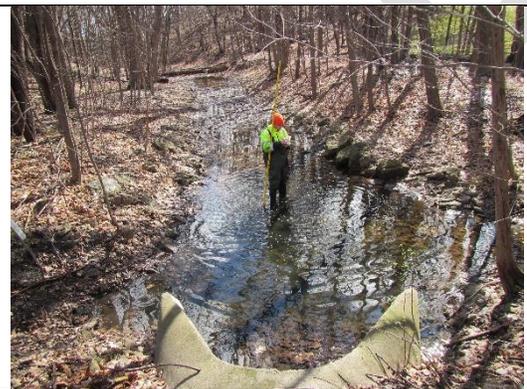
<p><b>IMG_0381</b></p> <p>Second culvert under Frontier Trail, draining into tributary.</p>

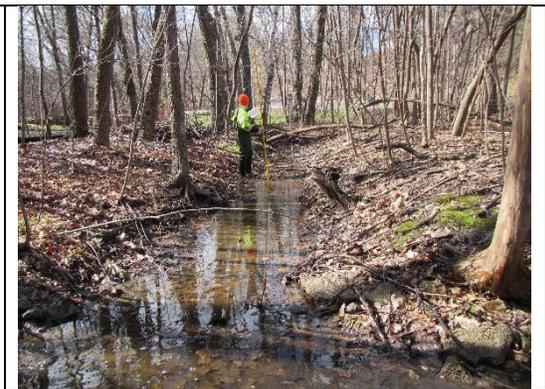
<p><b>IMG_0383</b></p> <p>General stream picture of south tributary draining into reach.</p>
--	---	--	--

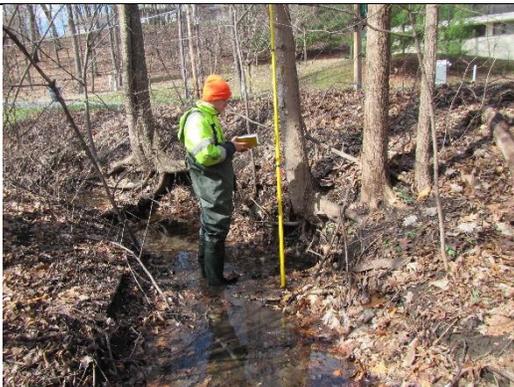
<p><b>IMG_0385</b></p> <p>Erosion along both banks measuring 0.8ft high.</p>

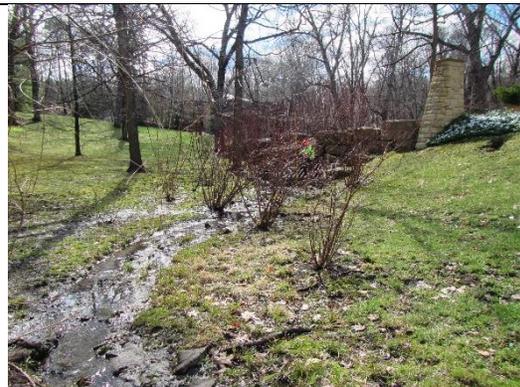
<p><b>IMG_0386</b></p> <p>Stream running through residential lawn.</p>

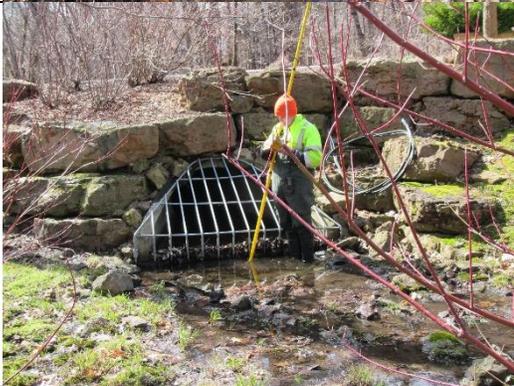
<p><b>IMG_0387</b></p> <p>DS culvert under residential driveway.</p>

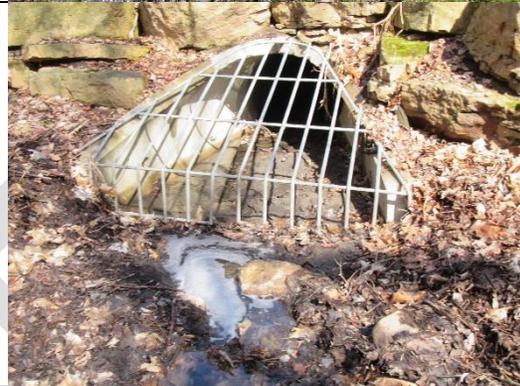
<p><b>IMG_0388</b></p> <p>US culvert under residential driveway; lots of leaf litter and sediment deposition, DS.</p>

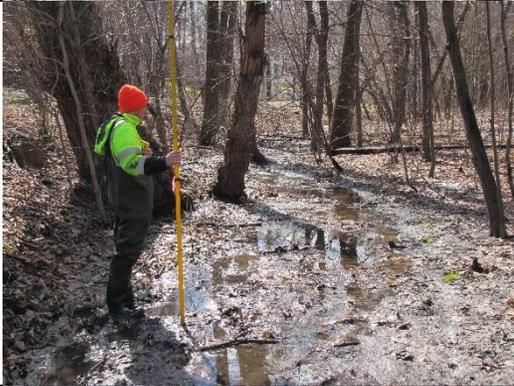
<p><b>IMG_0389</b></p> <p>General stream picture; low water level; sediment deposition.</p>

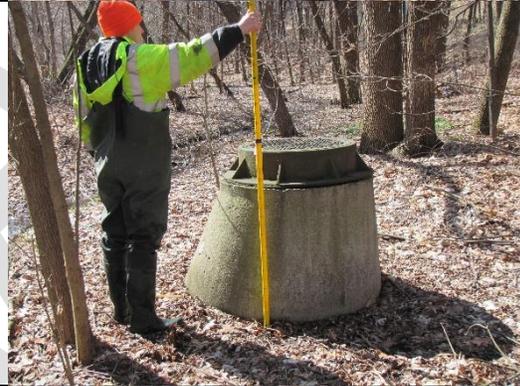
<p><b>IMG_0390</b></p> <p>First raised manhole cover, LB.</p>

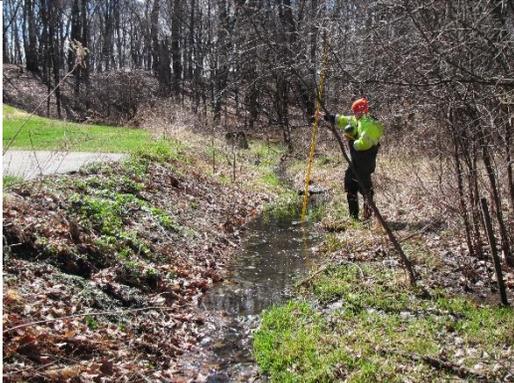
<p><b>IMG_0391</b></p> <p>Ditched along a driveway.</p>

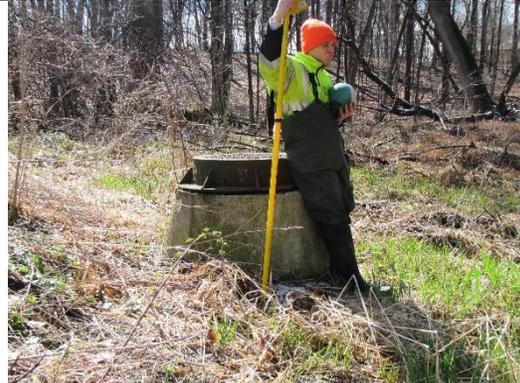
<p><b>IMG_0392</b></p> <p>Second raised manhole cover, RB.</p>

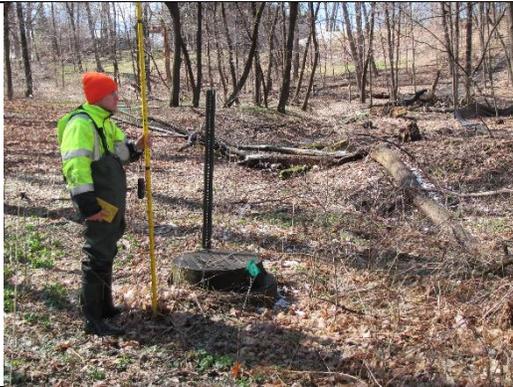
**IMG\_0393**

Third manhole cover, RB.

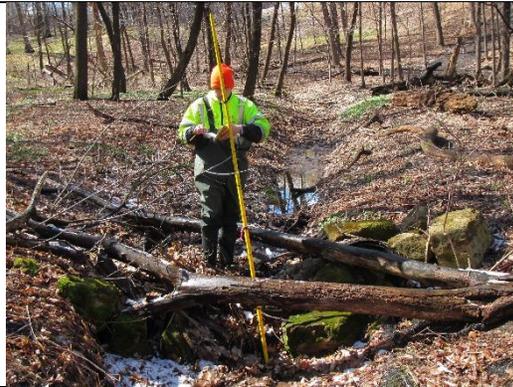
**IMG\_0394**

Woody debris built up at boulder check dam.

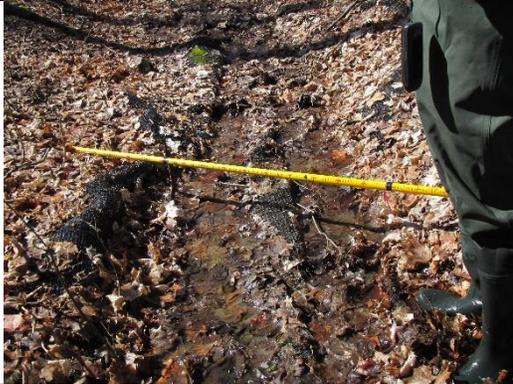
**IMG\_0396**

Stream lined with plastic netting for sediment control.

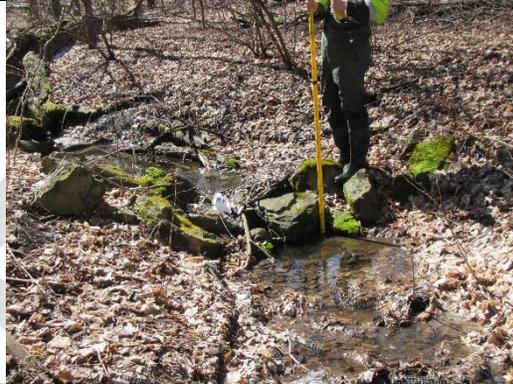
**IMG\_0397**

Second rock check dam.

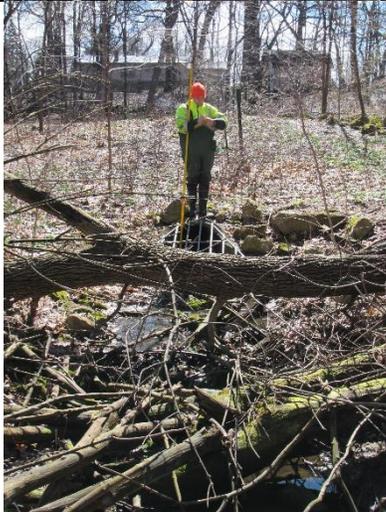
**IMG\_0398**

Heavy woody debris and downed trees; culvert below pond.

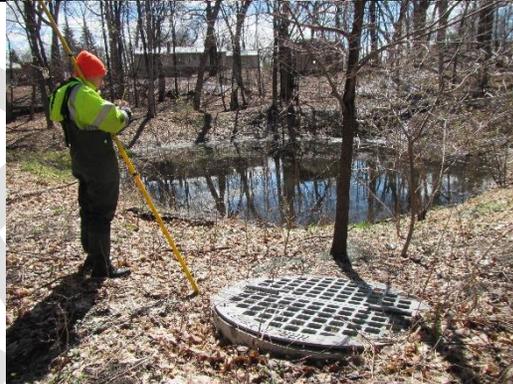
**IMG\_0399**

Overflow structure for pond draining into tributary.

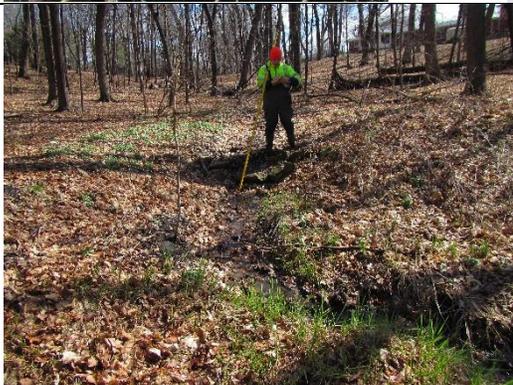
**IMG\_0401**

Check dam above pond.

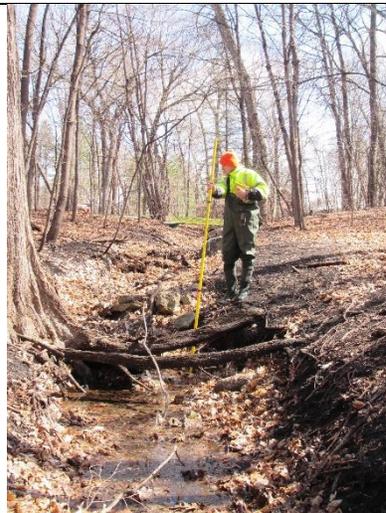
**IMG\_0402**

Second check dam above pond; roots spanning channel width.

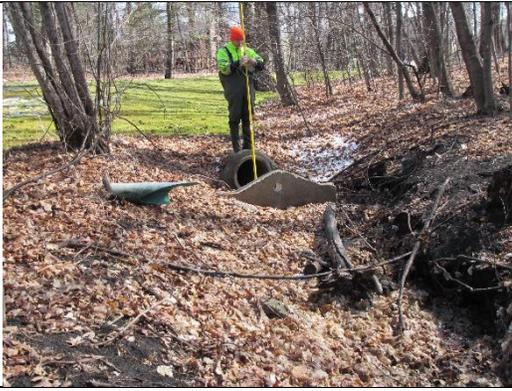
**IMG\_0404**

Old cement stormwater culvert and broken plastic drain tile causing significant erosion.

Overall, the channel within this subreach was fairly stable with relatively little bank erosion. Clogging of culverts by detritus and garbage could be an issue by backing up water. Above the ponds, surrounding bank slopes were steep (up to 60%) and many downed trees were scattered across them. A single mass wasting scarp was observed in this area as well. Bare, exposed soils were common in this stretch. Staff did find multiple yard-waste dump sites. The tributary stream had considerable deposition in slack water areas and above each check dam. The old culvert and the plastic drain tile at the top of the subreach could be replaced to reduce erosion.

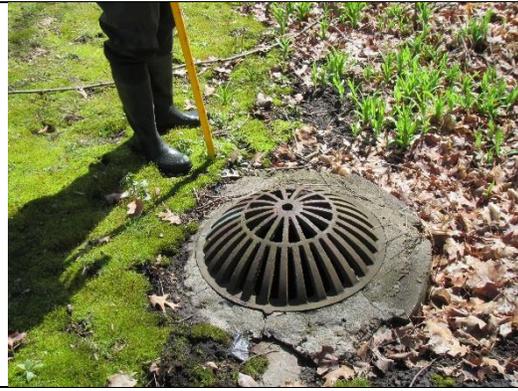
**IMG\_0405**

Storm drain pipe in residential yard; start of tributary.
